Bridge #02138(Routine)
SH 77-02- LM 0.71 over DITCH NO 13

Location: .70 MI S JCT SH 18

Team Lead: Tim Myrick Inspection Date: August 26, 2020

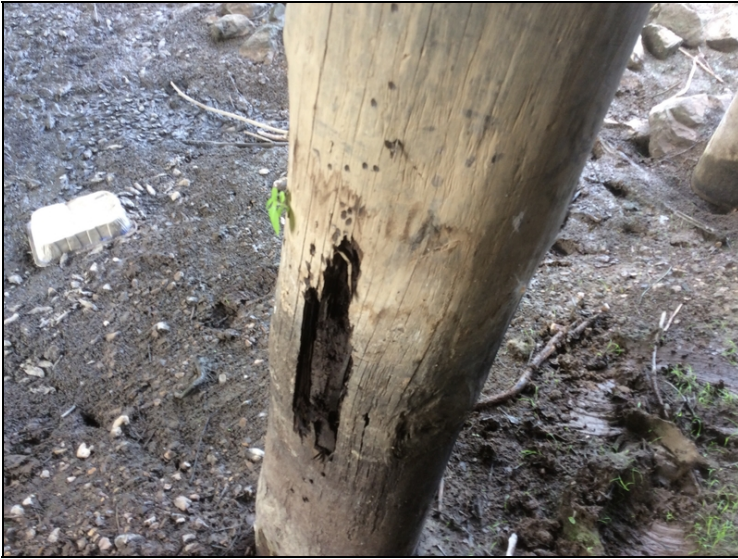
B3 p2

Bent 3 pile 1 & 2 has up to 2" of outside decay approximately 3' up from ground line and partially hollow.

Bent 3 pile 1 has up to 2" of outside decay, 4' high, approximately 3' up from ground line.

Bent 3 pile 2 has 1" outside decay and partially hollow.

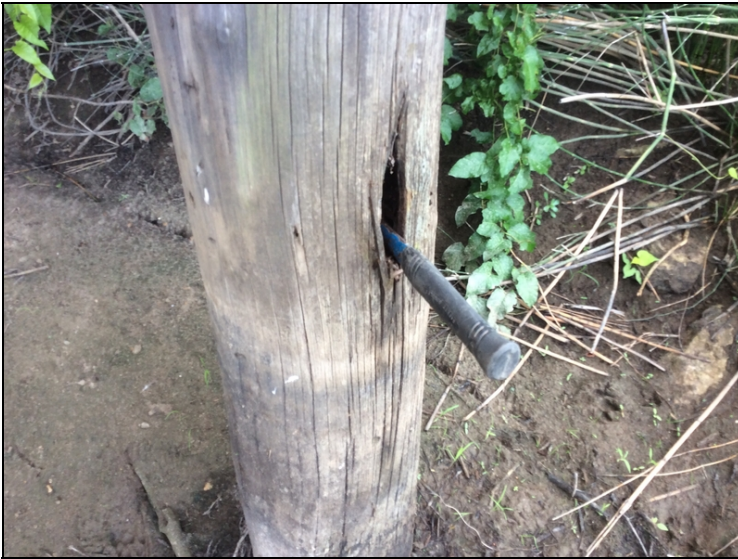
B3 p5

Bent 3 pile 5 bottom 4' has a 1" shell, hollow.

to Dist Bridge Crew for repairs when they have time - KAW 8/30/18
Bridge Crew currently working on other priorities, will continue to monitor. KAW 6/28/19

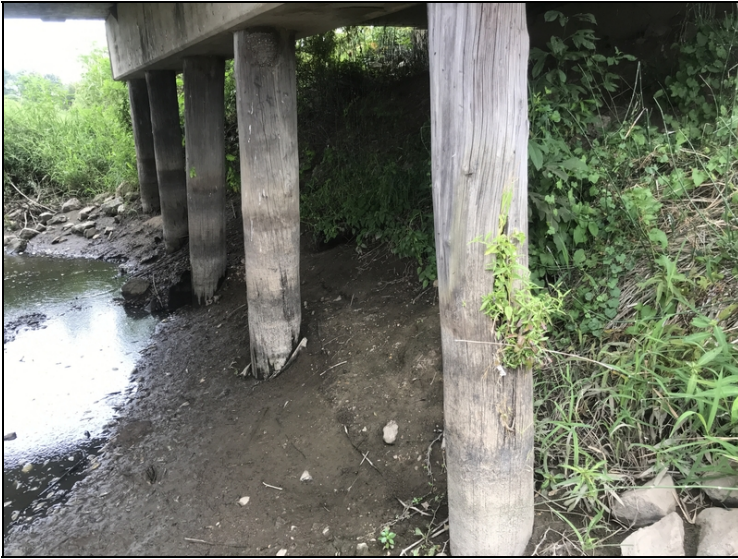
b3 p4 & 5

Bent 3 pile 4 has 1" outside shell, decayed & hollow.
Bent 3 pile 5 bottom 4' has a 1" shell, hollow.

Bent 3 pile 4 has 1" outside shell, decayed & hollow.

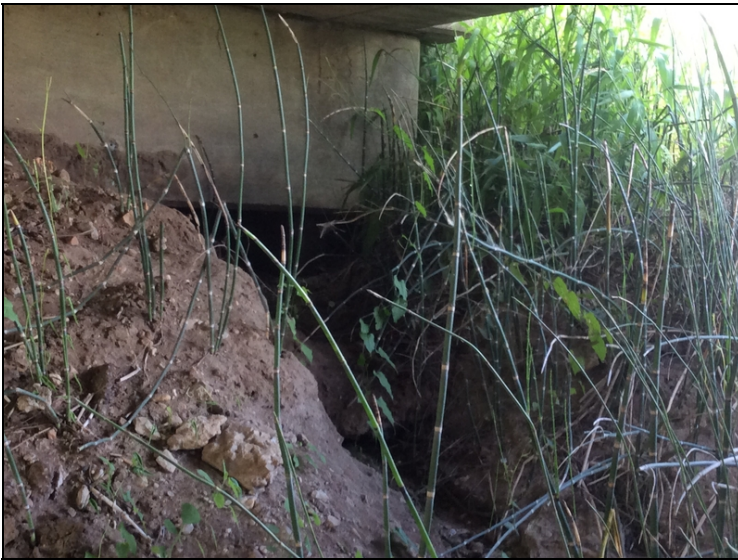
Right end of bent 4 abutment has a 5ft. long area of erosion, 1 ft. below & 2 ft. back under cap, exposing pile 5.

Right end of bent 4 abutment has a 5' long area of erosion, 1' below & 2' back under cap, exposing pile 5.
