Bridge #02141(Underwater type 2, Routine)
SH 77-02- LM 10.42 over Little Rvr Lt Hand Chute

Location: 1.8 MI N JCT SH 140

Team Lead: Alan Walter **Inspection Date:** June 18, 2020

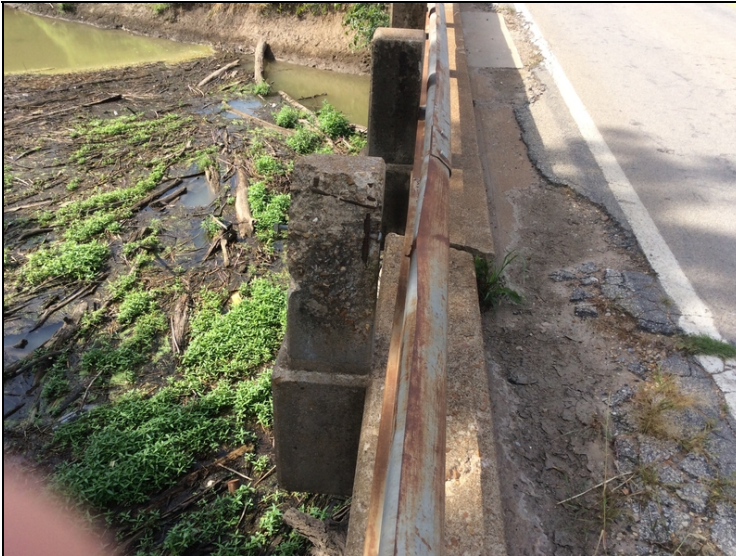
Bent 5 left guardrail

Metal Bridge Rail
Rail has 60% paint deter. and rust forming.
Lt rail is loose at spans 4 and 5.

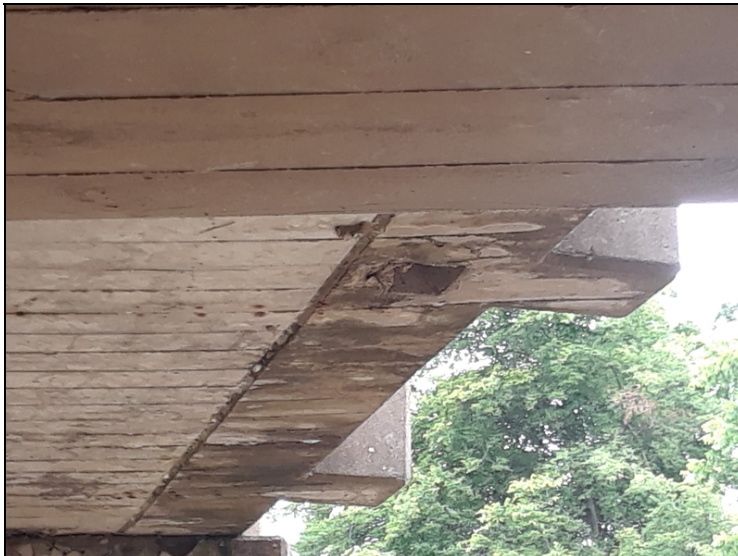
Soffit has insignificant cracking with some light efflorescence, spalls, and some exposed rebar:
Span 2 soffit has 6' of efflorescence.
Span 3 Soffit has 8sqft. of cracks with efflorescence.
Span 3 Soffit right Drain Opening has a 6" x 6" x 1 1/2" deep spall with exposed rebar.
Span 3 Soffit has 54sqft. of cracks.
Span 4 Soffit left Drain Opening has a 6" diameter spall with exposed rebar.
Span 5 Soffit left Drain Opening has an 18" x 6" x 1 1/2" deep spall with exposed rebar & 3' of delamination.
Span 5 Soffit right Drain Opening has a 1' x 1' delaminated area, impending spall.
Span 6 Soffit right Drain Opening has a 4' x 8" area of exposed rebar.
Span 6 Soffit left Drain Opening has a 1' x 1' delaminated area, impending spall.
Span 7 Soffit has a 1' x 6" spall with exposed rebar & 1' of delamination.

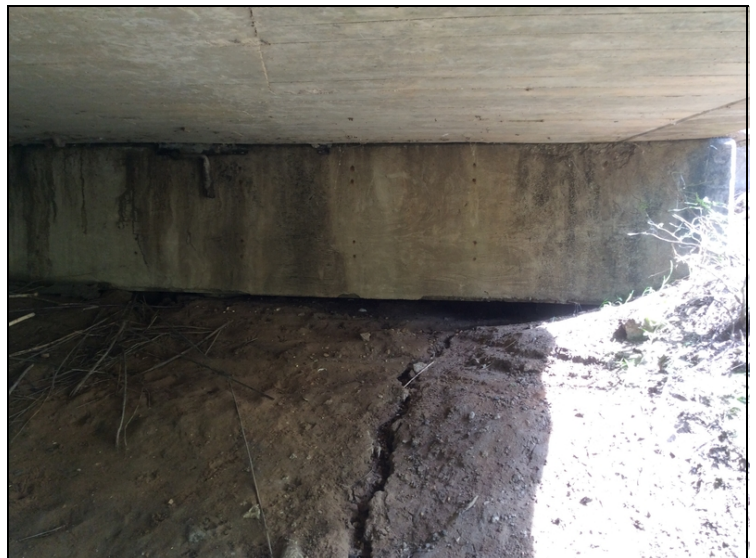
Left end bent 1

Bent 1 Cap has a 2' x 6" spall with no exposed rebar.

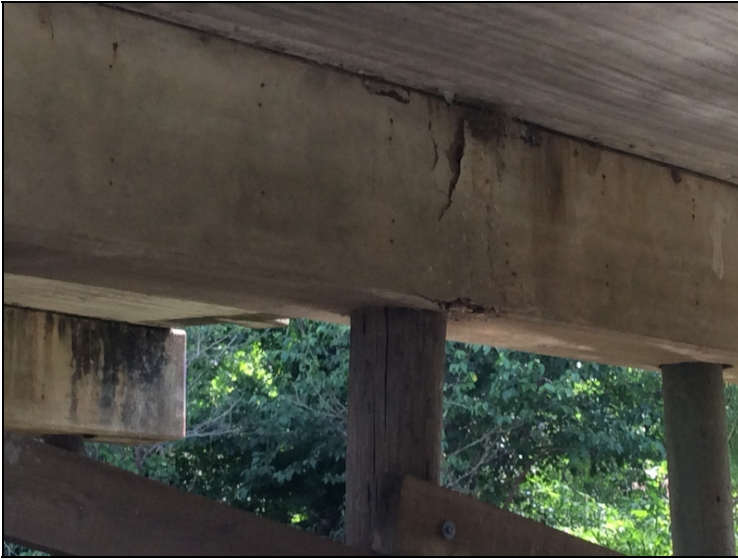
Bent 6 cap over pile 3 span 6 side.

Bent 6 Cap near Pile 3 has 3' x 1' spall with exposed rebar on the bottom & face of cap with a delaminated area to the face of cap with 2' of efflorescence.

Bent 6 Cap near Pile 3 has 3' x 1' spall with exposed rebar on the bottom & face of cap with a delaminated area to the face of cap, with 2 ft. of efflorescence.

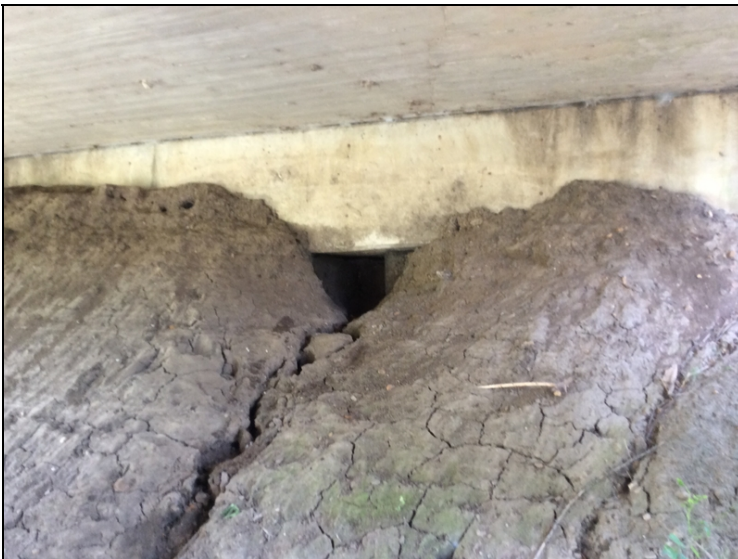
Bent 9 embankment erosion.

Moderate Slope Erosion under Span 8,7 ft. berm on left, no berm remaining right of center line, and Bent 9 Abutment has 6' long x up to 2' deep and up to 2' undermining under cap exposing Pile 2,3 & 4, typical.

Moderate Slope Erosion under Span 8 ,only 7' of berm at left end, no berm remaining right of center line, and Bent 9 Abutment has 6' long x up to 2' deep and up to 2' undermining under cap exposing Pile 4.

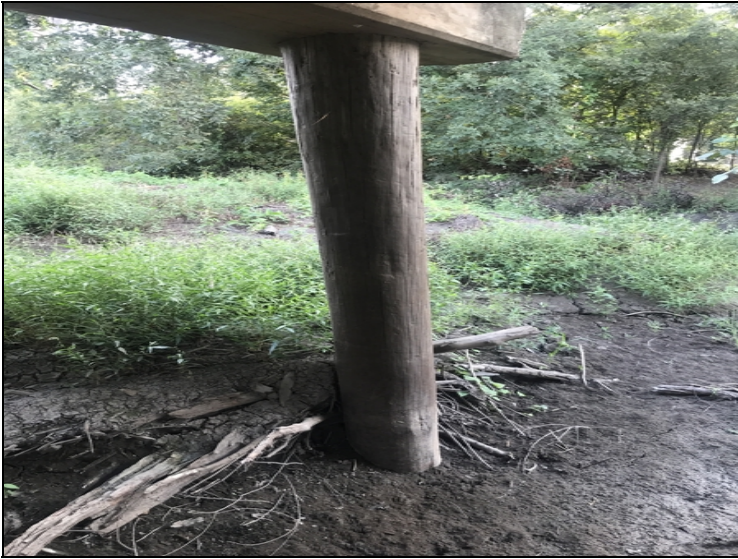
B3 p1

Bent 3 Pile 1 is decayed and hollow 4' above ground line.

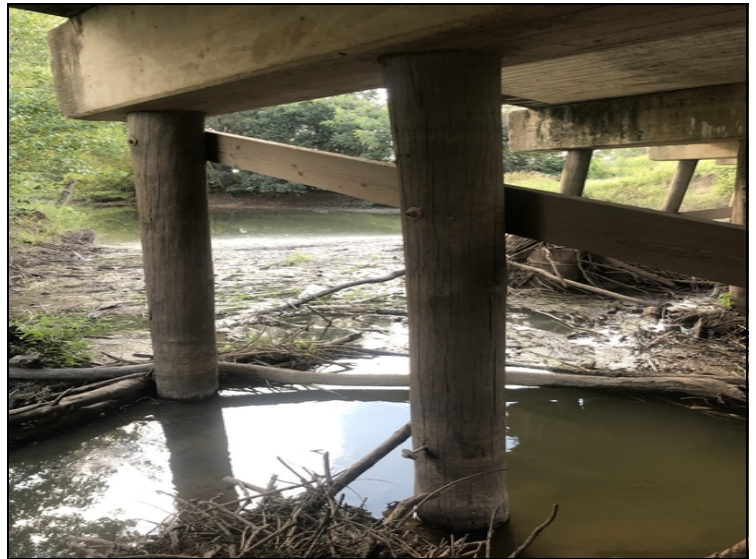
B4 p1 & p2

Bent 4 pile 2 decayed & partially hollow.

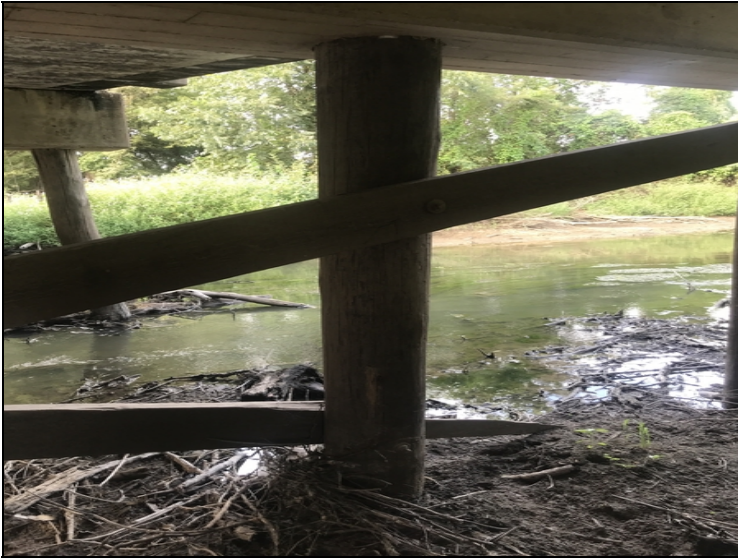
B4 p4

Bent 4 pile 4 decayed & hollow.

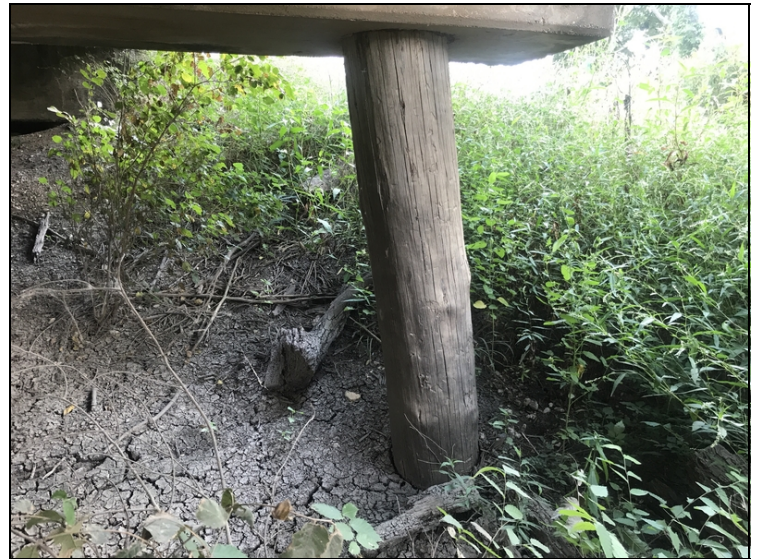
B2 p1

Bent 2 Pile 1 is decayed and partially hollow near ground line.

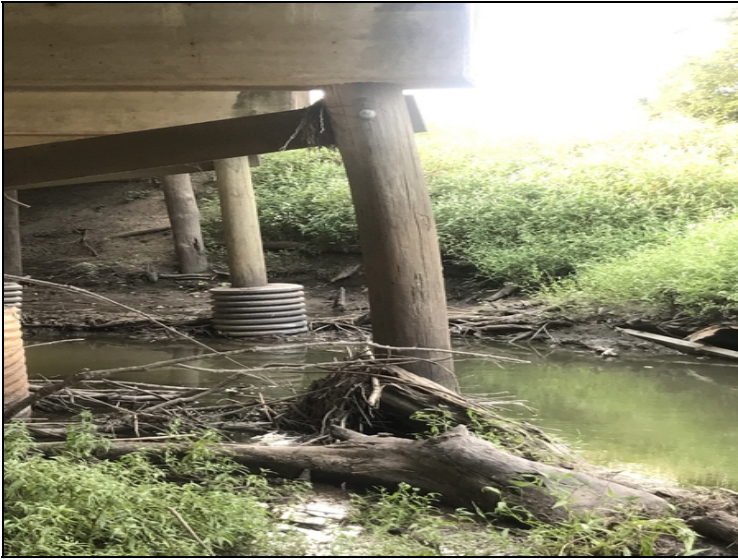
B6 p5

Bent 6 pile 5 checks and partially hollow.

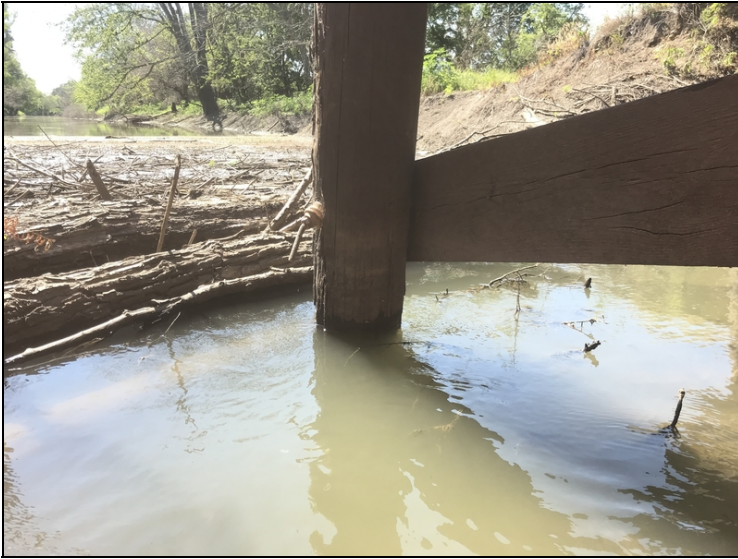
B7 p1

Bent 7 Pile 1 is decayed and partially hollow 3' above ground line with section loss below water line.

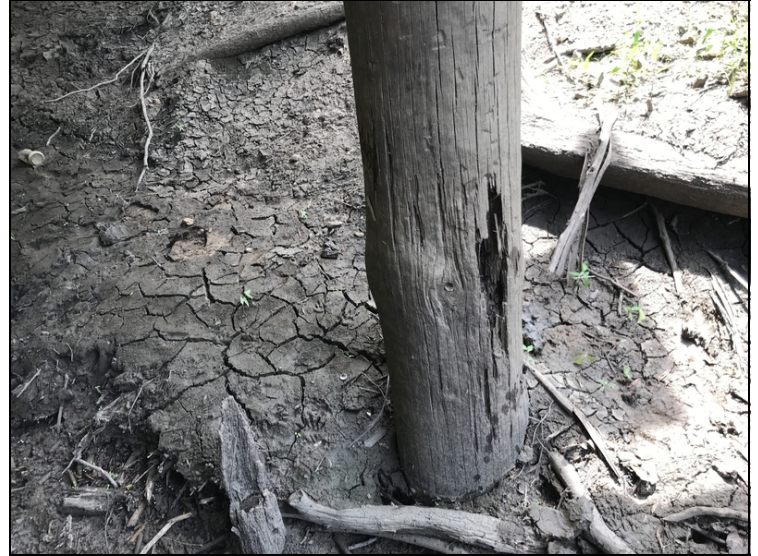
Bent 8 pile 5

Bent 8 Pile 5 is decayed hollow with a 1" shell.

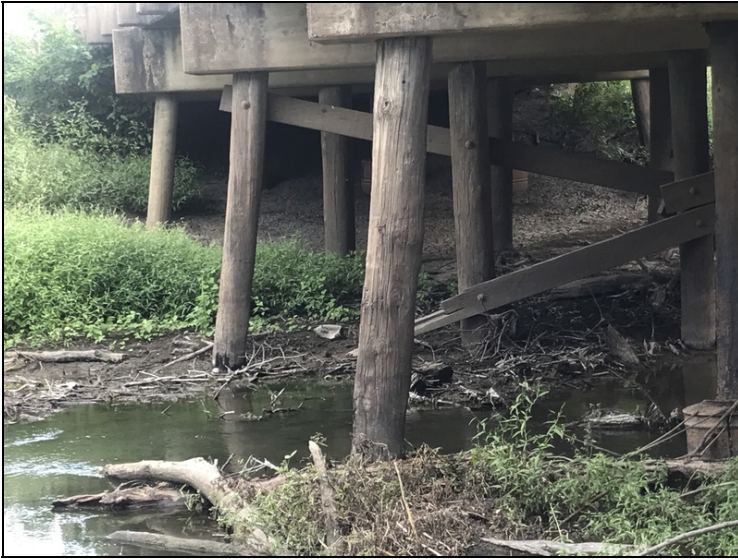
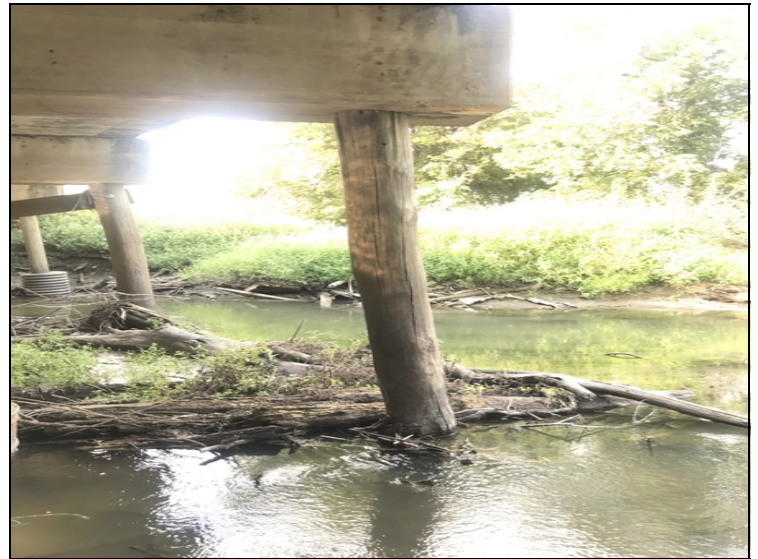
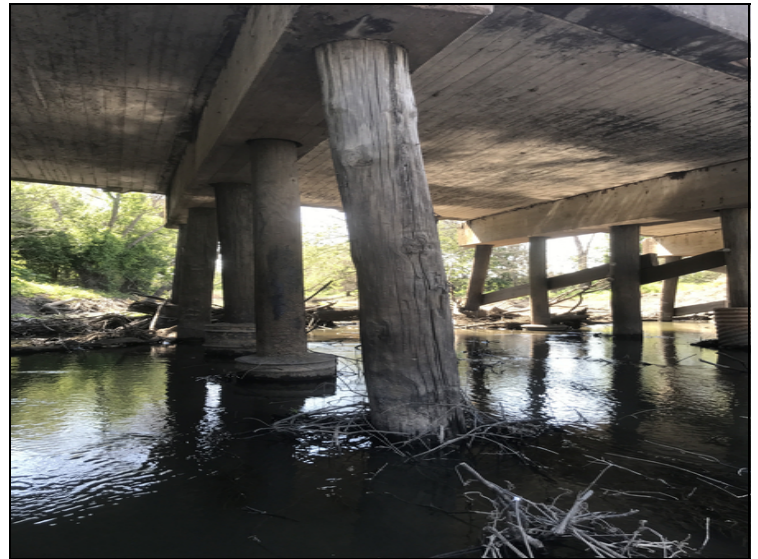
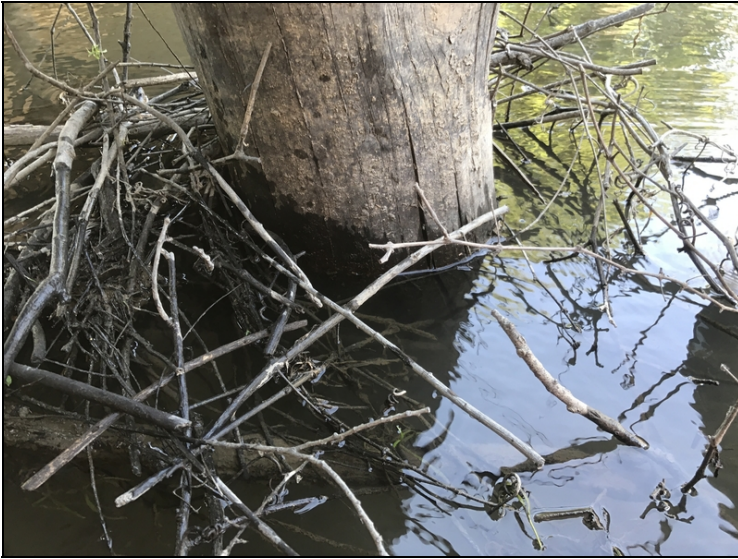
B5 p5

Bent 5 pile 5 has moderate checking with open cracks, decayed and is beginning to swell at water line.

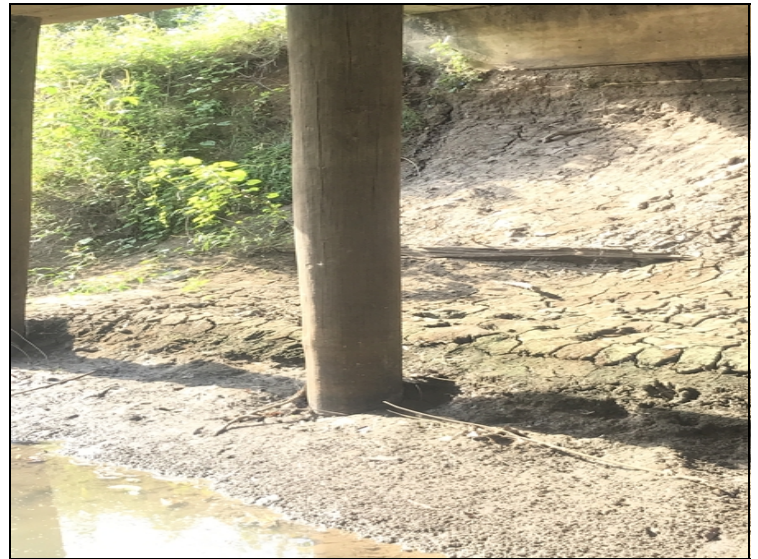
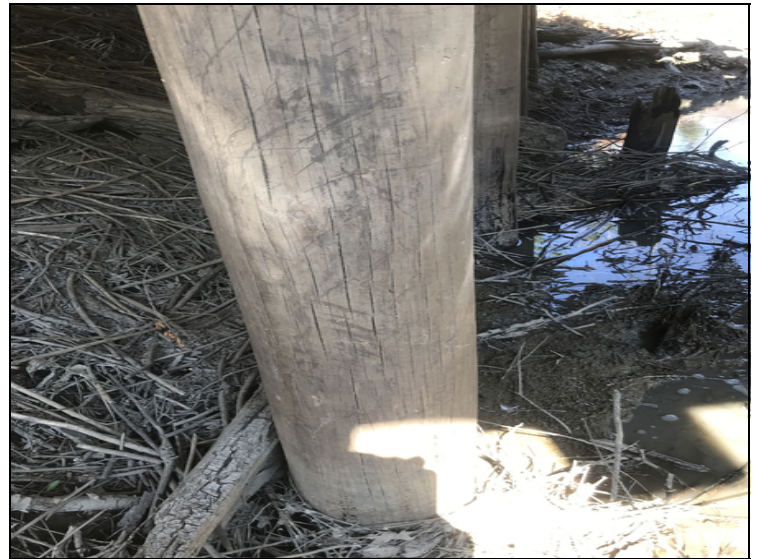
B8 p2

Bent 8 pile 2 has a 1/2 in. shell decayed & hollow.

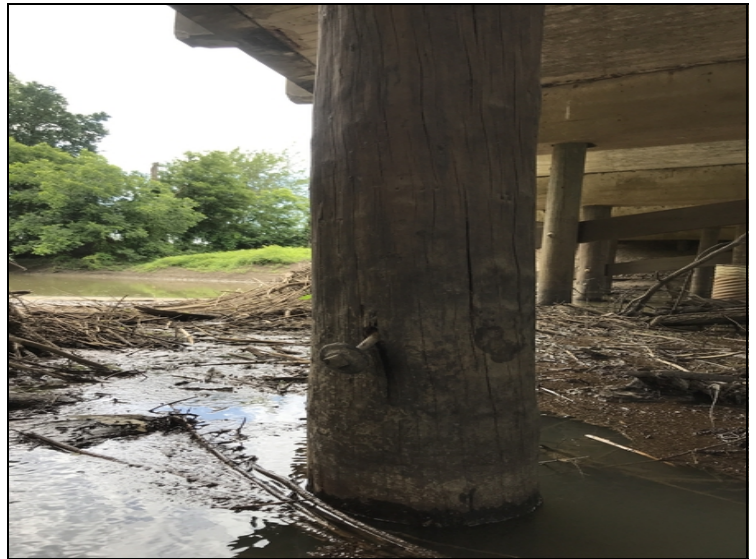
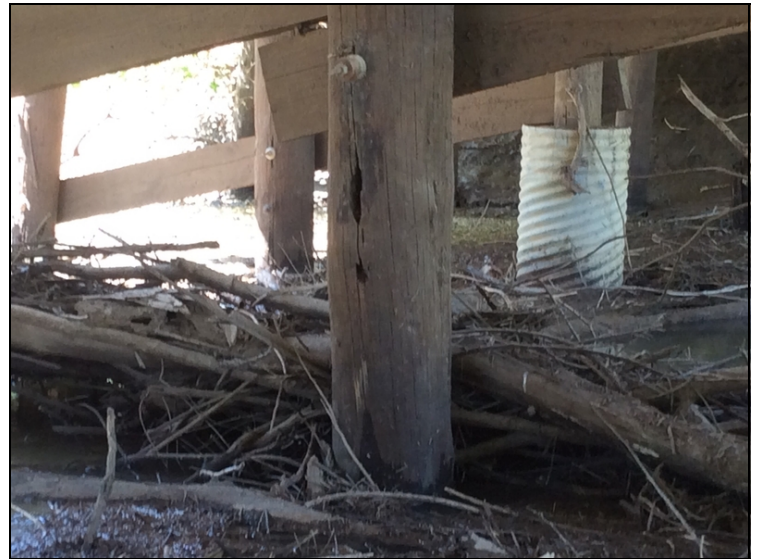
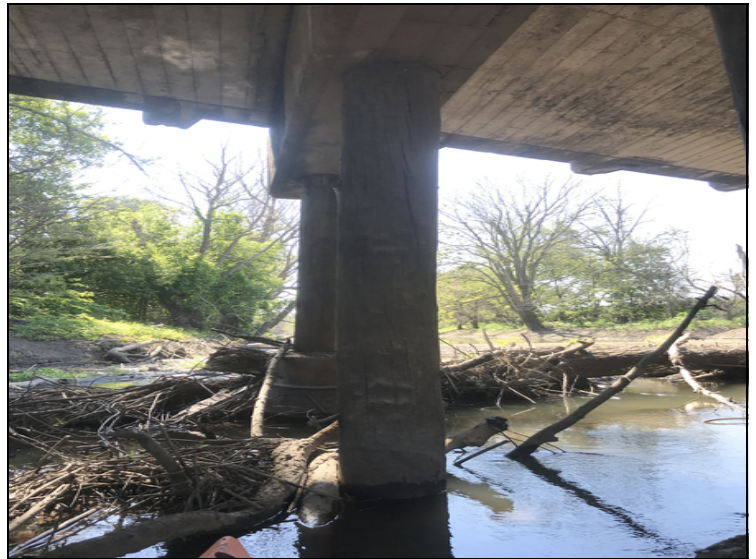
B5 p2

Bent 5 pile 2 has a 1" shell & hollow.

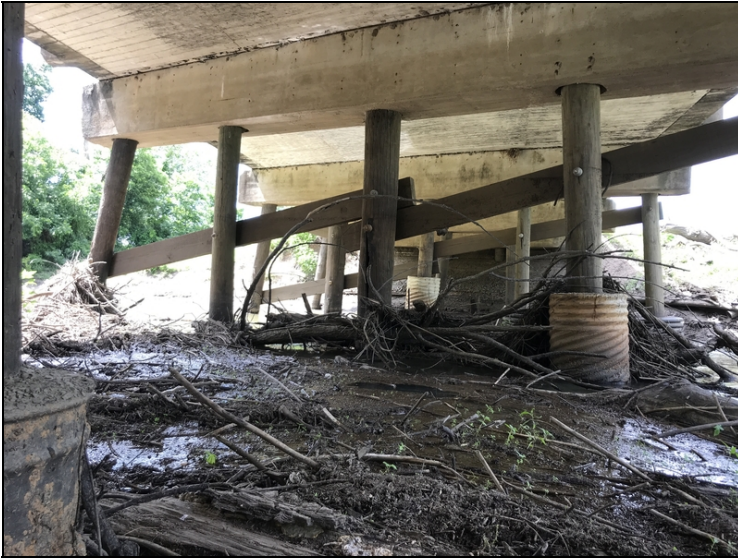
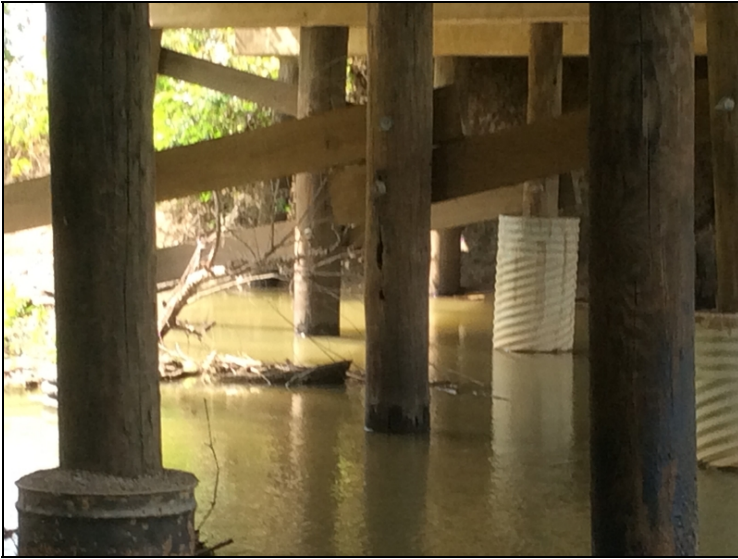
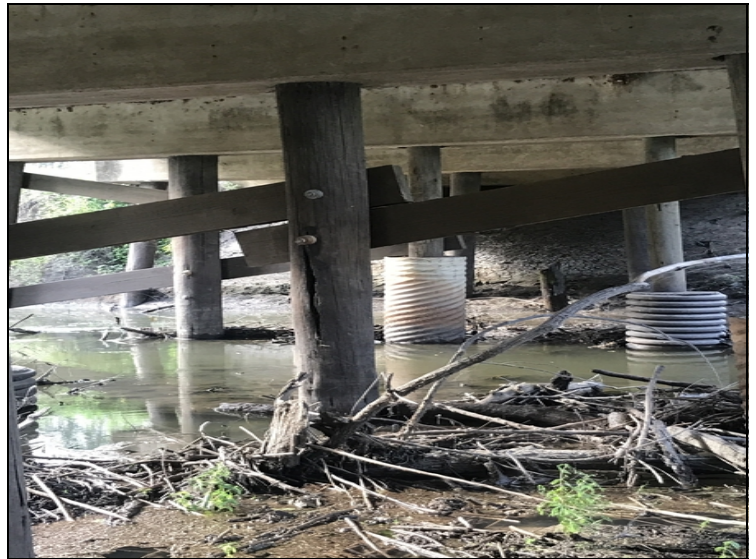
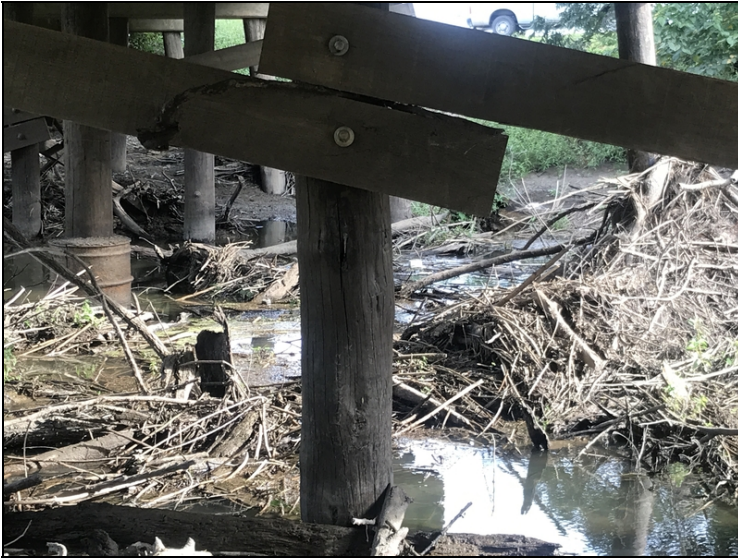
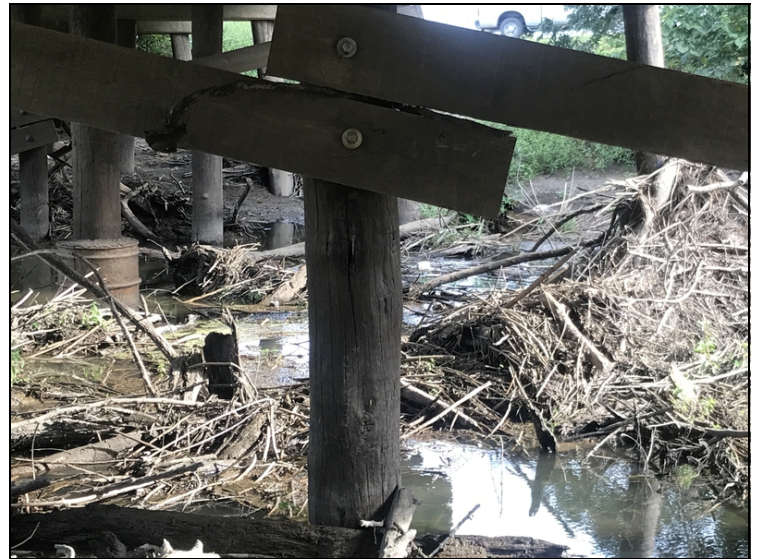
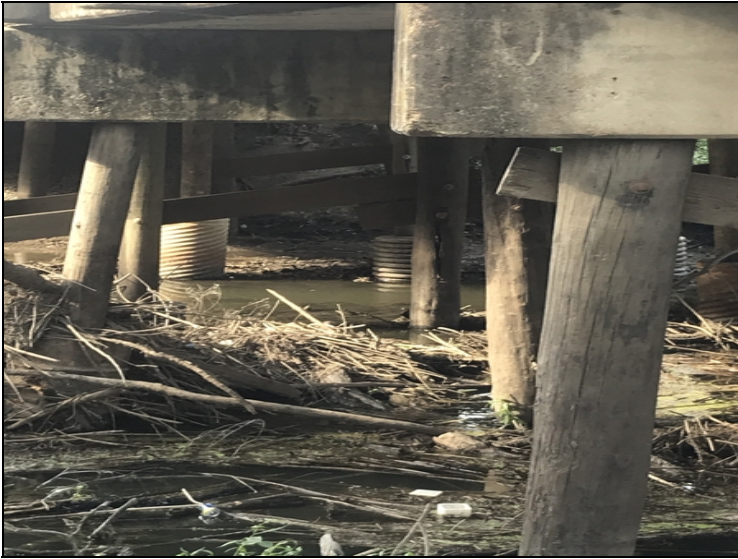
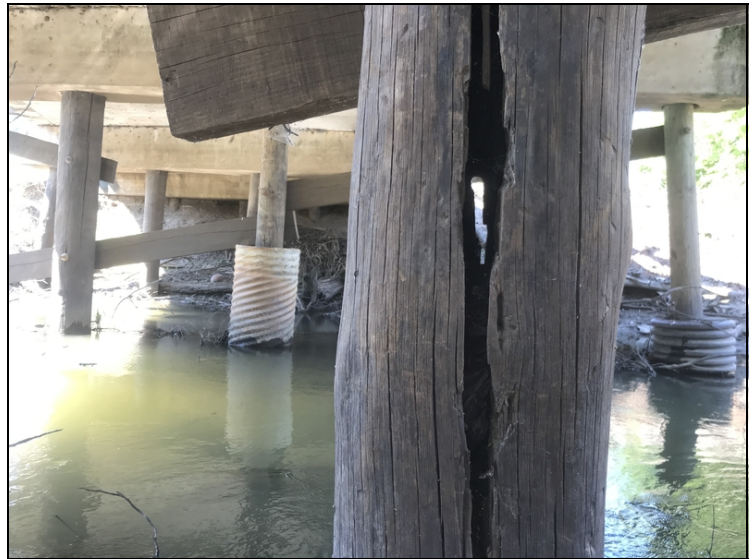
bent 6 pile 3

Bent 6 Pile 3 is decayed and mostly hollow 1 1/2" shell and hollow, has large hole completely through the pile, larger on beginning side.

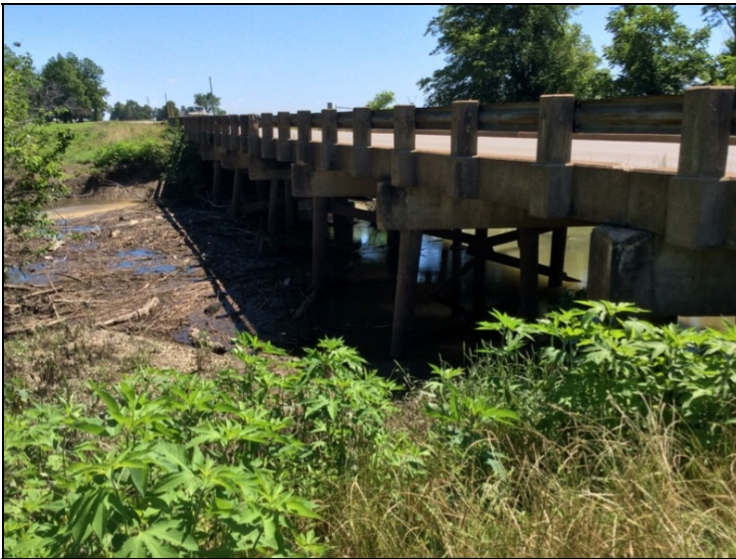
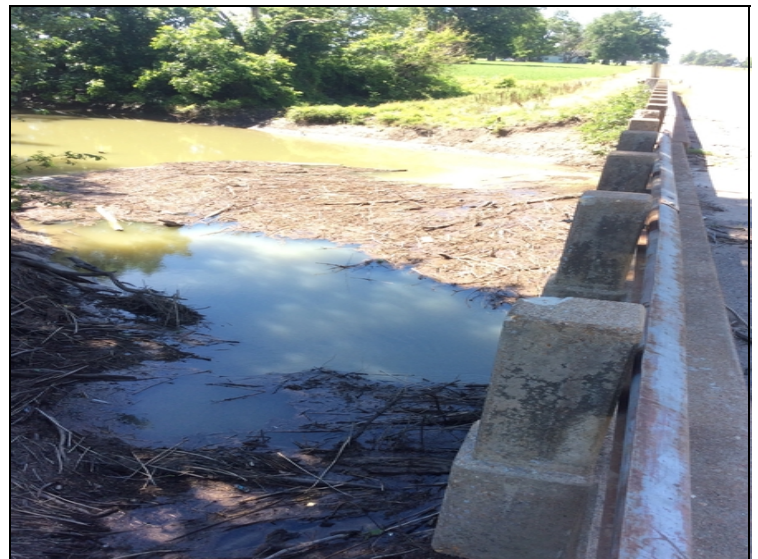
Large Drift up stream across entire channel extending 75' upstream & lodged on piles.

Large Drift extending 75' upstream across entire channel lodged on piles & under bridge.

Copy to Miss 1 crew for removal when they get a chance

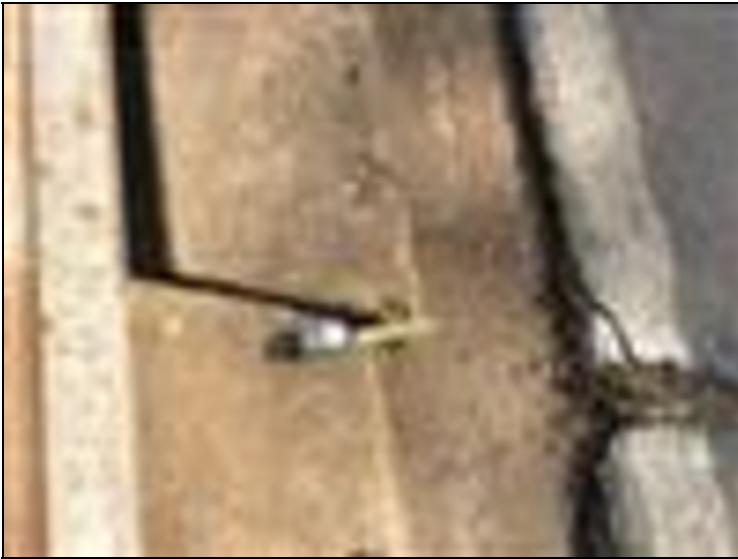
Concrete Slab has a 3 1/2" lateral shift at joint over bent 5, 2003 inspection, Span 4 and 5 appears shifted another 1/2" going from 3 1/2' to 3 3/4" out of alignment.

Concrete Slab has a 3 1/2 in. lateral shift at joint over bent 5, 2003 inspection, Span 4 and 5 appears shifted another 1/2" going from 3 1/2' to 3 3/4" out of alignment.

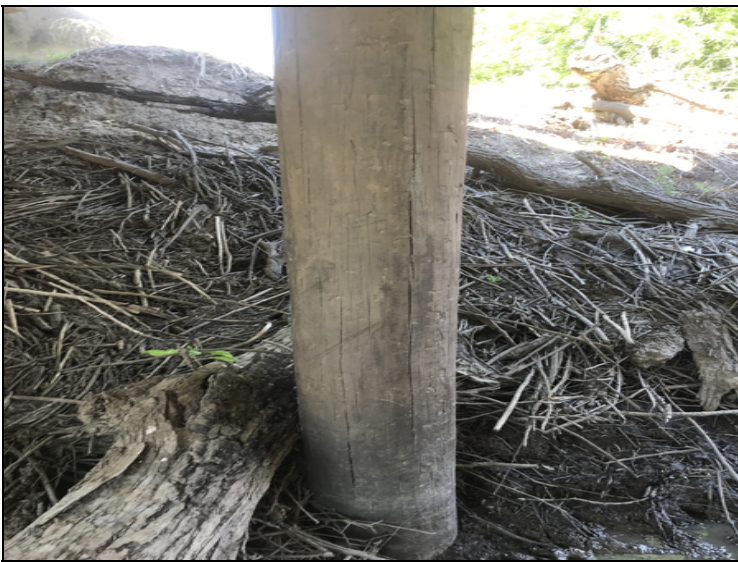
B8 p4

Bent 8 pile 4 decayed and partially hollow'
