Bridge #02870(Routine)
SH 77-02- LM 7.16 over LITTLE RIVER
Location: 1.1 MI N JCT OF SH 158

Team Lead: Richard Jones **Inspection Date:** July 28, 2021

IDENTIFICATION	
(1) State Names	Arkansas
(8) Structure Number	02870
(5) Inventory Route	77
(2) Highway Agency District	10
(3) County Code	93-Mississippi County, Arkansa

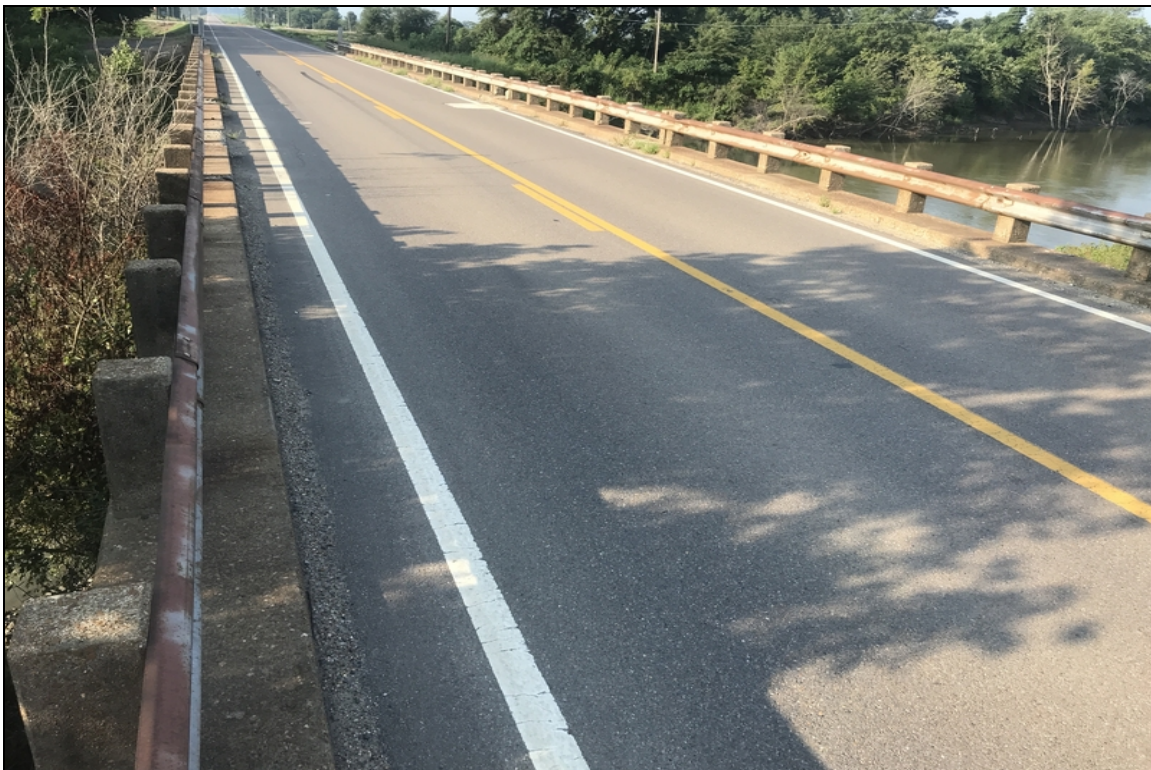
Wearing surface

Asphalt wearing surface has cracks with a few delaminated areas over joints.

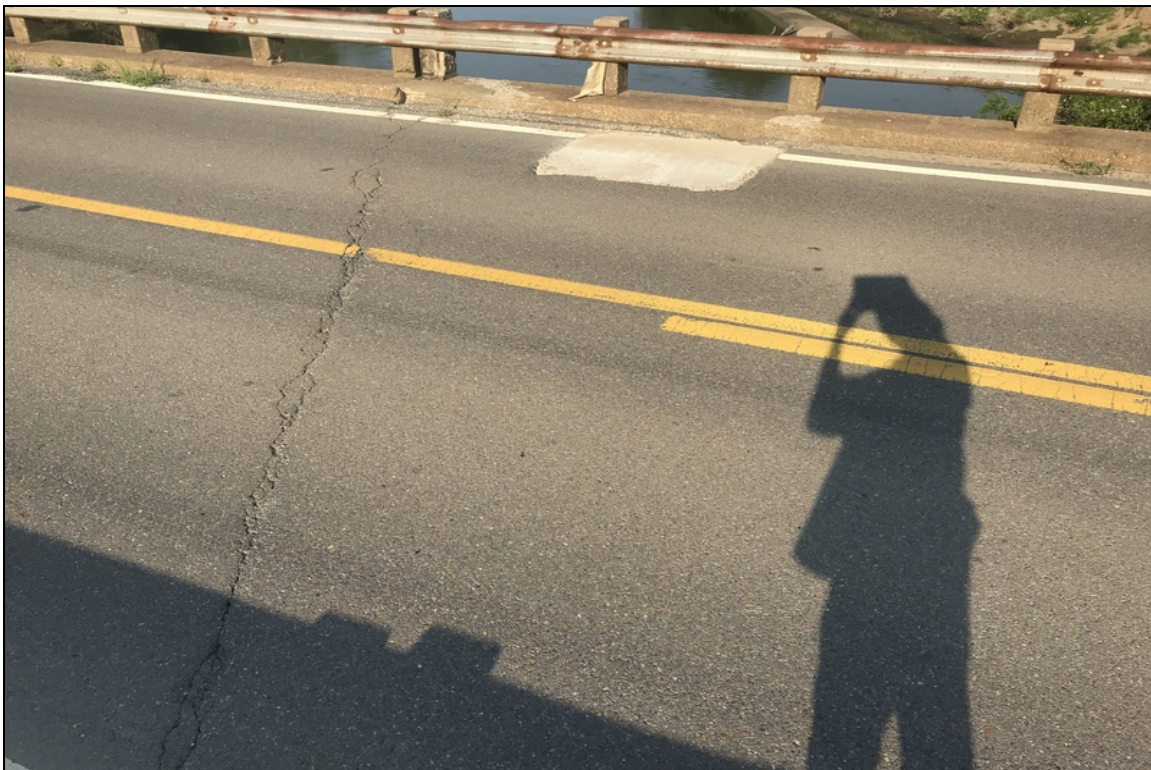
Span 2 near bent 3 full depth patch

Span 2 Rt lane near bent 3 has a 4' x 5' full depth patch.

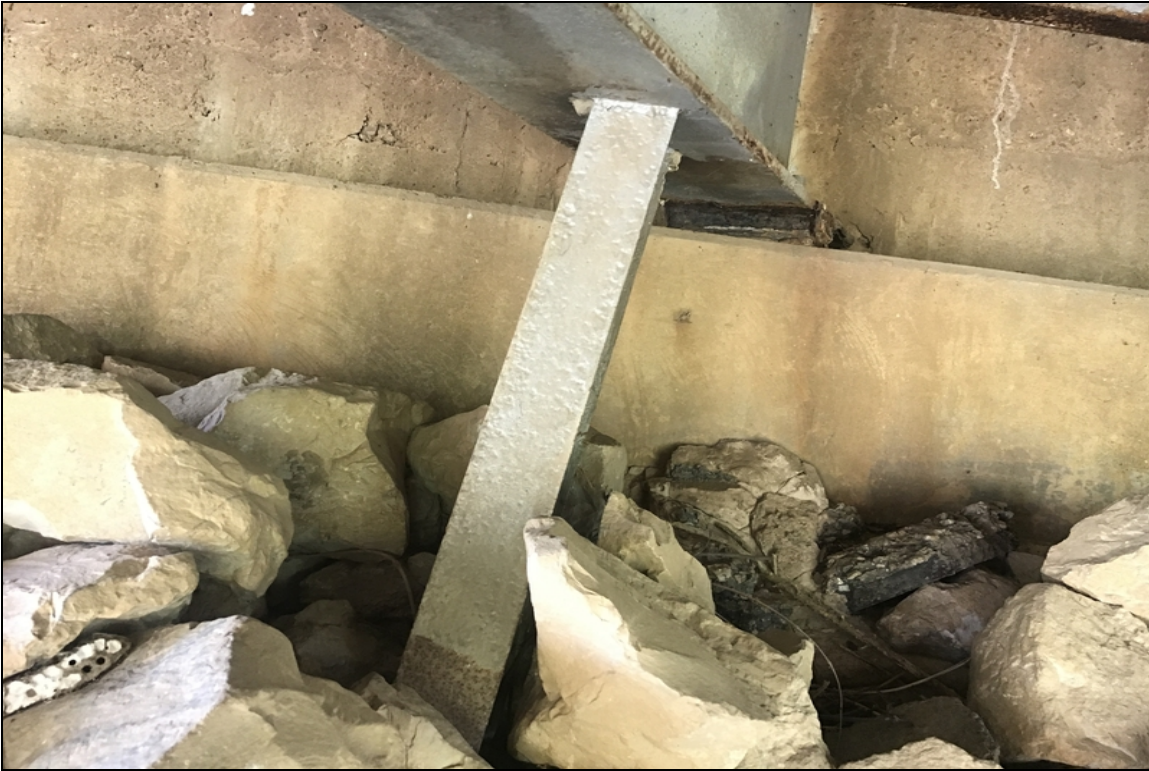
Span 1 bent 1 girder 3 has a steel channel stiff leg welded to bottom flange.

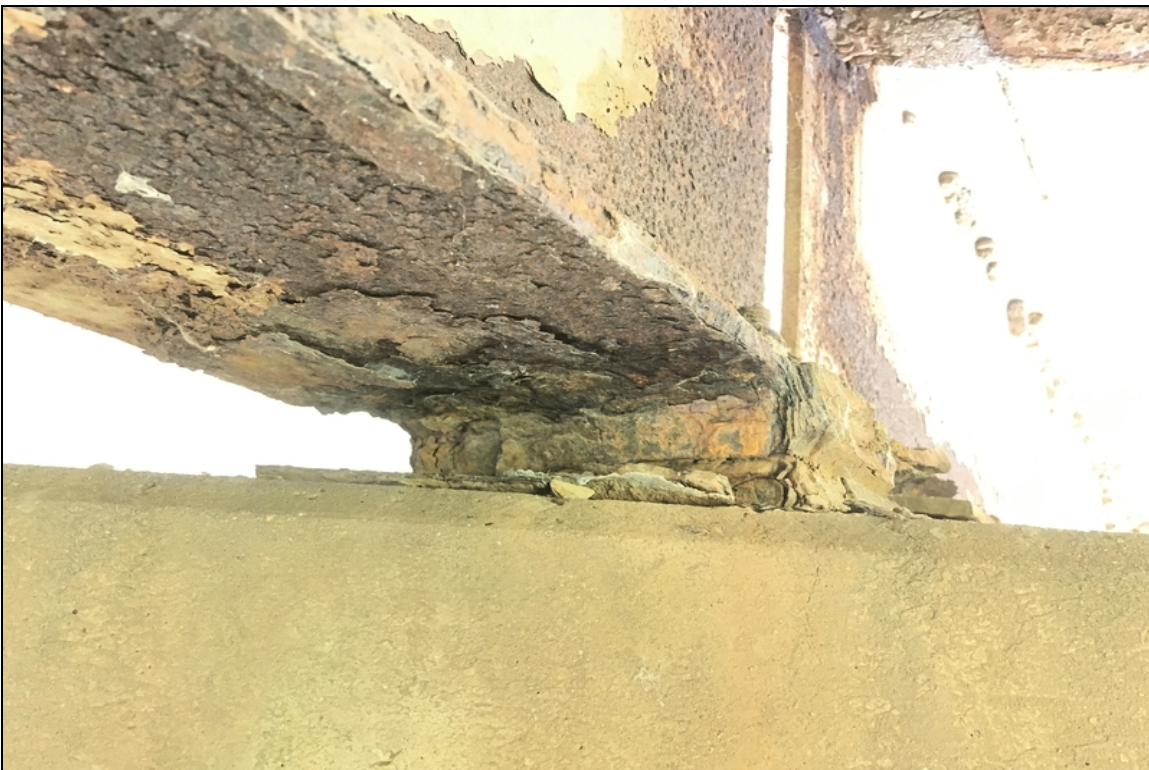
Span 1 bent 2 girder 3 has a 7" x 1" hole in web below haunch. Bottom flange has section loss along bearing.

Span 1 bent 2 girder 3 has a 4" x 1" hole in web at haunch and heavy section loss to bottom flange.

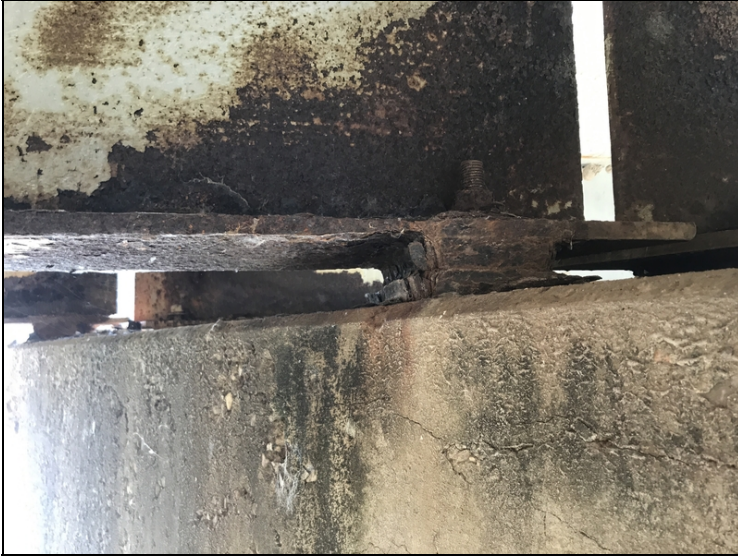
S2 b3 g2

Span 2 bent 3 girder 2 bottom flange has heavy section loss along bearing. 5/16" t remain on edge.

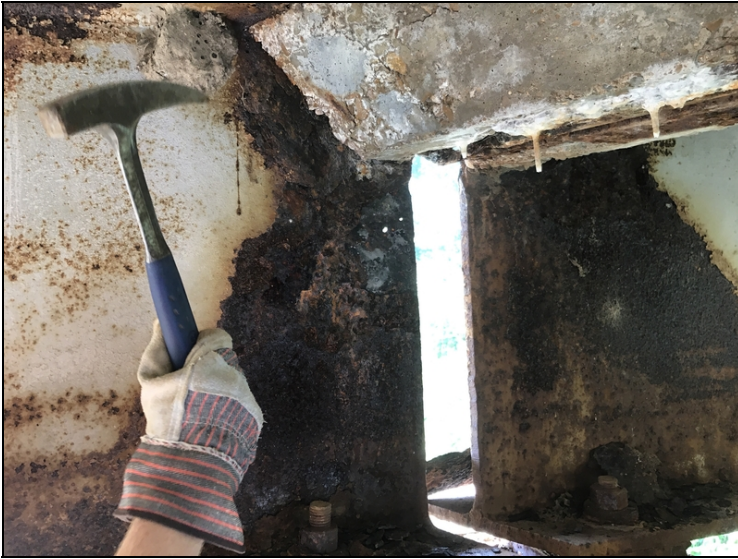
S4 b5 g1

Span 4 bent 5 girder 1 has a 4" diameter hole in web at haunch.

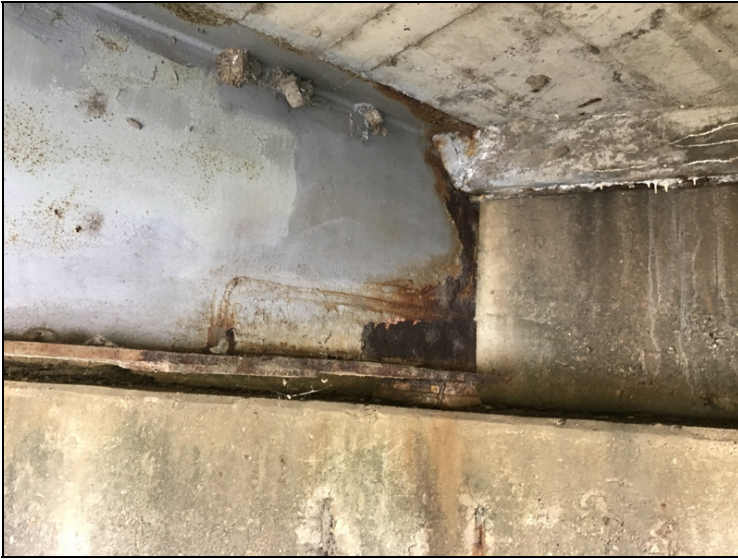
S5 b6 g3

Span 5 bent 6 girder 3 was T-spliced sometime in the past. Girder has a 5" x 1" hole in web at haunch.

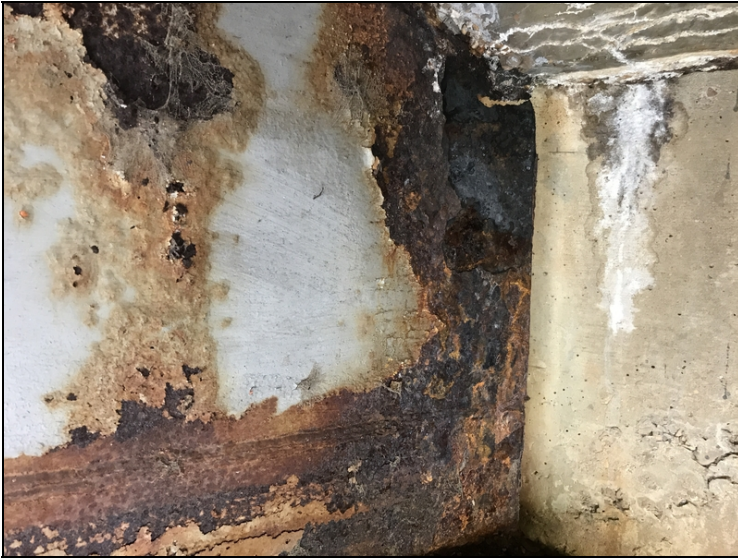
S5 b6 g4

Span 5 bent 6 girder 4 was T-spliced sometime in the past. Girder has a 4" x 1" hole in web at haunch. T-splice has rust with minor measurable section loss.

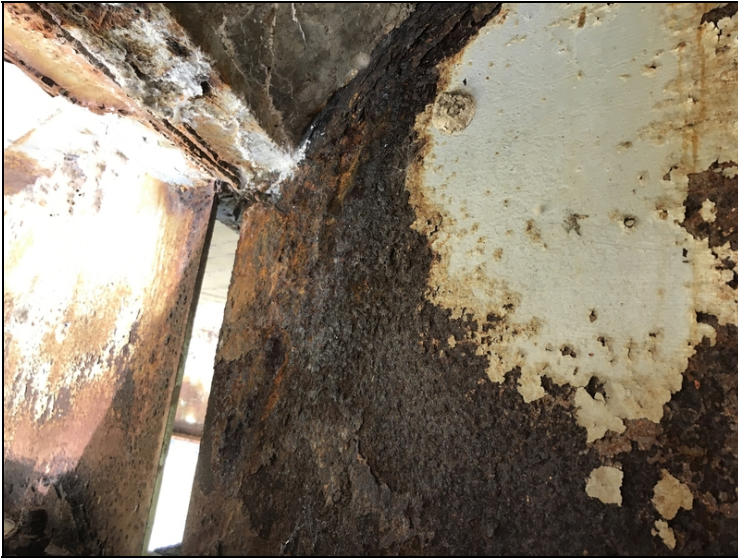
S2 b3 g4

Span 2 bent 3 girder 4 has a 4" x 2" hole in web near haunch. Bottom of web has a 12" x 6" area of moderate section loss 5" from end.

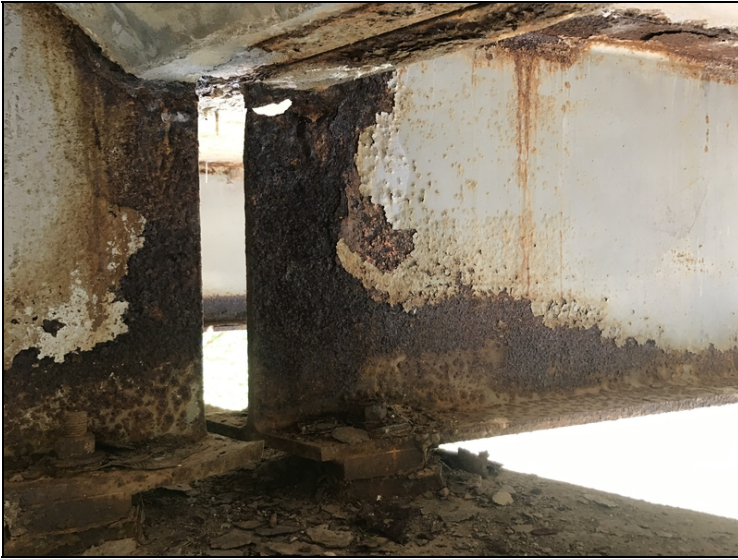
S2 b2 g2

Span 2 bent 2 girder 2 has a 2" x 3" hole in web at haunch.

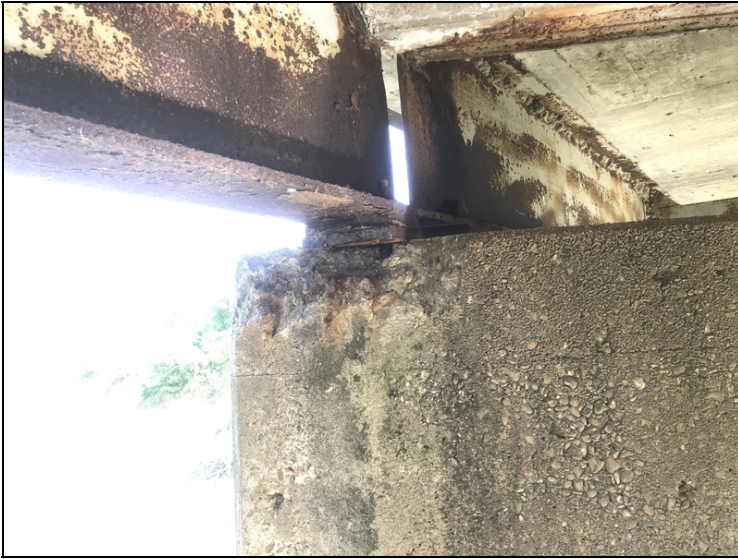
Span 4 bent 4 bearing 5

Bent 4 cap has several spalls with exposed rebar on bottom around piles. Face of cap has 3' of shallow spalls with rebar exposed. Ahead side of cap at bearing 5 has a 2' x 1' x 4" deep spall with approximately 20% loss of bearing area. Bent 4 pile 1 has an encasement repair from past damage. Piles have concrete and timber braces.

Bridge Crew completing similar repairs on bridge just north of this loc. will repair these when schedule allows. KAW 3-31-2020

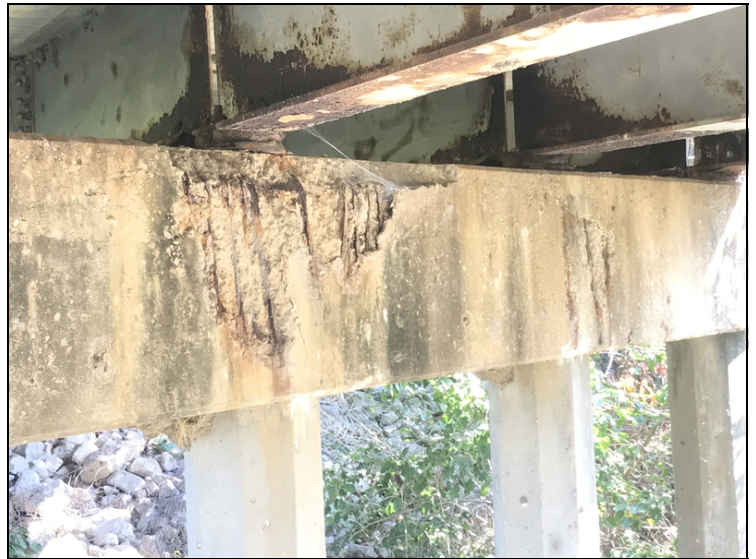
Bent 2 ahead under girder 2 and 3

Bent 2 cap has a 1' spall under bearing 5 on back side with approximately 25% loss of bearing area. Cap is spalled 3" back under bearing. Ahead side of cap has a 2' diameter spall with rebar exposed over pile 2, and a 8' x 2' x 2" deep spall with exposed rebar at bearing 3. Exposed reinforcement steel has up to 50% loss of section.

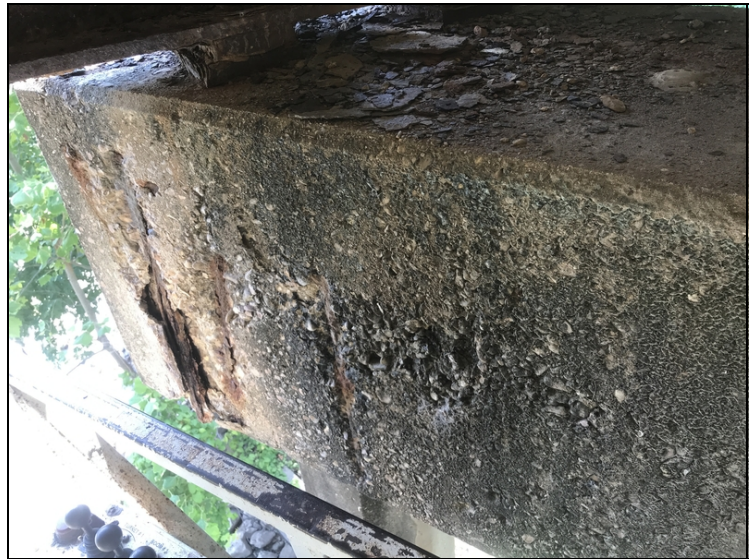
Bent 5 cap Lt

Bent 5 cap has shallow spalls with rebar exposed over piles 1 and 4. Ahead side under bearing 5 has a 1' x 1' x 3" spall with exposed rebar under bearing with up to 20% section loss to reinforcing steel.

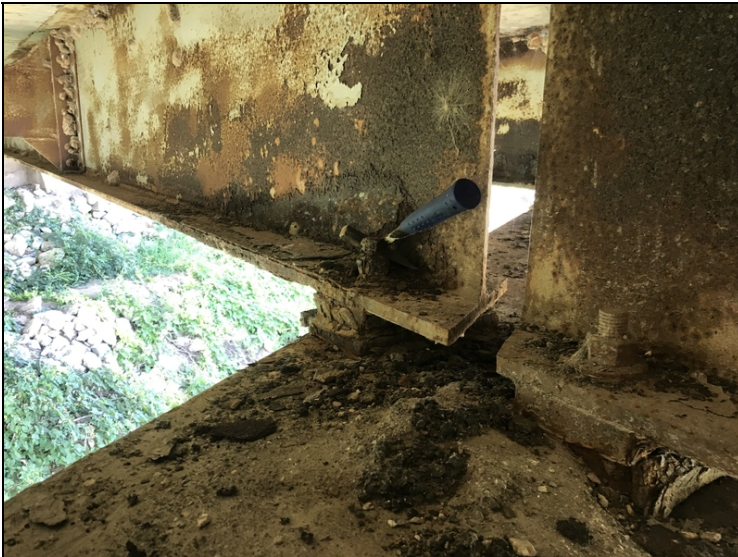
S5 b5 g4

Span 5 bent 5 girder 4 and a 3.5" x 1" hole in bottom of web 5" from end of girder.

To District Bridge Crew for repair when their schedule allows. KAW 7/18/19

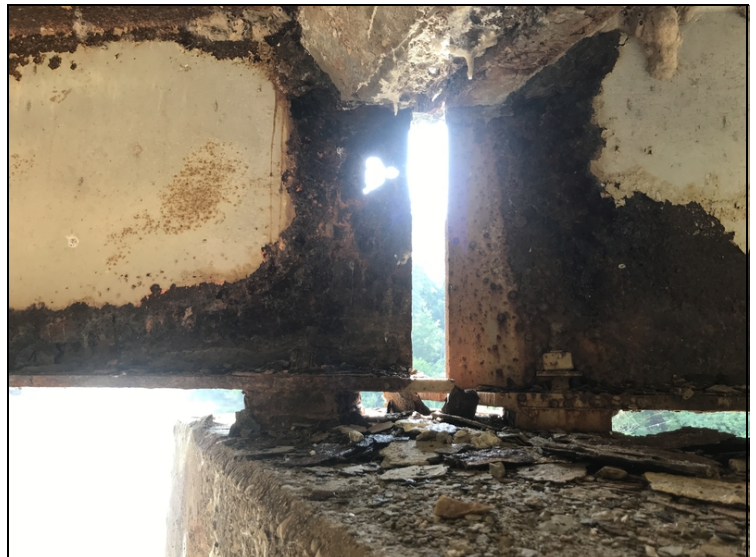
S2 b3 g1

Span 2 bent 3 girder 1 end of girder has heavy section loss with a 9" x 6" area of near complete section loss below haunch.

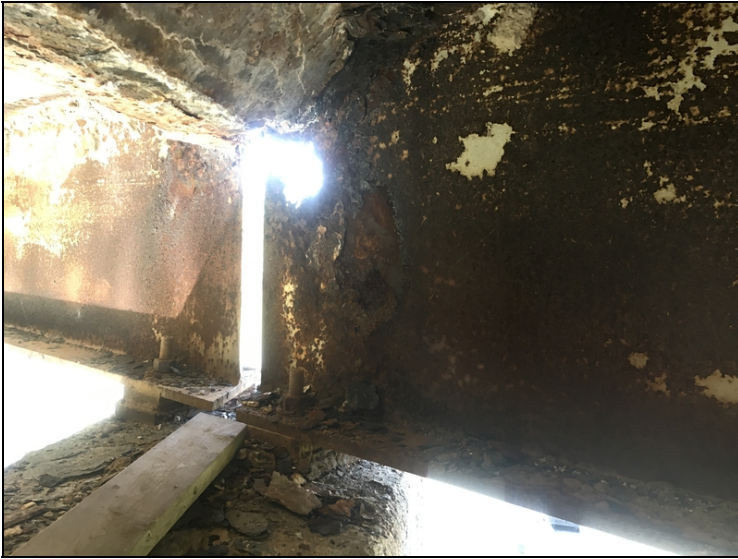
Span 2 bent 3 girder 5 has a 6" diameter hole in web at haunch.

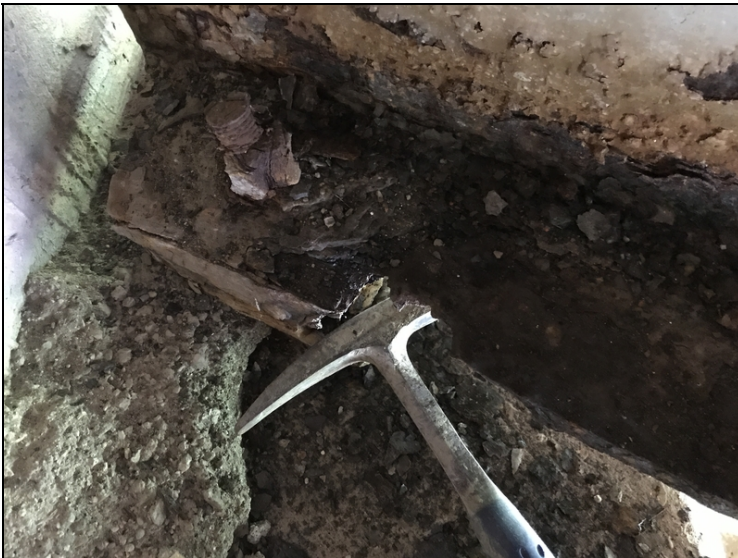
S1 b1 g2

Span 1 bent 1 girder 2 has 1.5' of heavy section loss along bottom of web. Web has a 1/4" diameter hole over bearing. Rt side of bottom flange has a 3" wide x 2" long hole in flange near bearing.

to Dist Bridge Crew for repair as priorities allow KAW 7/6/2020

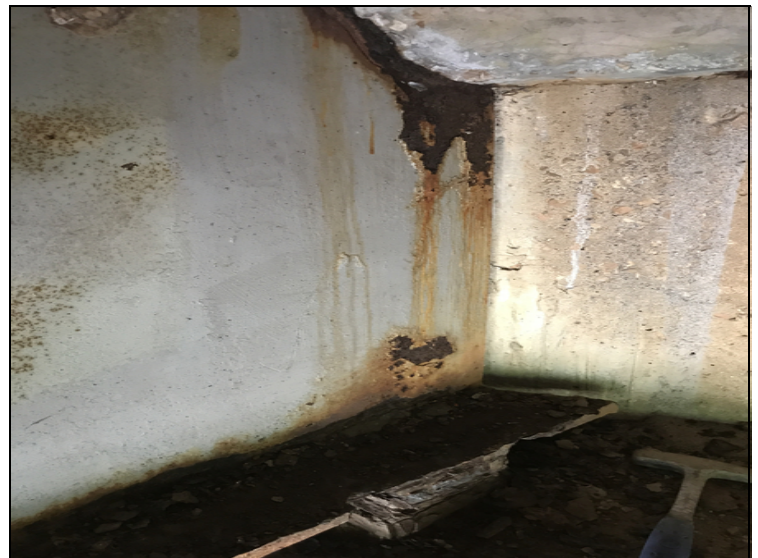
S1 b1 g4 left

Span 1 bent 1 girder 4 has a 1.5" diameter hole in web below haunch. Bottom of web has a 6" area of moderate section loss over bearing. Bottom flange has heavy section loss with holes rusted through near bearing.

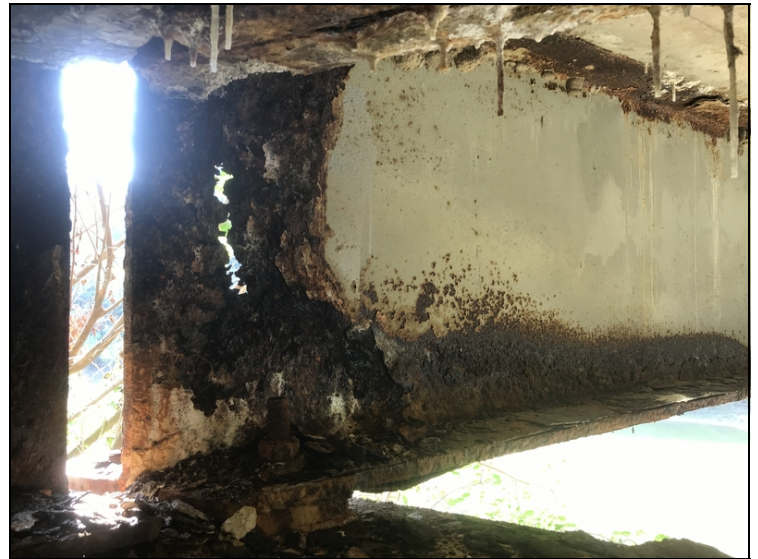
Span 2 bent 2 girder 1 web has heavy section loss with a 1" x 7" hole between haunch and bearing.

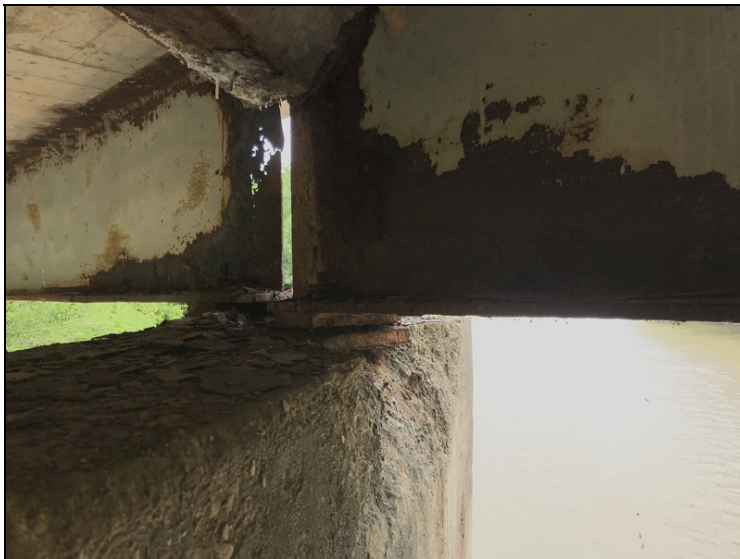
S3 b3 g1

Span 3 bent 3 girder 1 has settled 3/4" due to a 3' x 1' spall in cap under bearing 1. Deck, girder, and concrete post all measure 3/4" lower than previous span. Masonry plate has 60% loss of bearing currently and has up to a 1/2" gap between masonry plate and sole plate. Concrete beneath the bearing is disintegrated.

to Dist Bridge Crew for repair as priorities allow KAW 7/6/2020

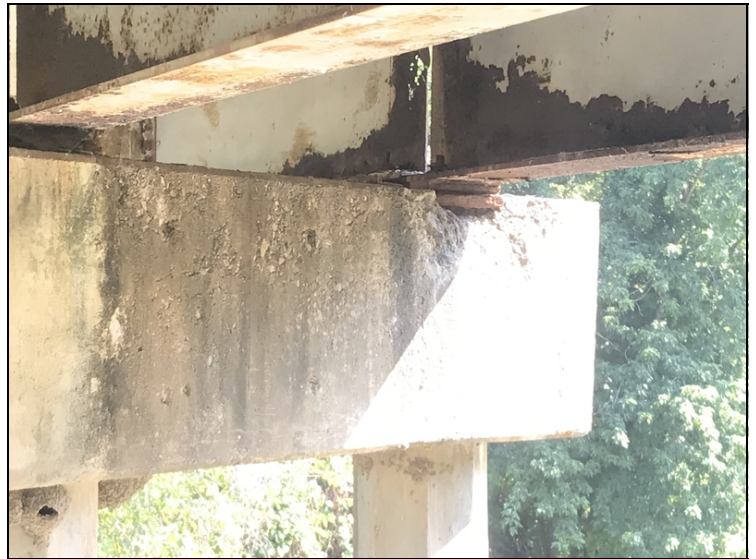
Span 3 bent 3 bearing 1

Bent 3 cap has a 3' spall under bearing 1 on ahead side. Cap is spalled back under bearing 4". Bearing has approximately 60% loss of bearing area and has settled ¾". Cap has spalls with rebar exposed near piles 1 – 4.
