Bridge #02871(Routine)

SH 77-02- LM 6.83 over LITTLE RIVER

Team Lead: Tim Myrick Inspection Date: November 24, 2020

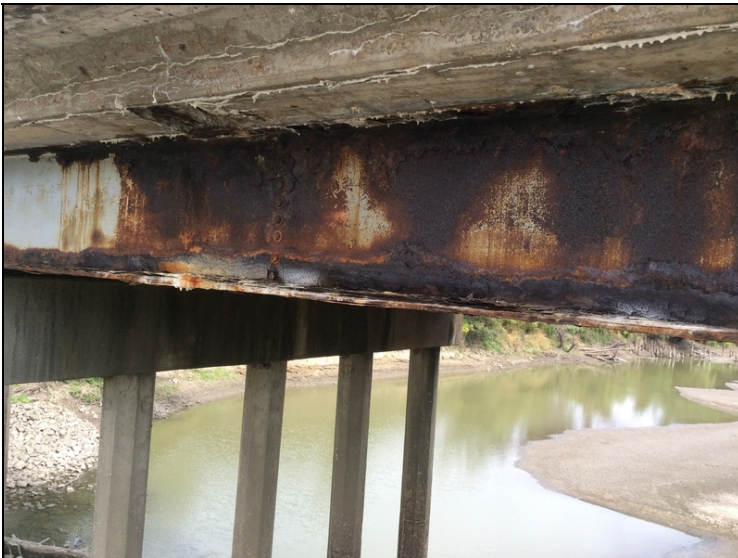
02871 10-01-2015 Span 4 Girder 5.

2' on ends of majority of girders are rusted with up to 1/2" loss of section to bottom flange or web.  
Exterior girders are rusted with up to 5/8" section loss to web and flanges at drain openings, especially spans 3, 4, & 8, see span 4 girder 5.  
Majority of girder have holes in web at haunch: See notes for location and dimensions.  
Span 1 bent 1 girder 1 anchor bolt nut missing.  
Span 2 bent 3 girder 2 is moving under traffic with a 1/8" gap on the left end of bearing: several floating girders over length of bridge.

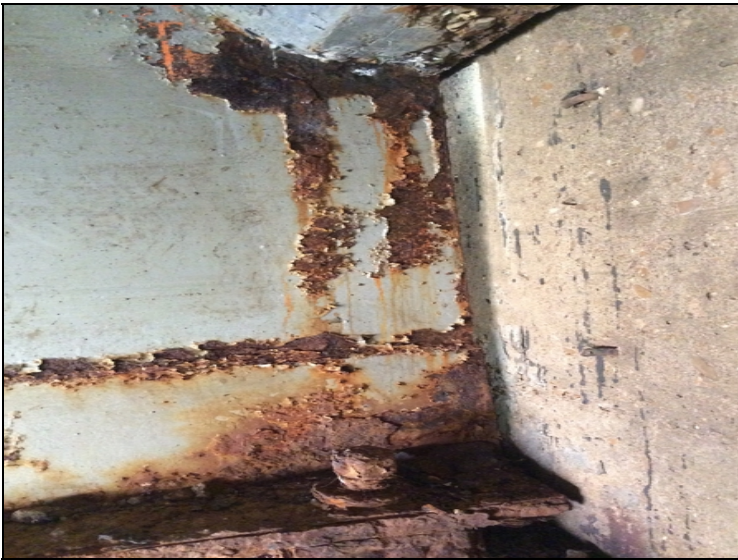
02871 10-01-2015 Span 8 Girder 1 over Bent 8.

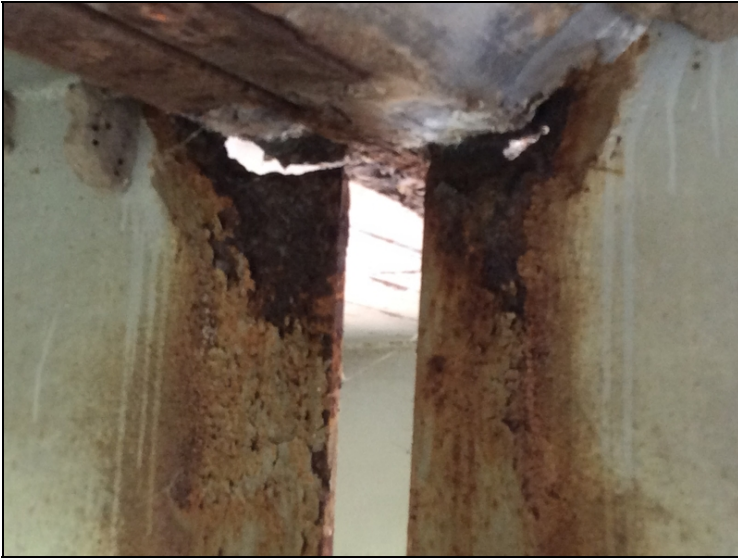
02871 10-01-2015 Span 5 Girder 3 & Span 6  
Girder 3 over Bent 6.

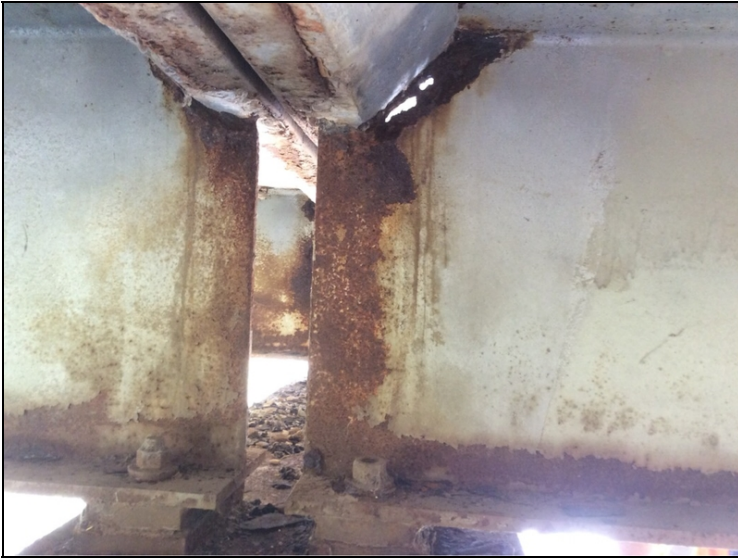
02871 10-01-2015 Span 1 Girder 5 over Bent 2.

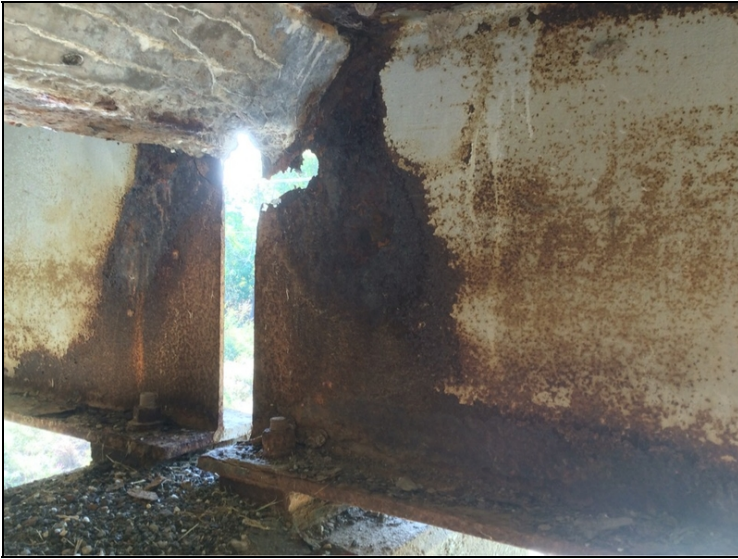
02871 10-01-2015 Span 3 Girder 3 over Bent 4.

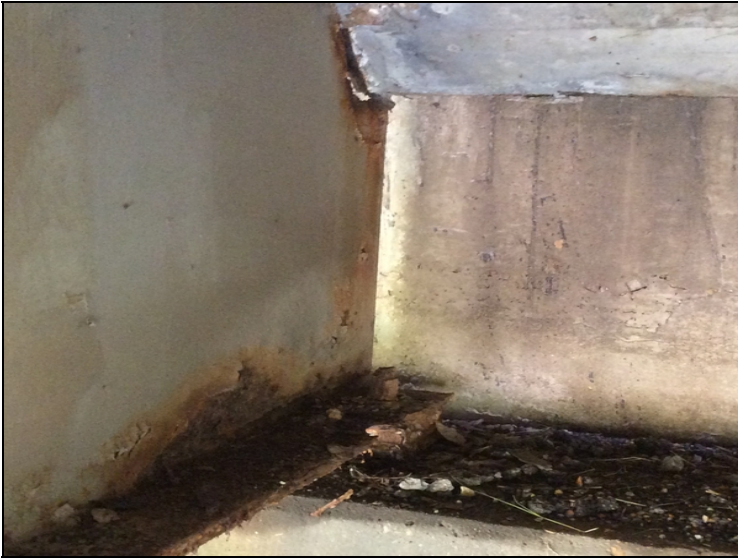
02871 10-01-2015 Span 1 Girder 2 over Bent 1  
bottom flange.

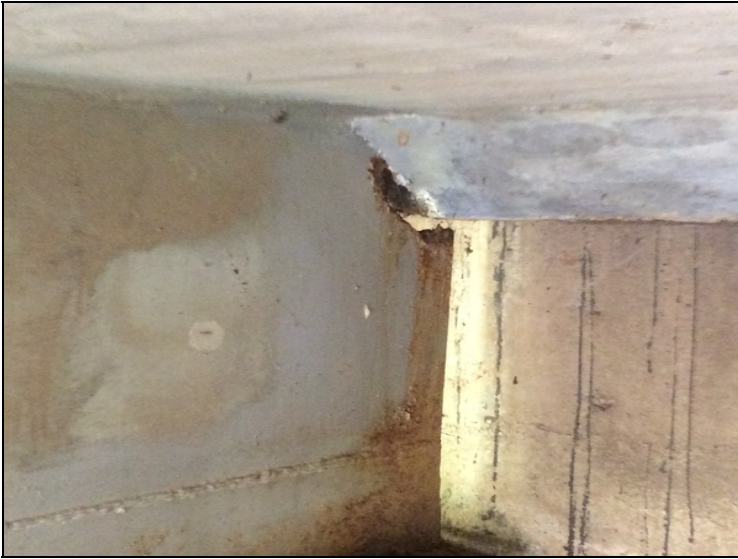
02871 10-01-2015 Span 1 Girder 3 over bent 1.

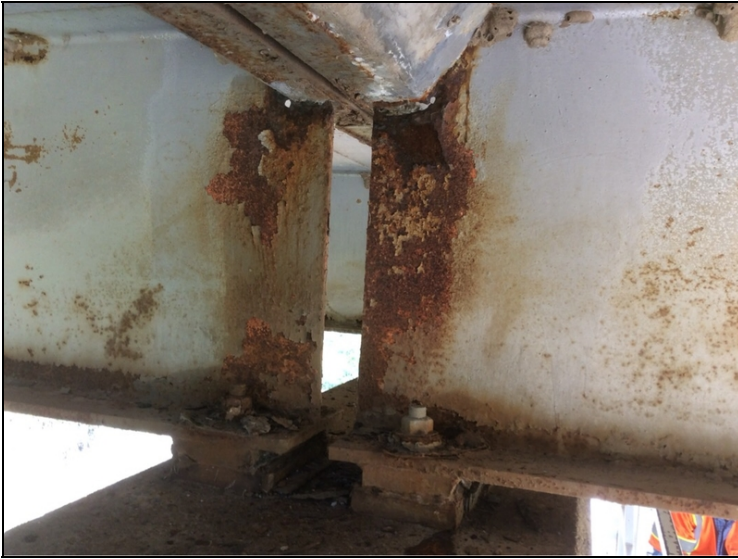
02871 10-01-2015 Span 3 Girder 5 over Bent 4.

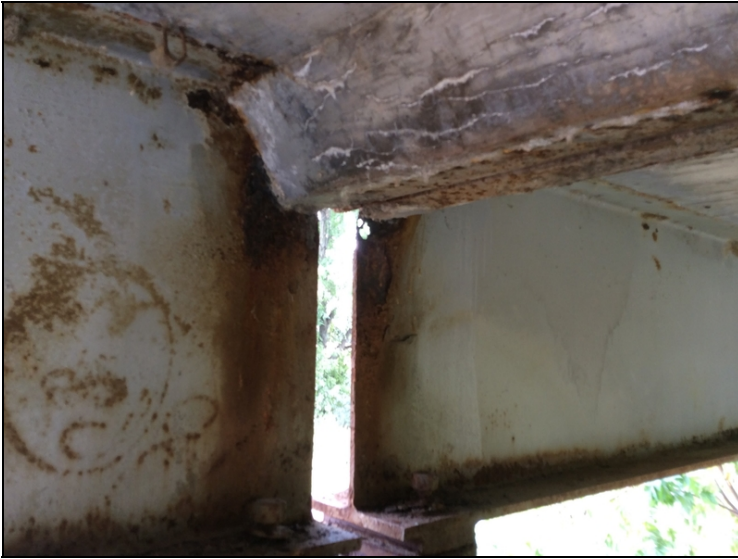
02871 10-01-2015 Span 5 Girder 1 over Bent 5.

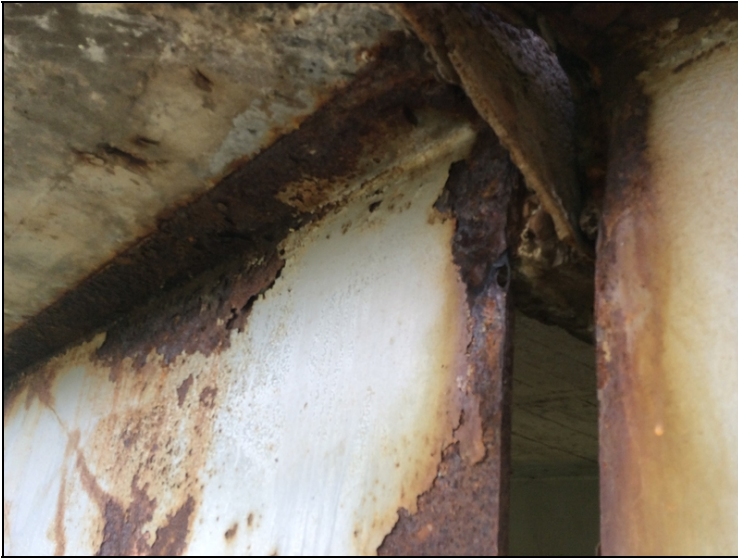
02871 10-01-2015 Span 7 Girder 1 over Bent 7.

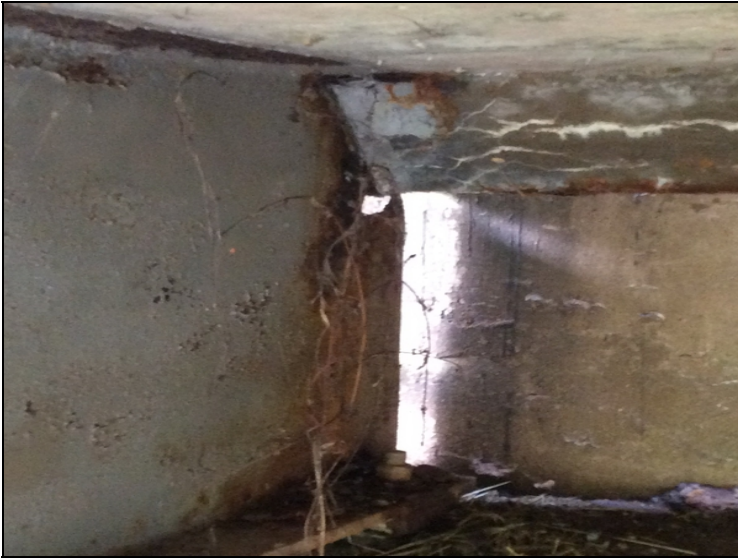
02871 10-01-2015 Span 1 Girder 5 over bent 1.

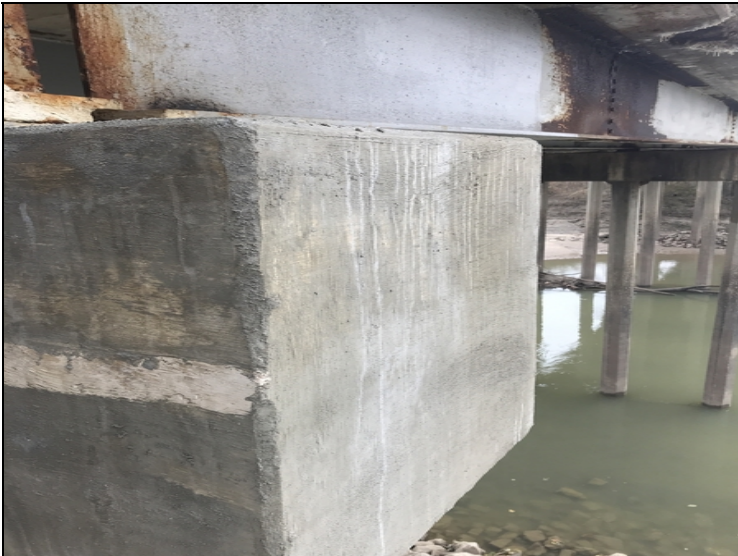
Bent 2 cap RT end repaired

Bent 2 cap 3' of right end has been repaired under bearing 5.

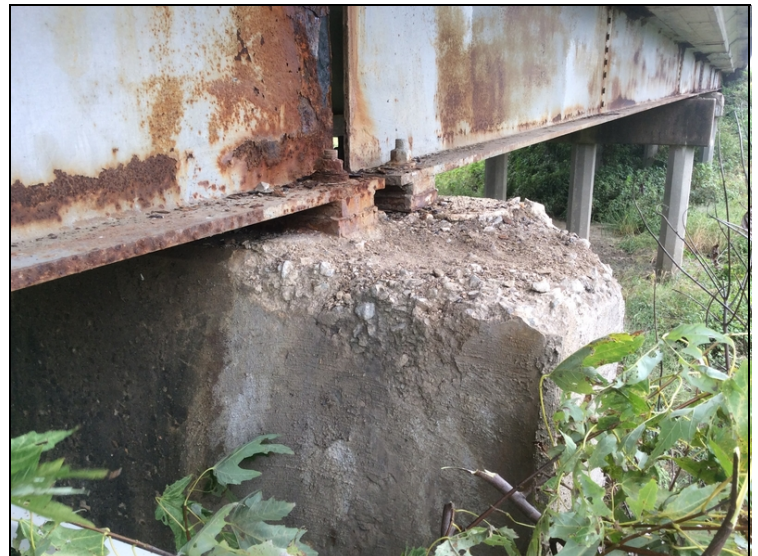
02871 10-01-2015 Right End of Bent 5 Cap.

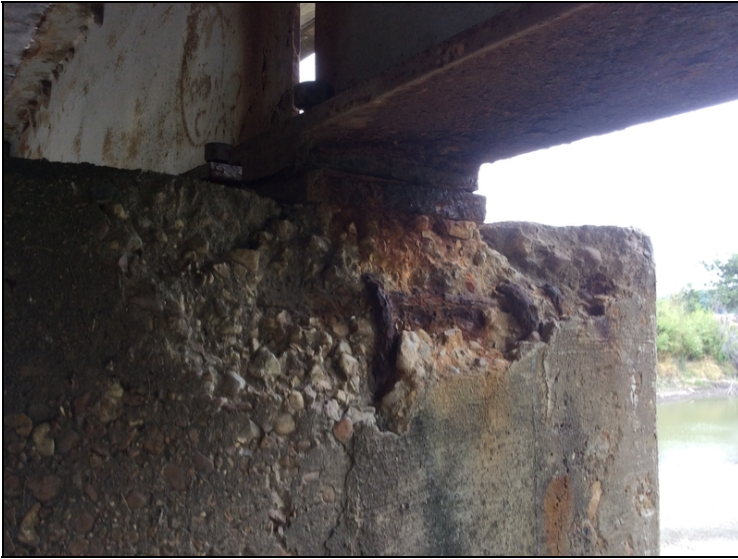
Bent 5 concrete cap left end near girder 1 bearing has a 2' X 9" X 3 1/2" deep spall with exposed rebar with section loss, and beginning to lose some bearing.

02871 10-01-2015 Bent 5 Cap Span 5 Side Under Bearing 1.

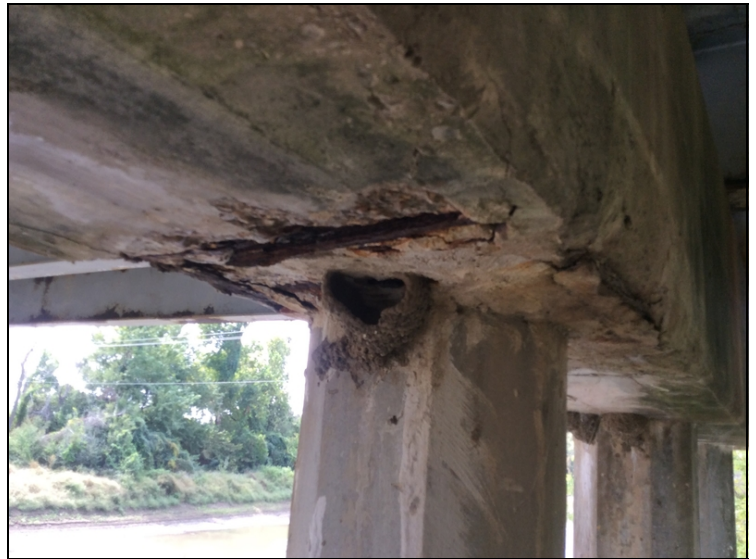
Bent 2 cap has a spall over pile 3 with 3' of exposed rebar.

02871 10-01-2015 Bottom of Bent 2 Cap near Pile 3.

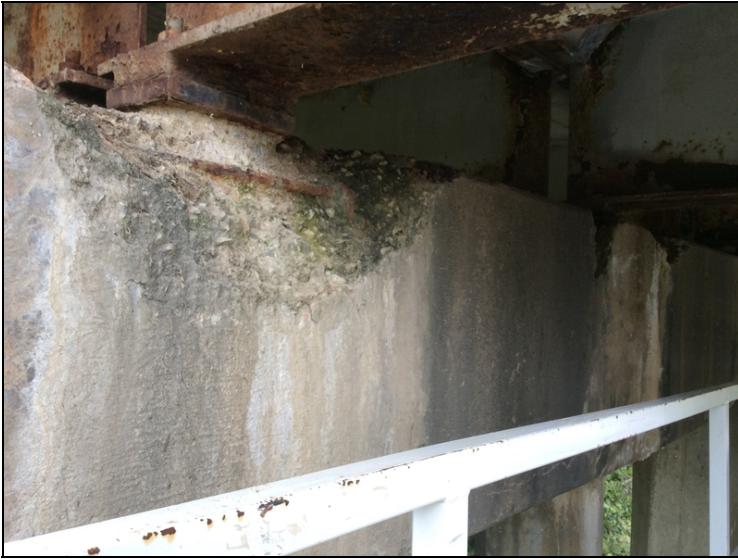
Bent 2 cap has a 1' x 8" x 6" spall on span 2 side under girder 4 with 5% loss of bearing.

02871 10-01-2015 Bent 2 Cap Span 2 Side Right  
End under Girders 4 & 5.

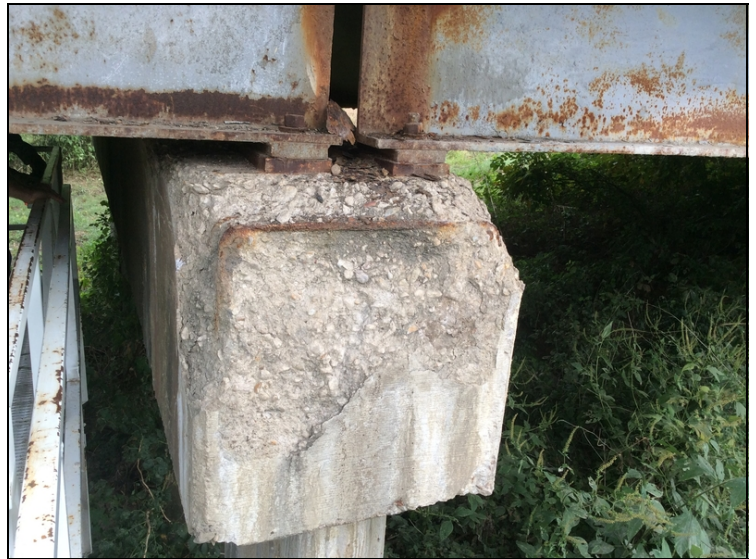
Bent 8 right end of cap has 3' of deterioration with exposed rebar.

02871 10-01-2015 Right end Bent 8 Cap.

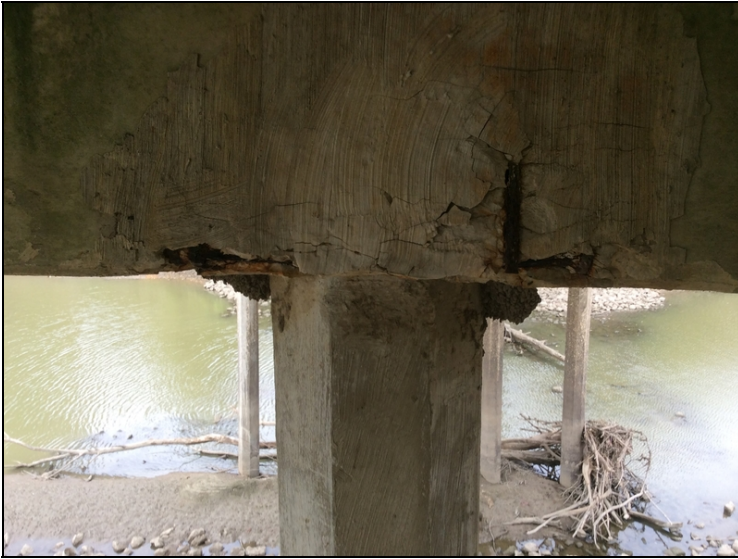
02871 10-01-2015 Bent 5 Cap Span 5 Side over  
Pile 3.

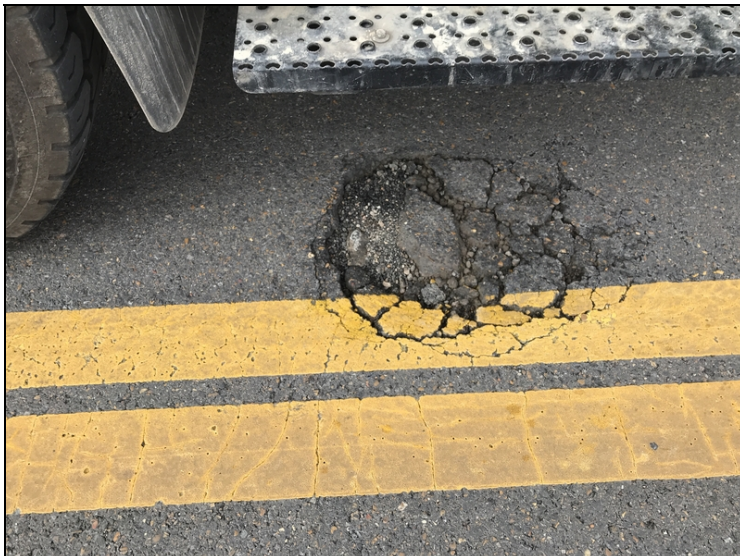
Span 2 deck near centerline

Span 2 has an 18" diameter spall with broken concrete in deck near center line.

Span 2 top of deck near center line has a 2' x 2.5' patch, broken and loose.

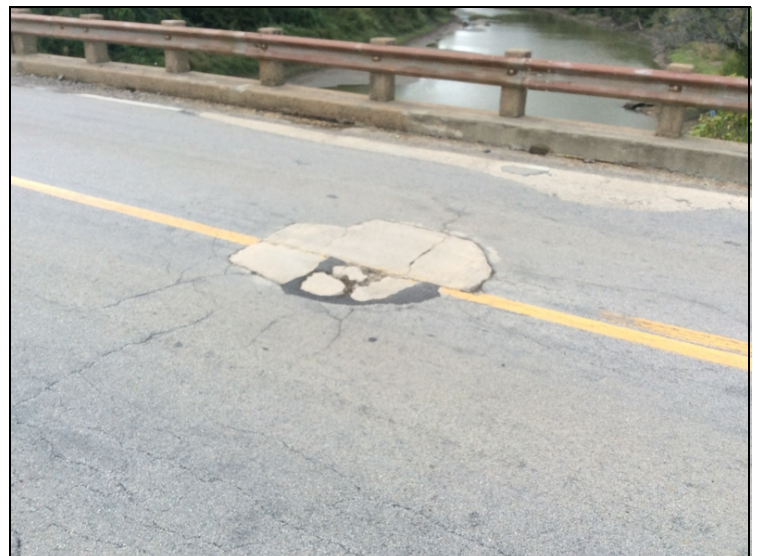
02871 10-01-2015 Span 2 centerline repair.

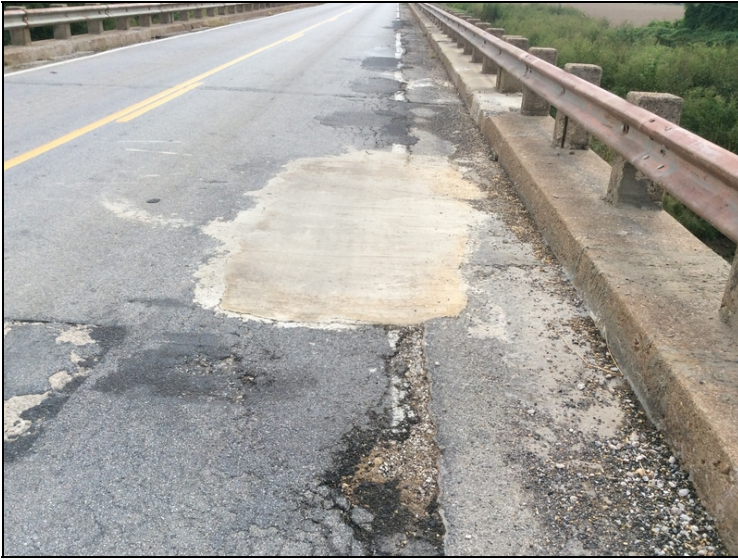
02871 10-01-2015 Span 3 Right lane repair.

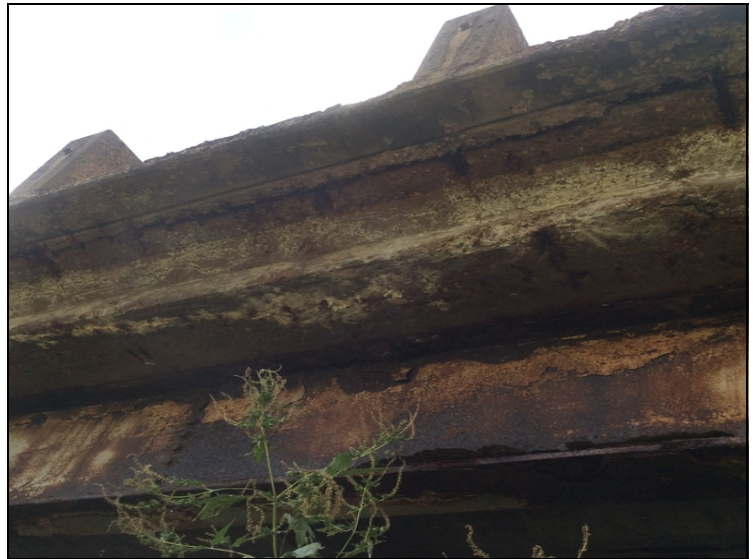
02871 10-01-2015 Span 8 left overhang.

Left and right overhangs have several shelled out areas with exposed rebar.

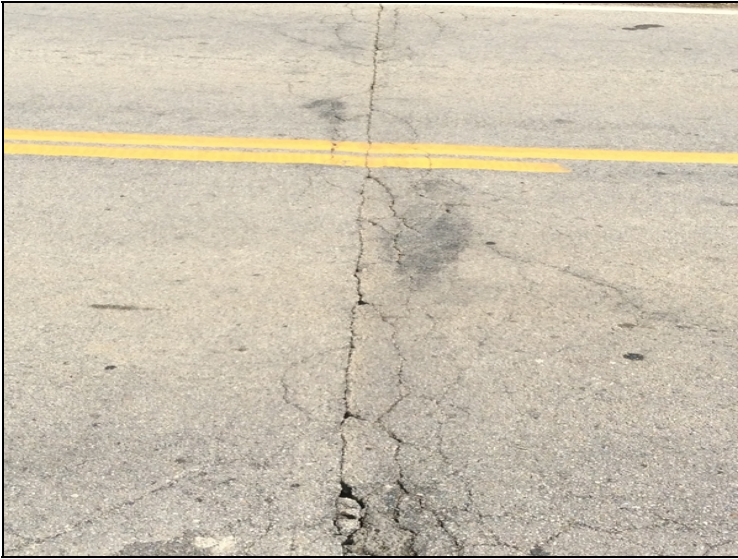
02871 10-01-2015 Bent 4 joint.

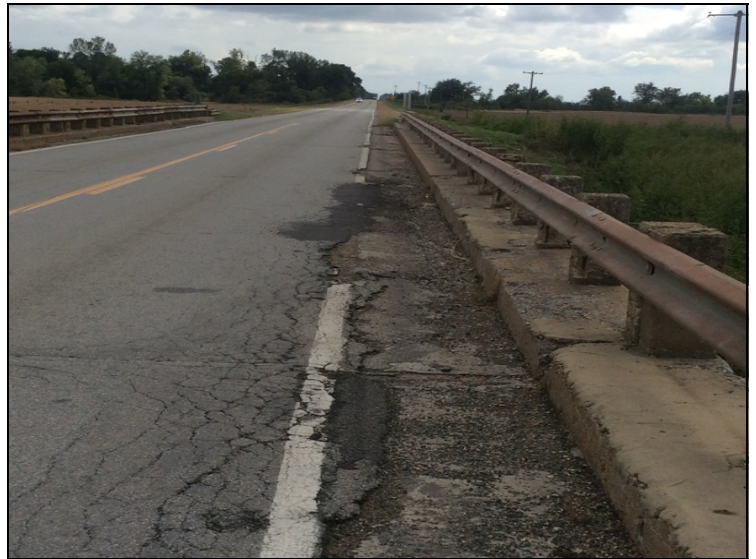
02871 10-01-2015 Span 5 Right gutterline.

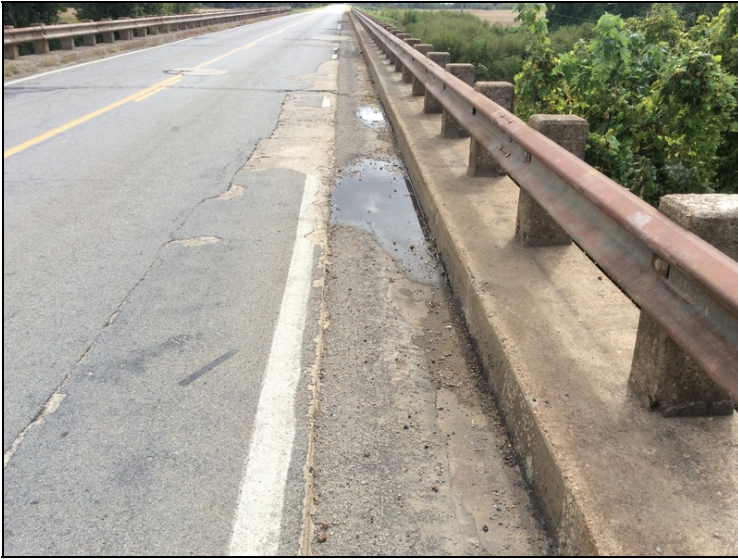
02871 10-01-2015 Span 1 Right gutterline

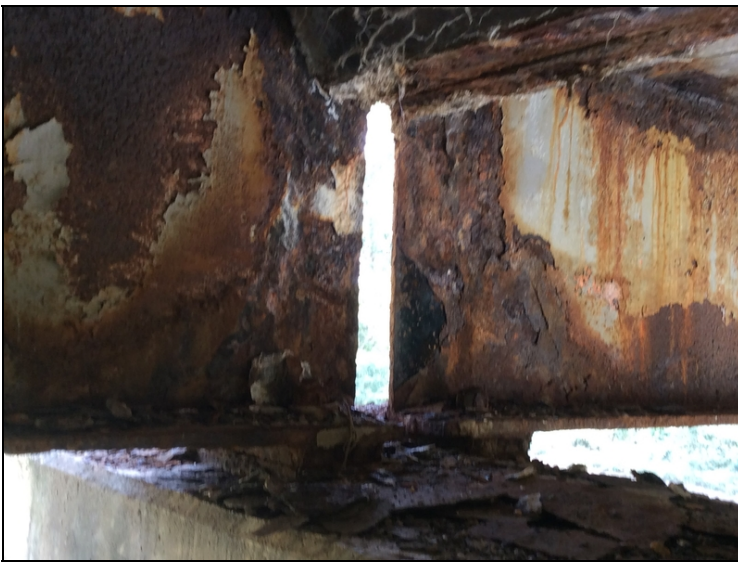
Bearings are rust covered with section loss.  
Span 1 & 2 Girder 1 Bent 2 pack rust with section loss especially at web.

02871 10-01-2015 Span 1 Girder 1 & Span 2  
Girder 1 over Bent 2.

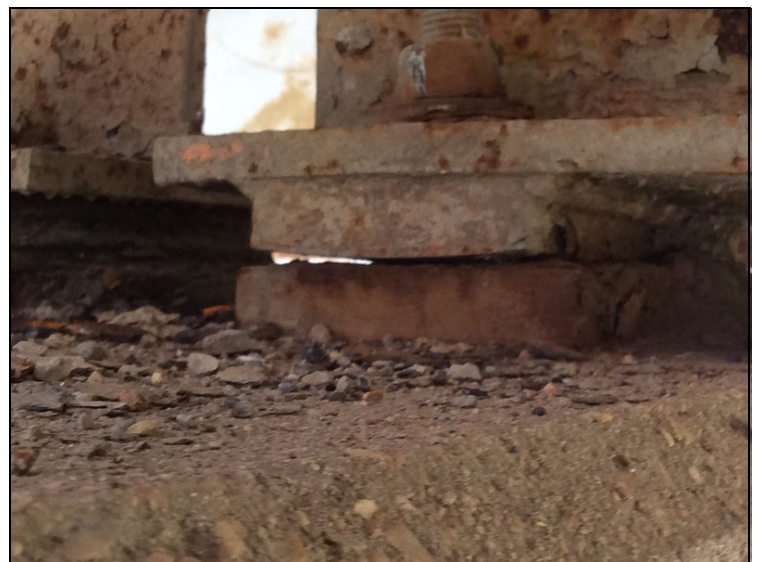
02871 10-01-2015 Span 2 Girder 2 over Bent 3  
Movement under traffic.

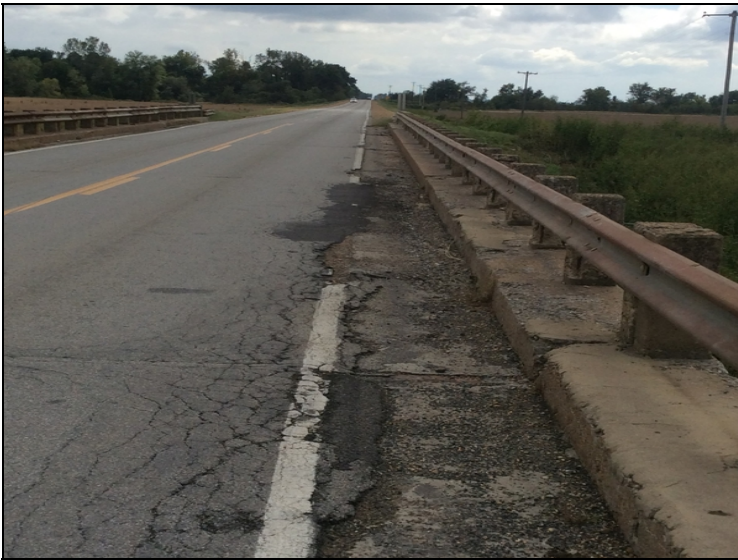
02871 10-01-2015 Span 5 Right gutterline.

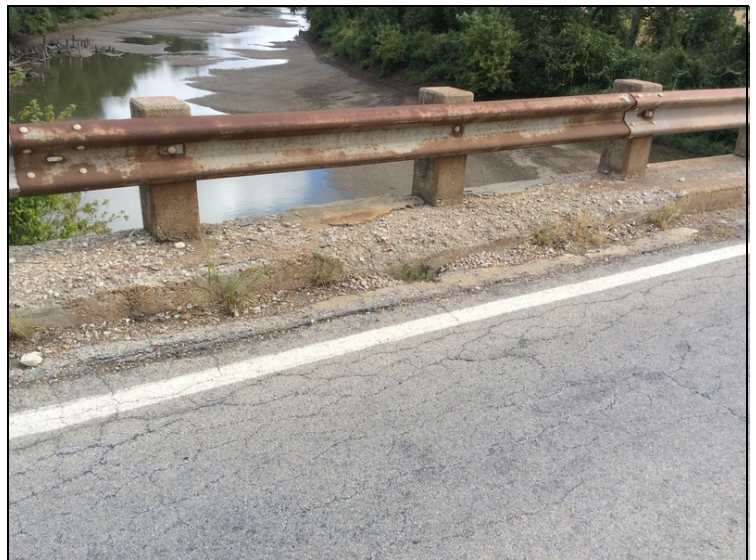
All Concrete Curbs has some deterioration with section loss.

02871 10-01-2015 Span 2 Left Curb.

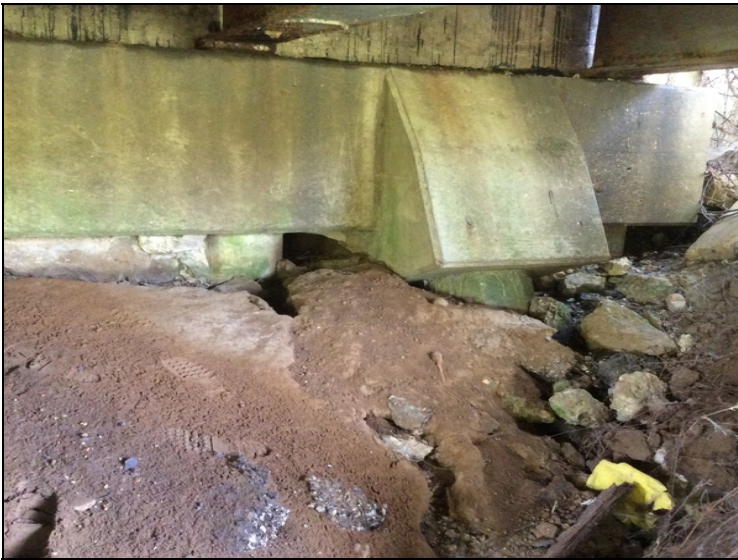
Bent 9 Slope Erosion has up to 1.5' erosion at abutment and up to 2' back under Cap.

02871 10-01-2015 Bent 9 right end of abutment erosion.

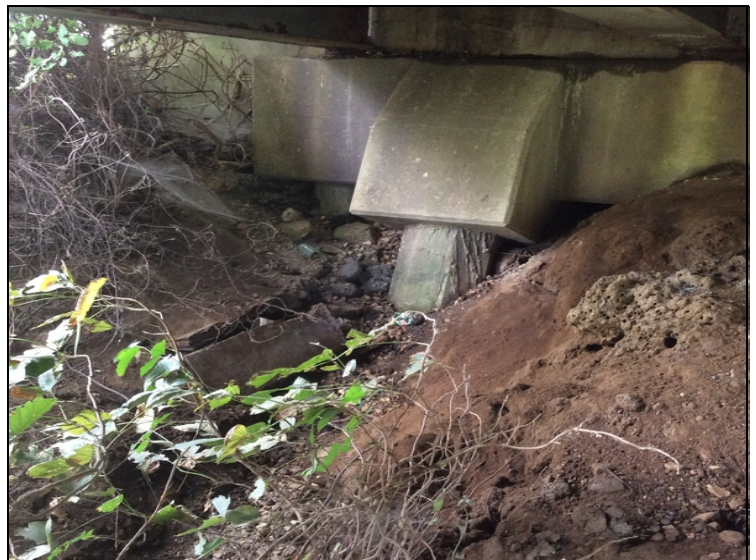
02871 10-01-2015 Bent 9 left end of abutment erosion.

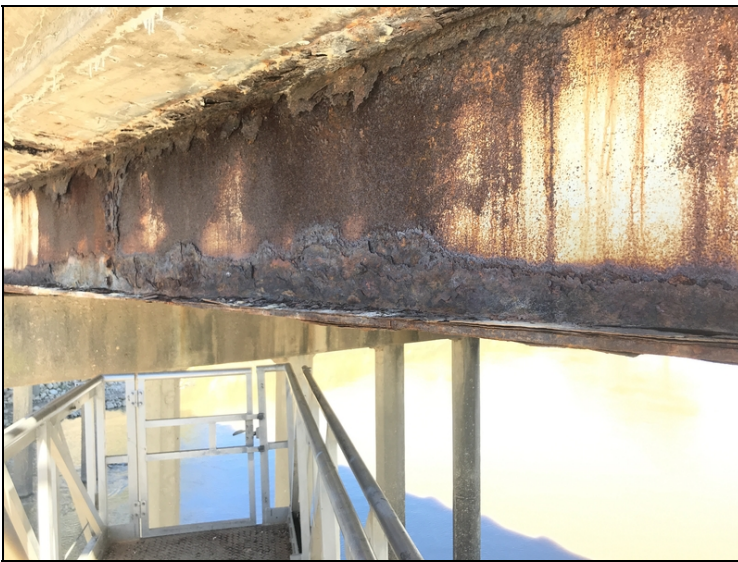
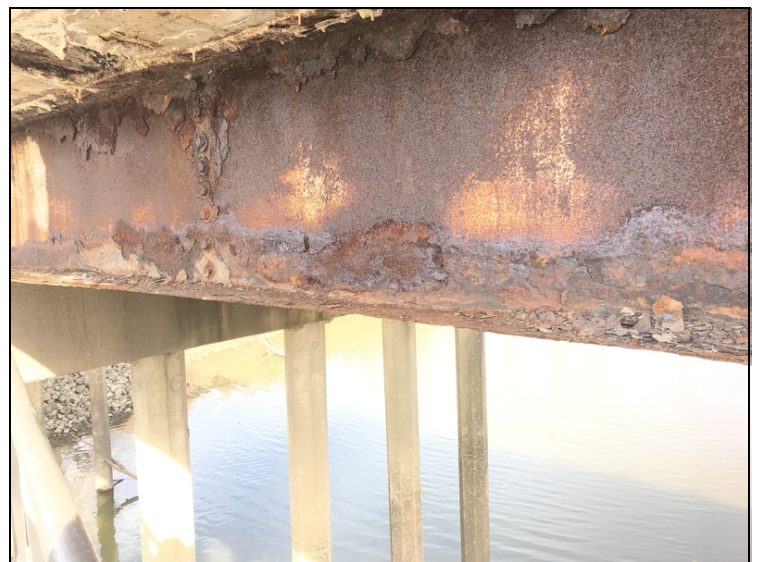
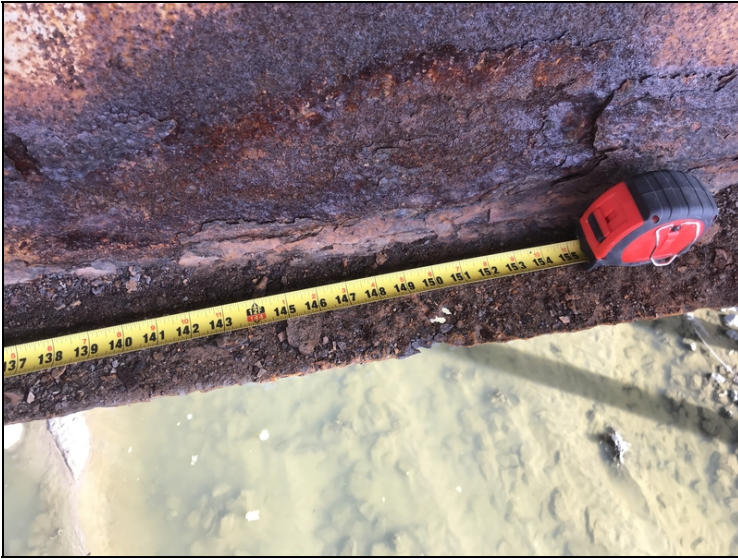
S4 g5

Span 4 girder 5 has the bottom flange with severe section loss near Diaphragm connection bolts (outside edge under drains).

to Dist Bridge Crew for repair when schedule allows. KAW 11-15-19
