Bridge #02872(Routine)
SH 77-02- LM 6.76 over LITTLE RIVER
Location: 0.05 MI S JCT OF SH 158

Team Lead: Tim Myrick **Inspection Date:** November 24, 2020

IDENTIFICATION	
(1) State Names	Arkansas
(8) Structure Number	02872
(5) Inventory Route	77
(2) Highway Agency District	10
(3) County Code	93-Mississippi County, Arkansa

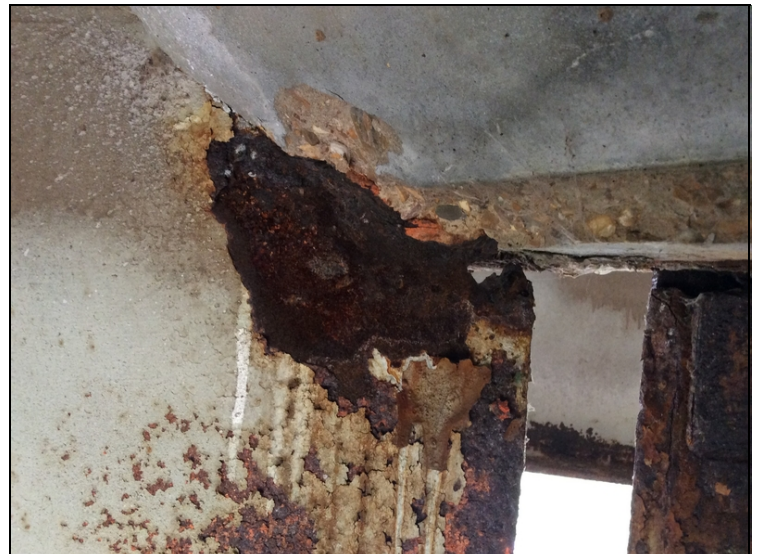
02872 10-01-2015 Span 2 Girder 2 over bent 2
bottom flange.

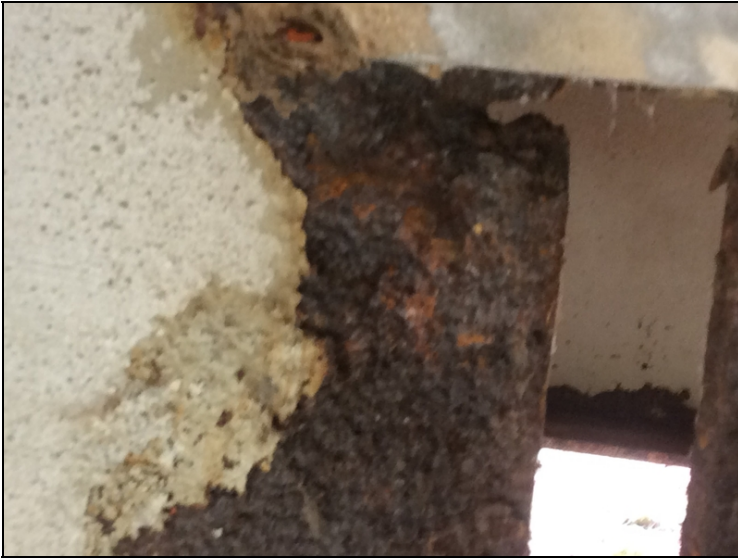
02872 10-01-2015 Span 5 Girder 5 over Bent 5.

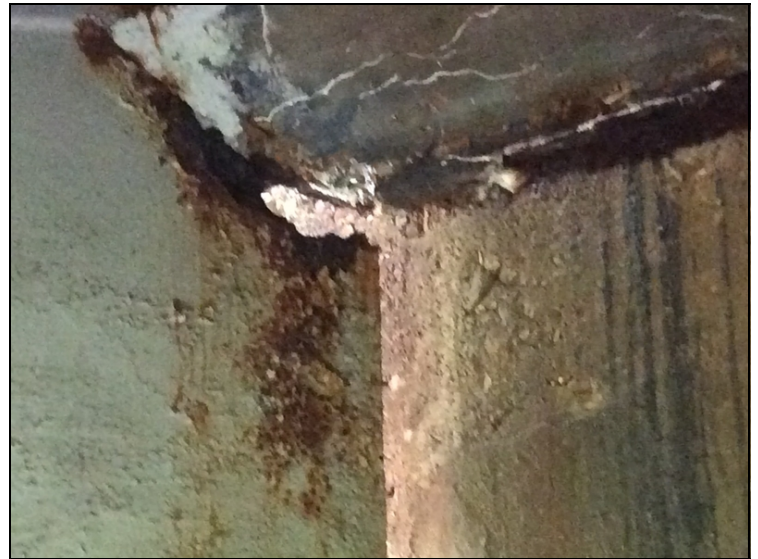
02872 10-01-2015 Span 2 Girder 2 over bent 2.

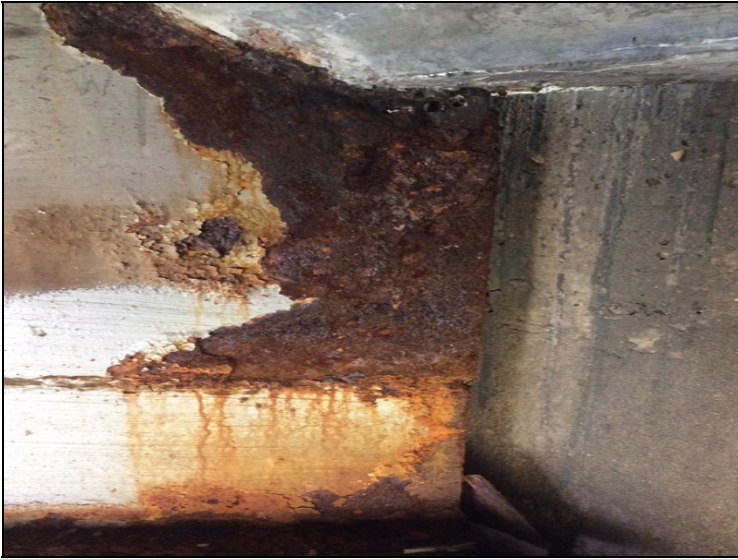
02872 10-01-2015 Span 1 Girder 5 over Bent 1.

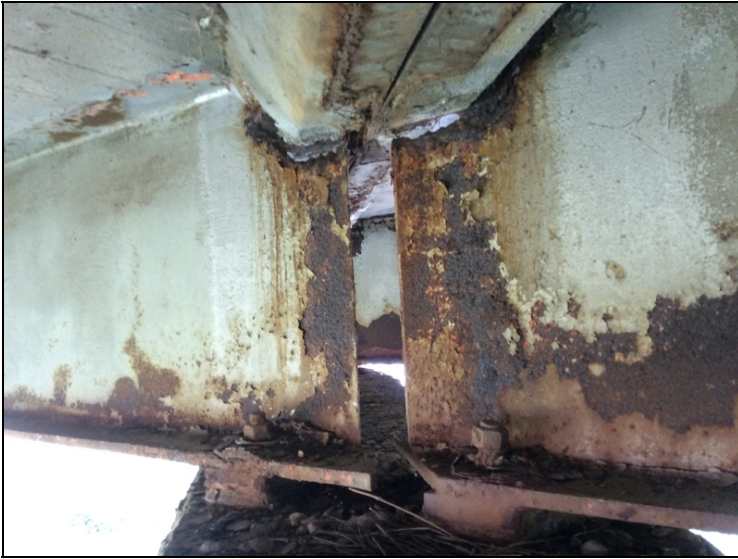
02872 10-01-2015 Span 2 Girder 2 over Bent 3.

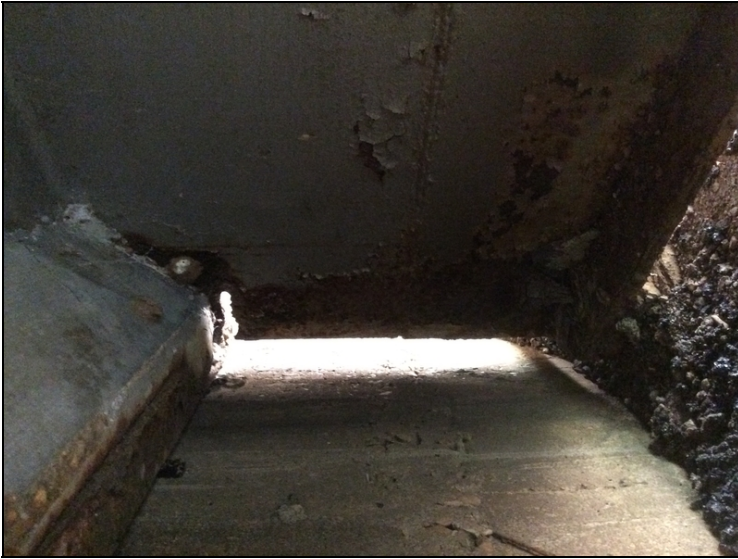
02872 10-01-2015 Span 3 & 4 Girder 4 over Bent
4.

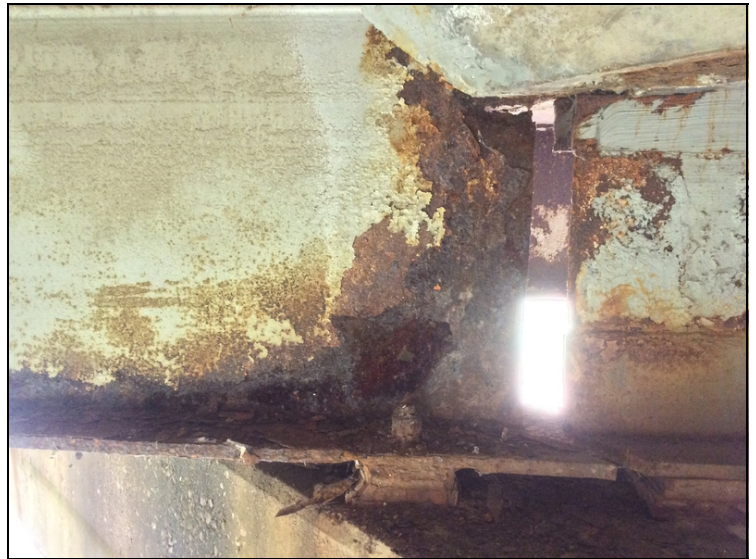
02872 10-01-2015 Span 5 Girder 3 over Bent 6.

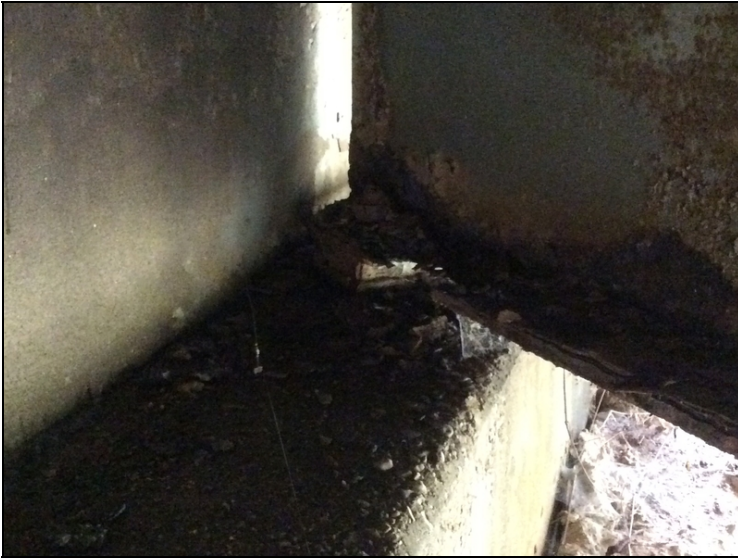
02872 10-01-2015 Span 2 Girder 4 over Bent 2.

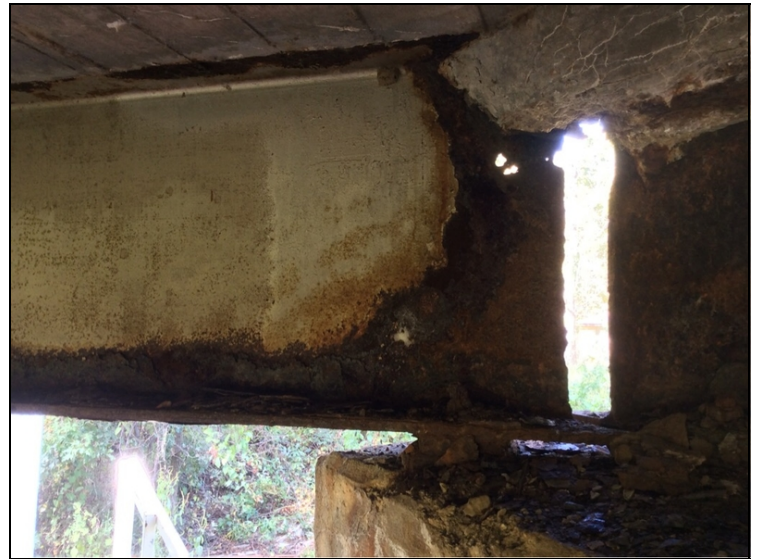
02872 10-01-2015 Span 5 Girder 4 over bent 6 left
bottom flange.

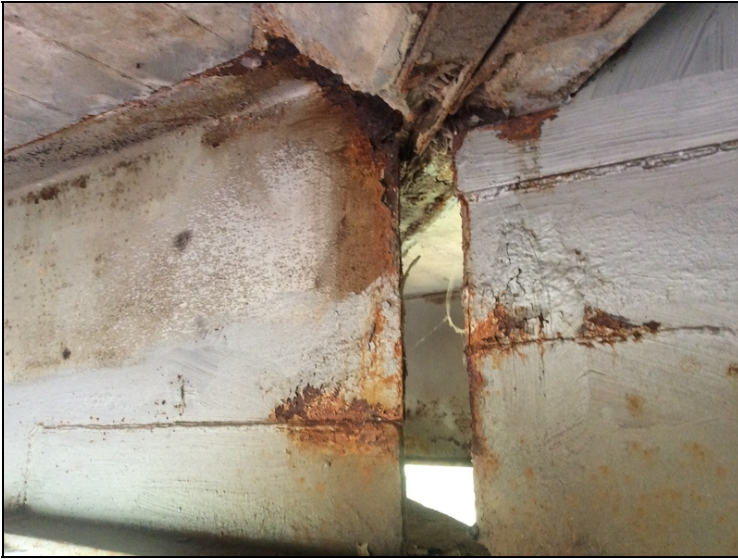
02872 10-01-2015 Span 1 Girder 3 over Bent 1.

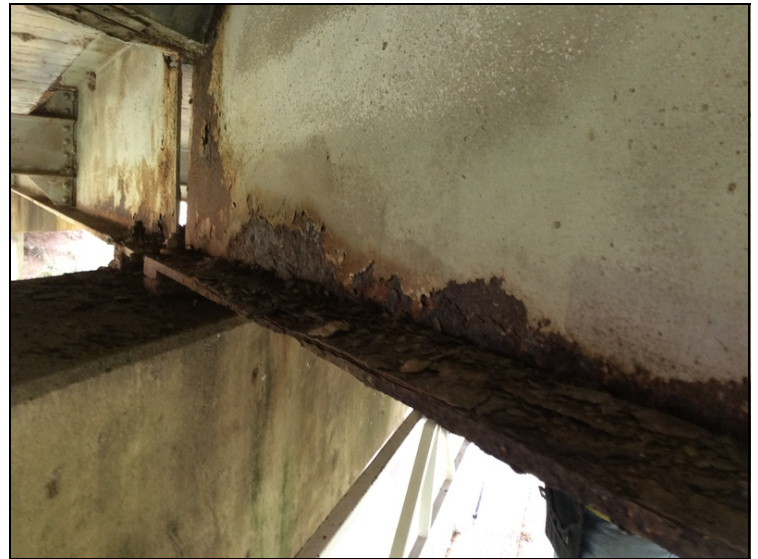
02872 10-01-2015 Span 1 Girder 3 over Bent 2.

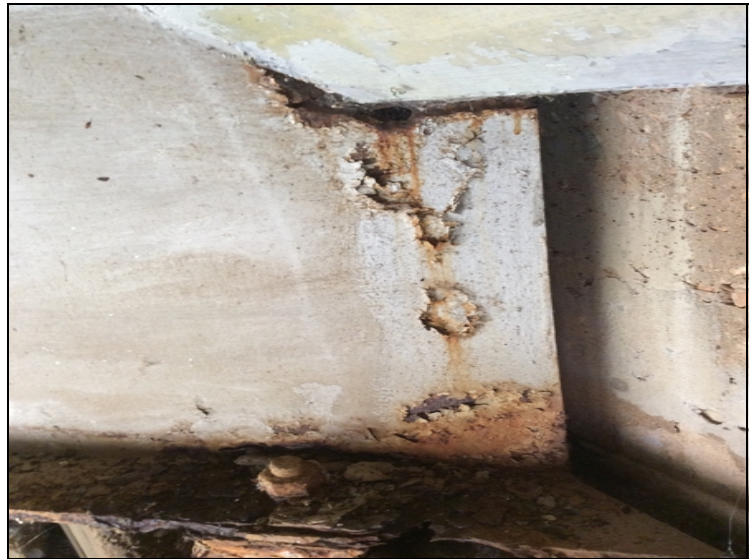
02872 10-01-2015 Span 3 Girder 3 over Bent 4

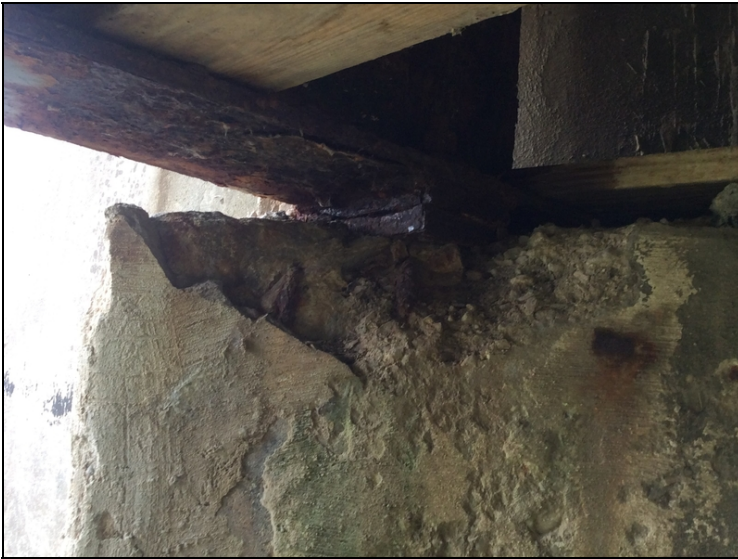
Majority of Bearings are rust covered with some section loss.
Majority of Anchor Bolts have heavy section loss with a few having complete section loss.

02872 10-01-2015 Span 5 Girder 1 bearing @ bent 6.

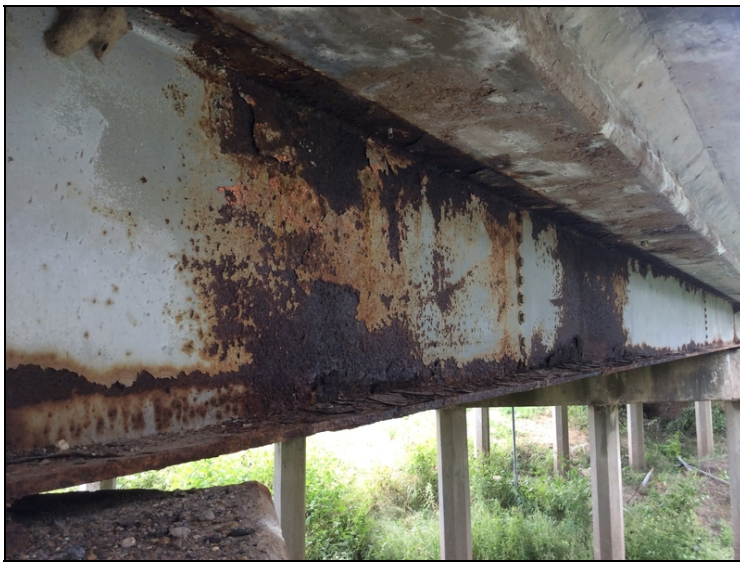
All Steel Girders are rusted with pitting and 4' on ends of Girders have up to 1/4" section loss to web and bottom flange. Exterior Girders are rusted with pitting and up to 1/4" section loss to mostly top and bottom flanges.

02872 10-01-2015 Span 3 Girder 5.

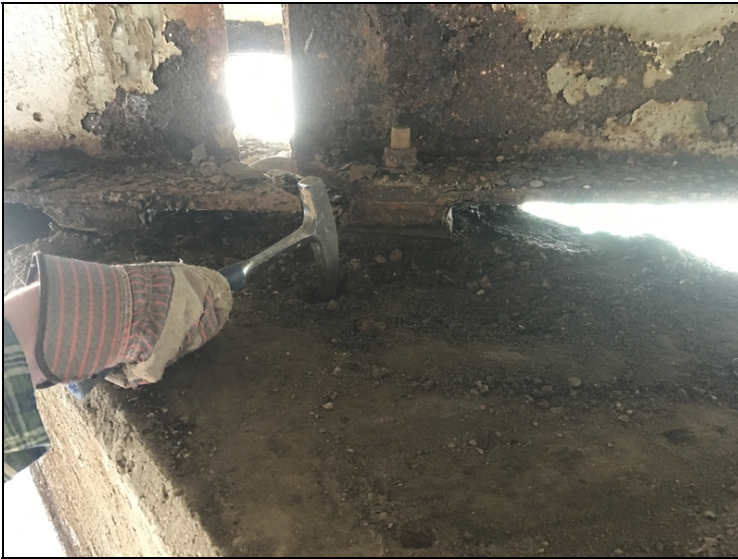
B5 bay 2

Have several small shelled out areas with some expose rebar, inadequate coverage due to steel placement.

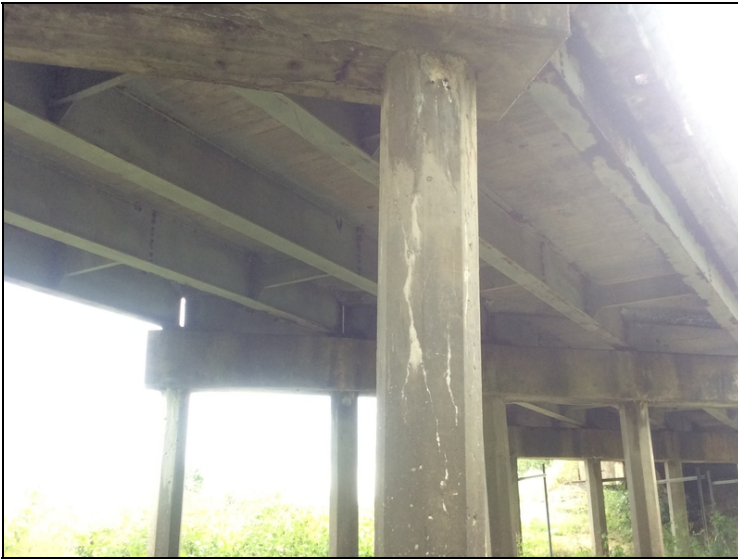
Top 3' of Bent 3 Pile 4 has some cracking visible.
Top 10' of Bent 3 Pile 5 has moderate cracking with efflorescence visible.

02872 10-01-2015 Bent 3 Pile 5.

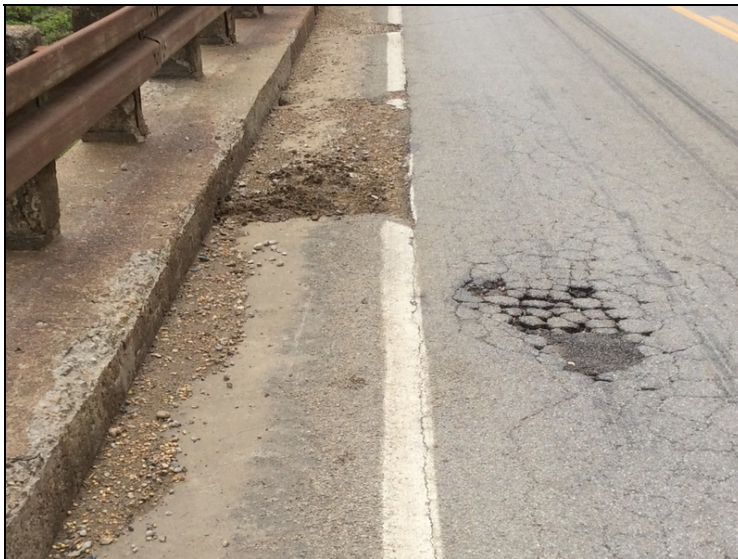
Top of Deck left & right Gutter lines have areas of scaling.
Top of Deck left Gutter line Span 3 has a 2.5' x 10" x 2" deep deterioration and spalled out area.
Top of Deck left Gutter line Span 4 has a 2.5' x 4' x 2" deep deterioration and spalled out area.
Top of Deck left Gutter line Span 5 has a 2.5' x 20' x 2" deep deterioration with spalled out area.

02872 10-01-2015 Span 3 Left gutterline.

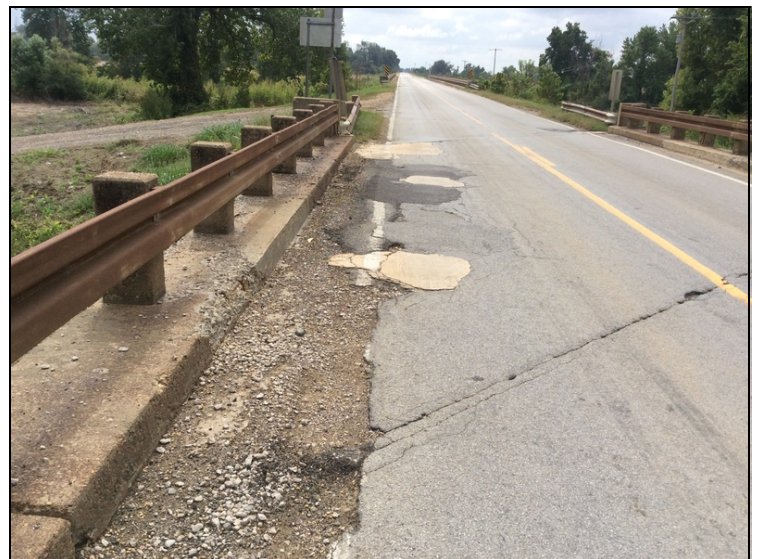
02872 10-01-2015 Span 5 Left gutterline & left lane.

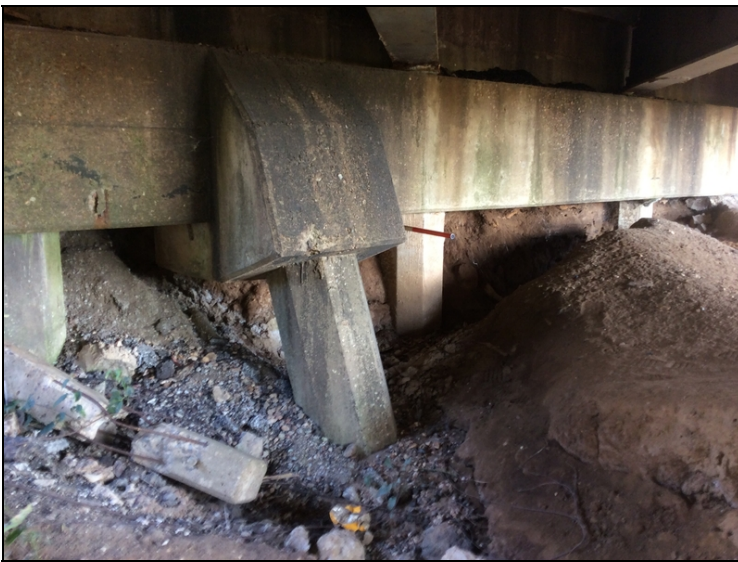
Bent 1 abutment erosion heavy Slope erosion and undermining of bent 1 abutment, 3' deep x 3' back under cap has exposed piling.

Bent 1 erosion, 2017

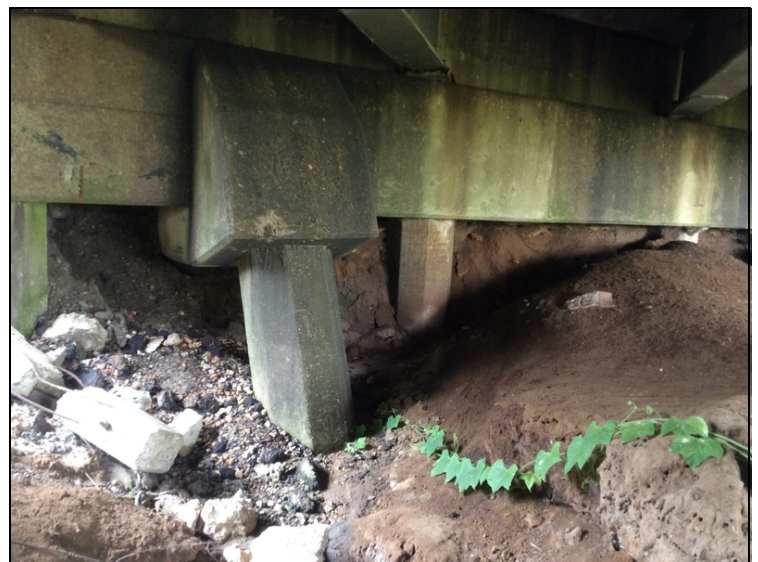
02872 10-01-2015 Bent 1 Abutment Right end

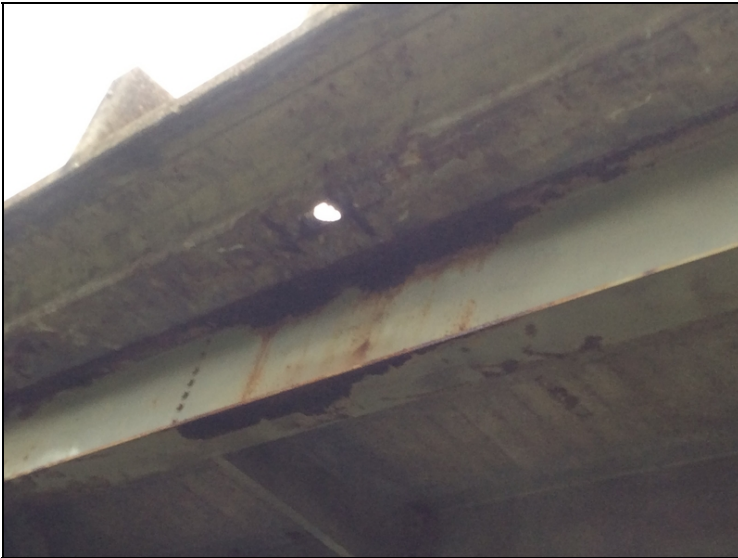
Left and right Overhangs have some spalled areas with rebar exposed.
Bottom of Deck has some cracking with efflorescence.
All Open Joint angle iron is rusting with initial section loss, only 3 to 4 foot of joint visible due to asphalt overlay.

02872 10-01-2015 Span 4 right side first drain.

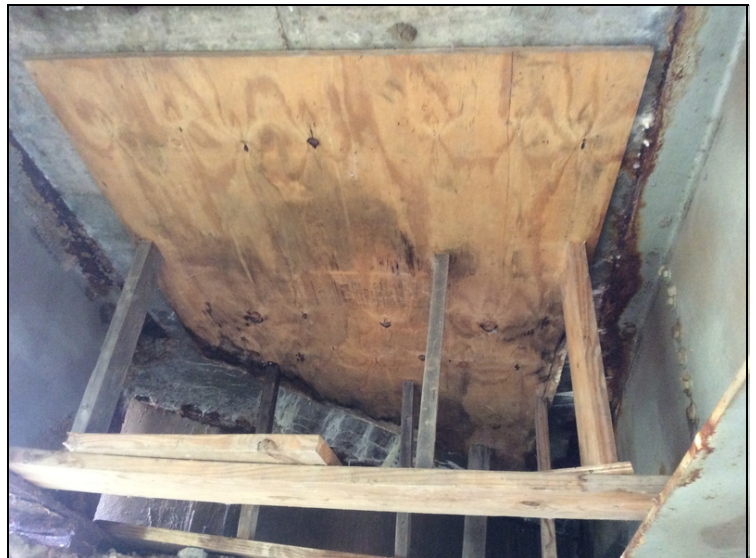
02872 10-01-2015 Span 5 Bay 1 @ bent 6.

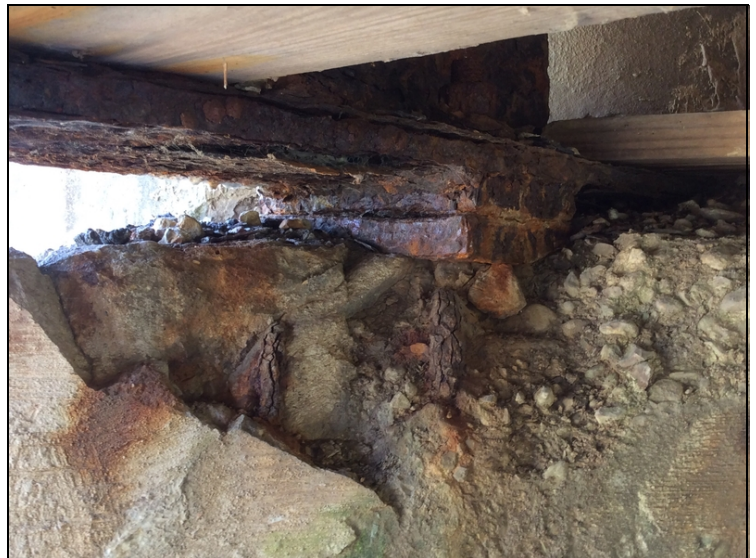
Bent 2 cap left end of has a 2' x 6" spall with exposed rebar, 1' of exposed rebar on bottom near pile 2, a 2' x 4" spall with exposed rebar at pile 4, 2' of deterioration near girder 5.
Bent 3 cap has heavy deterioration and cracking with 10' total of exposed rebar due to lack of steel coverage. Span 3 side of cap has 15' of spall with some exposed rebar, right end of cap over pile 5 has 3' of cracking.
Bent 4 top of cap left end between girders 1 & 2 is spalled up to 2" deep.
Bent 4 left end of cap has 3' spalled with exposed rebar (with section loss) over pile 1.
Bent 5 cap has 6' of cracking & impending spalls.
Bent 6 abutment left end has a 2' x 4" deep spall with exposed rebar (with section loss to rebar) under bearing 1 with 1" of loss of bearing.

02872 10-01-2015 Bent 3 Cap Span 3 Side.

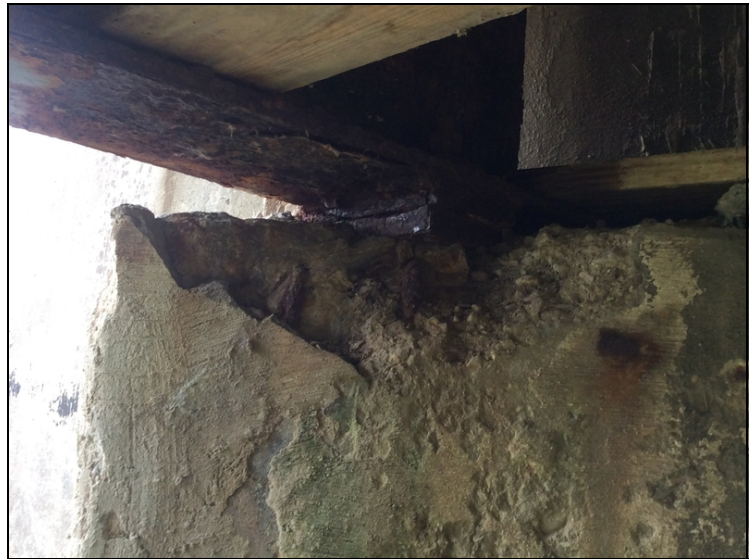
02872 10-01-2015 Span 5 Girder 1 bearing @ bent 6.

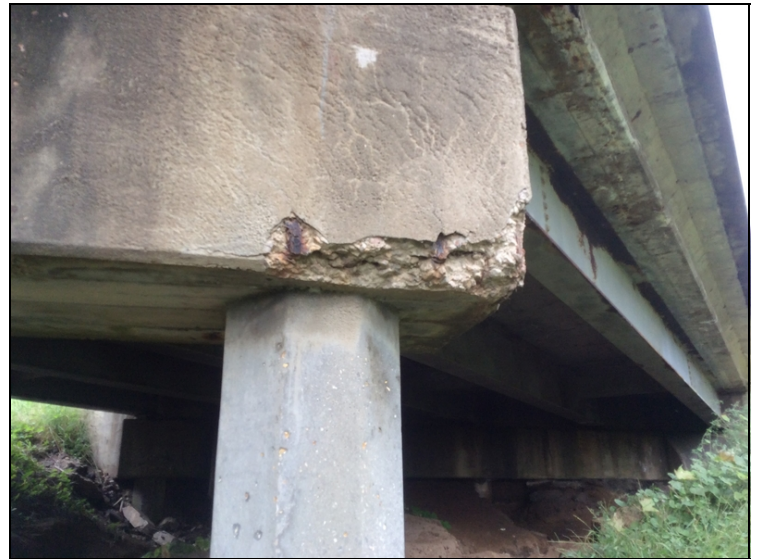
02872 10-01-2015 Bent 2 Cap Left end

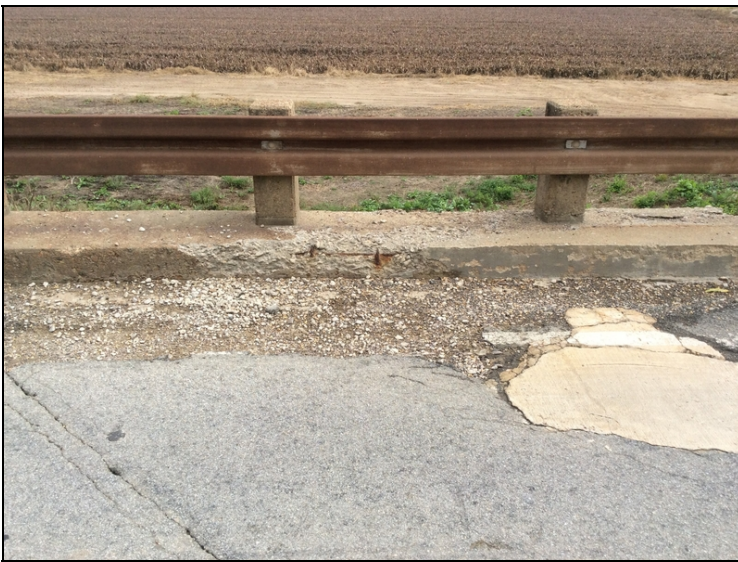
Several areas of concrete curbs are deteriorated with section loss and some rebar exposed.

02872 10-01-2015 Span 5 left curb.

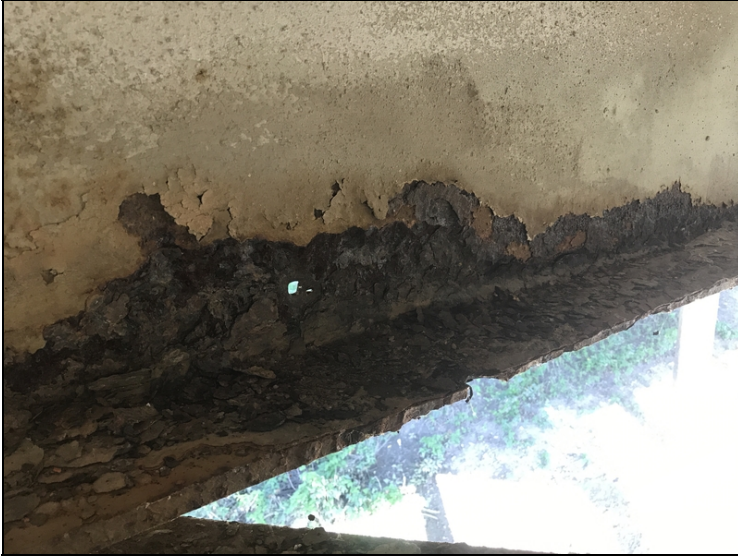
Span 3 girder 3 near bent 4

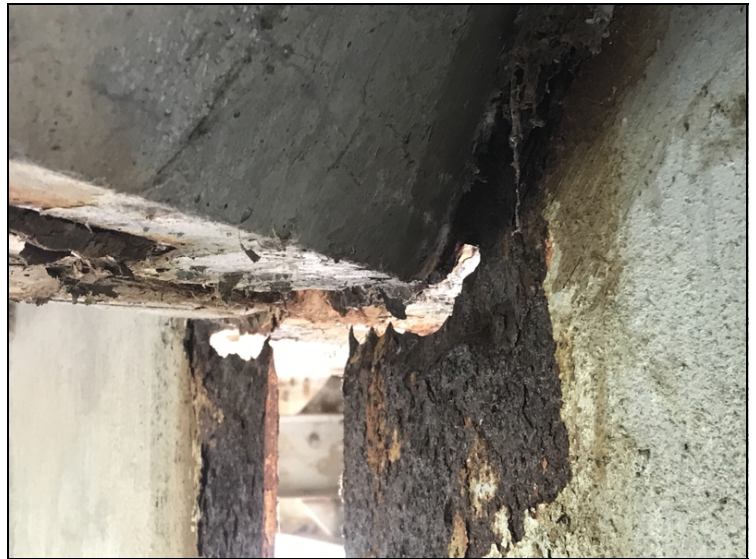
Span 4 girder 4 at bent 4

Span 4 bent 4 girder 4 has a 7"x 1" hole in web at haunch, and heavy section loss at bearing.

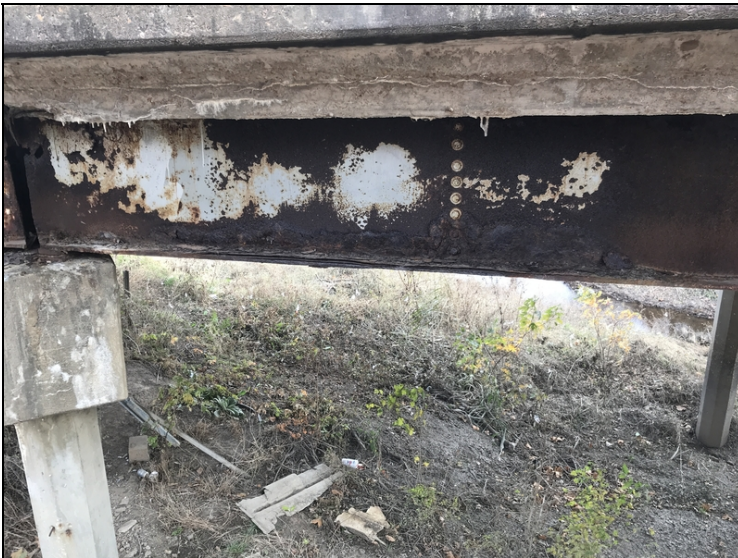
S2 g5

Span 2 bent 2 girder 5 has 9" x 1" hole in web at haunch, 3/8" section loss bottom flange 5" x 3' area and crushing.
Span 2 bent 3 girder 1 has a 18" crack with holes in web crushing over cap.
Span 5 bent 6 girder 4 has a 1" diameter hole everywhere in web at Haunch and end of web, and the left flange (near bearing) has a 4" x 8 1/2" hole and the right flange has heavy section loss with a 1" hole, plus web has 3 1/2" x 1" hole.
