District 10, Mississippi County

Bridge #02881 (Routine)
SH 77-02- LM 6.34 over LITTLE RIVER

Team Lead: Tim Myrick Inspection Date: November 24, 2020

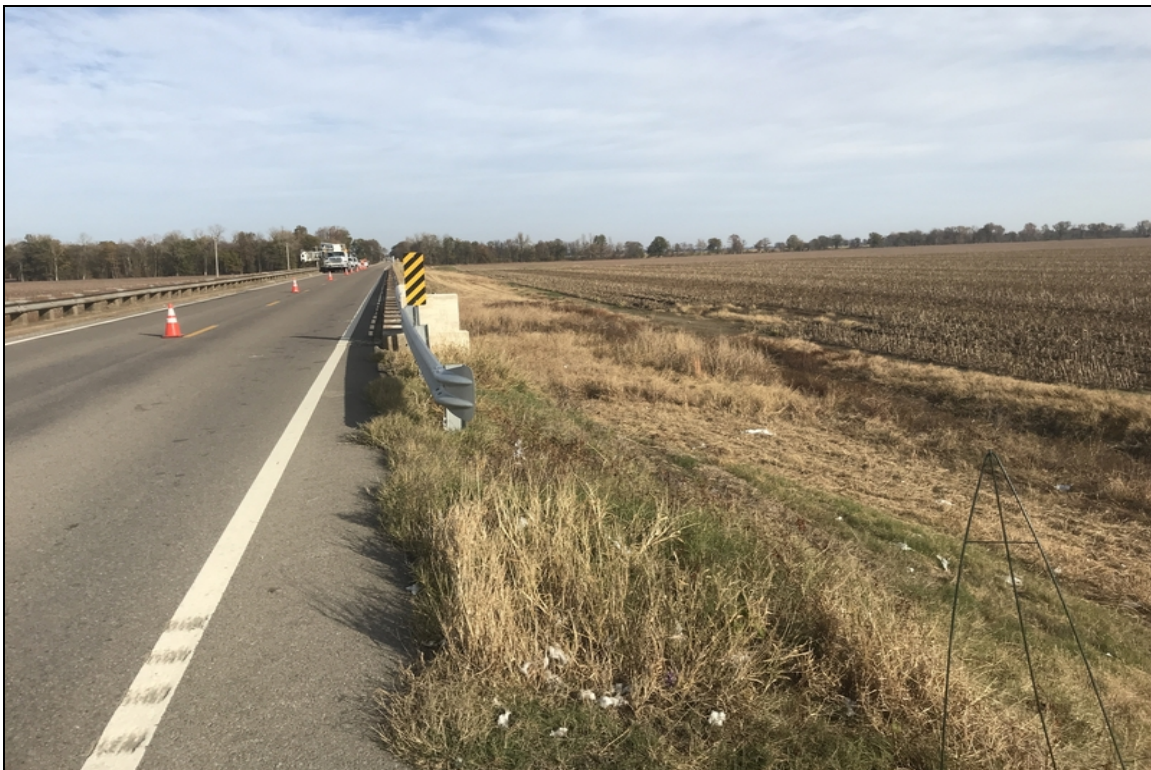
ending end sign crew fixed this by end of day

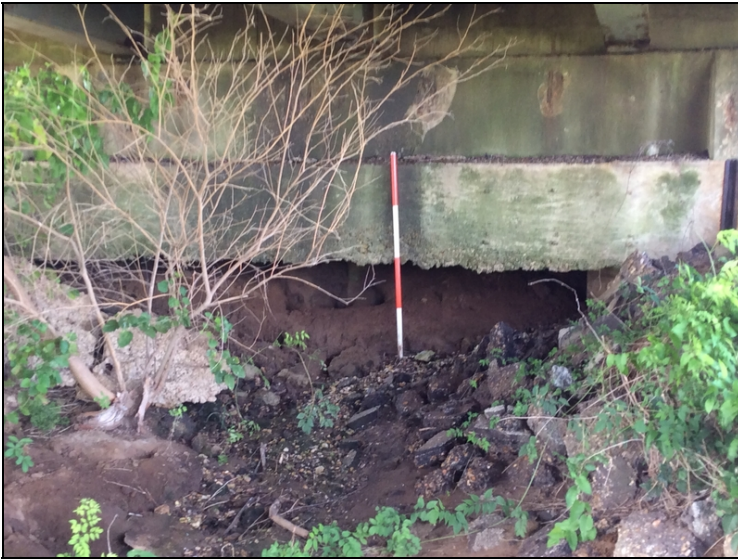
Bent 1 & Bent 10 Abutments have moderate slope erosion from roadway runoff causing undermining of abutments:
Bent 1 Abutment has some embankment erosion near center line
Bent 10 has up to 20ft. length of concrete x 2ft. high and up to 6ft. back under abutment, see 2016 photos.

Bent 10 abutment embankment erosion.

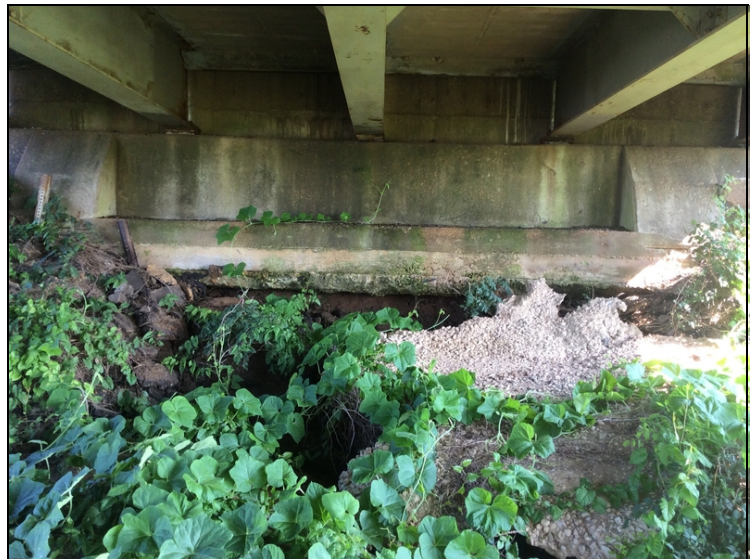
Bent 1 erosion.

Bent 1 abutment has some embankment erosion near center line and some repairs have been made since last inspection.

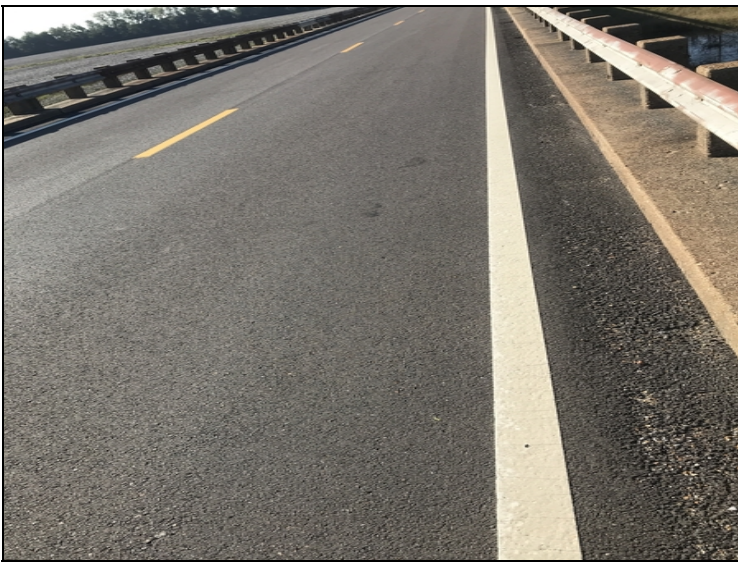
Dirt and Debris in Gutterlines.

Deck has been overlayed job #100838 observed at inspection JFA 10-04-2018

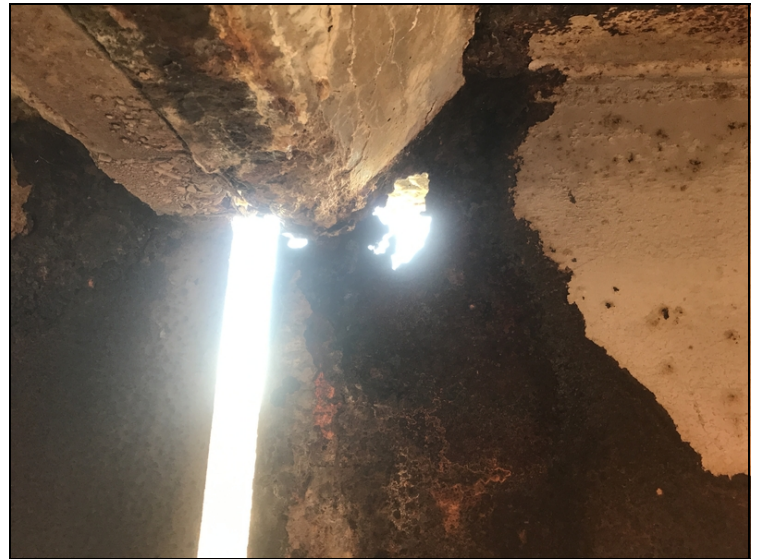
S8 b8 g1

Span 8 bent 8 girder 1 has a 7" x 4" hole rusted thru web at concrete haunch.

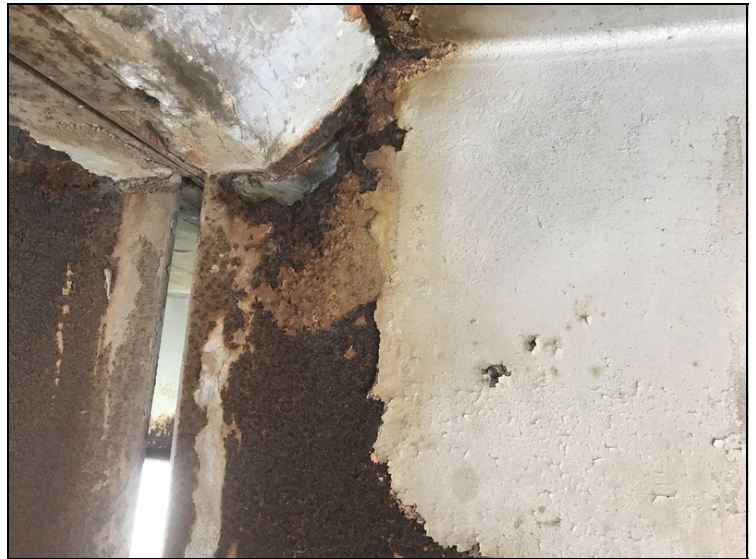
S8 b9 g3

Span 8 bent 9 girder 3 has a 5" X 2" hole rusted thru web at concrete haunch.

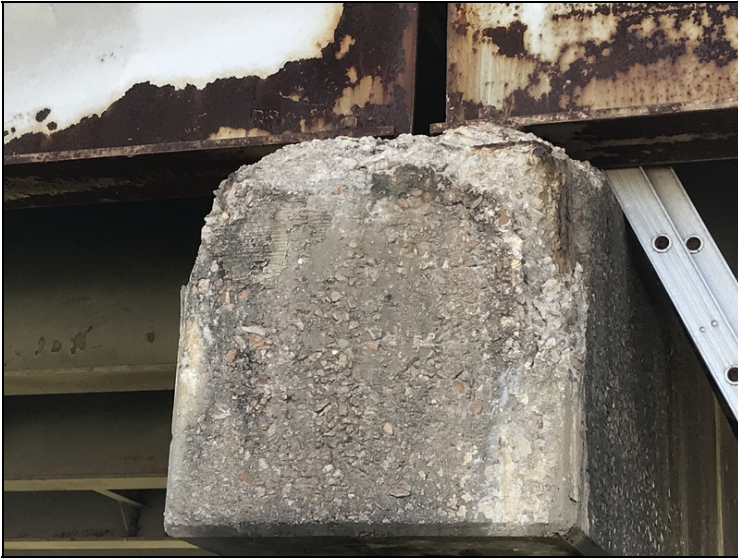
Bent 2 cap RT end

Bent 2 cap right end has 1' on end spalled 1.5' H x 3" deep with exposed rebar.

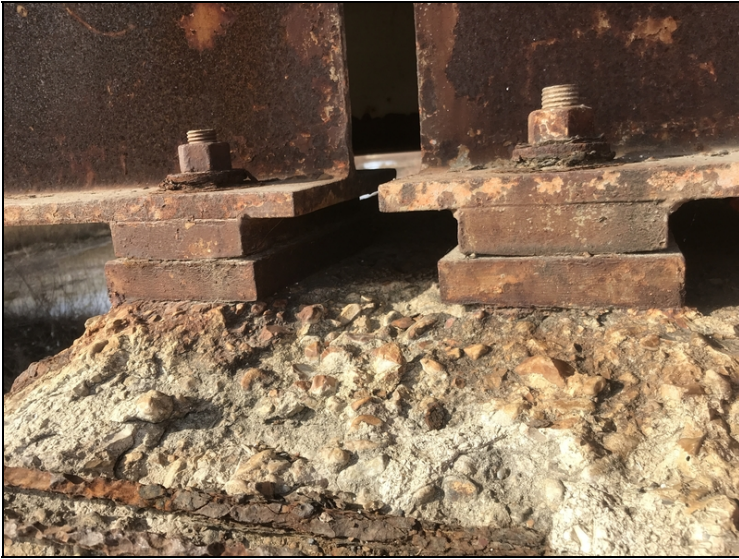
B2 left

Bent 2 cap left end has a spall near girder 1, 14" x 8" x 2.5" deep and a spall near pile 1, 12" x 6" x 3" deep with exposed rebar.

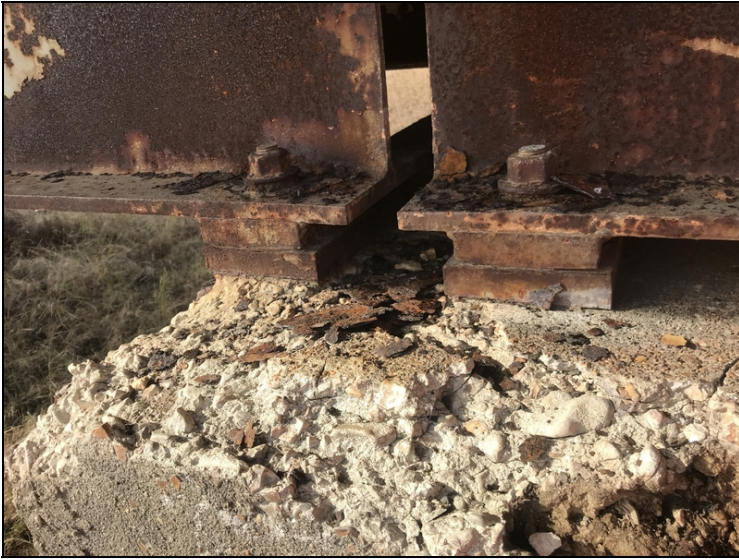
B6 left

Span 6 bent 6 cap left end, is spalled near bearing, 2' x 1' x 2" deep with exposed rebar.

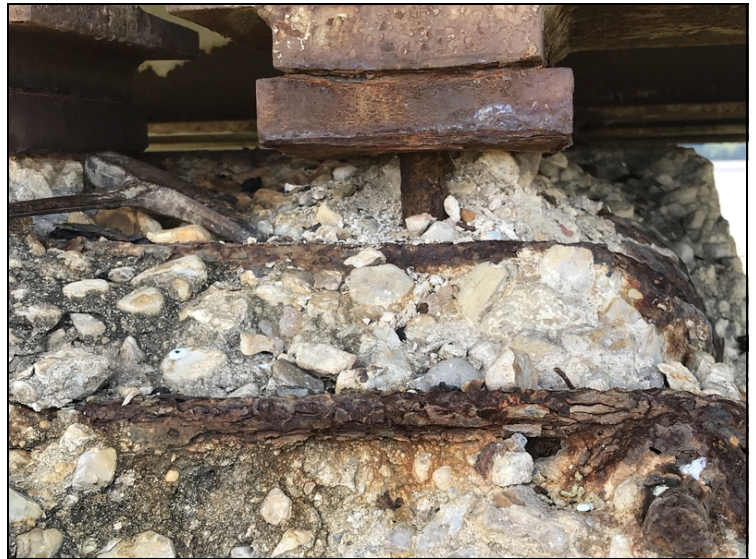
Bent 6 cap right end has heavy deterioration & section loss with 60 % loss of bearing area under span 6 girder 5 bearing, see 2018 photo.

Span 6 girder 5 bearing at bent 6

3/19/2020 Special inspection of sub due to item 60 rated a 4. District bridge crew has repaired the critical finding at bent 6 right end and sub will be moved to a 5.

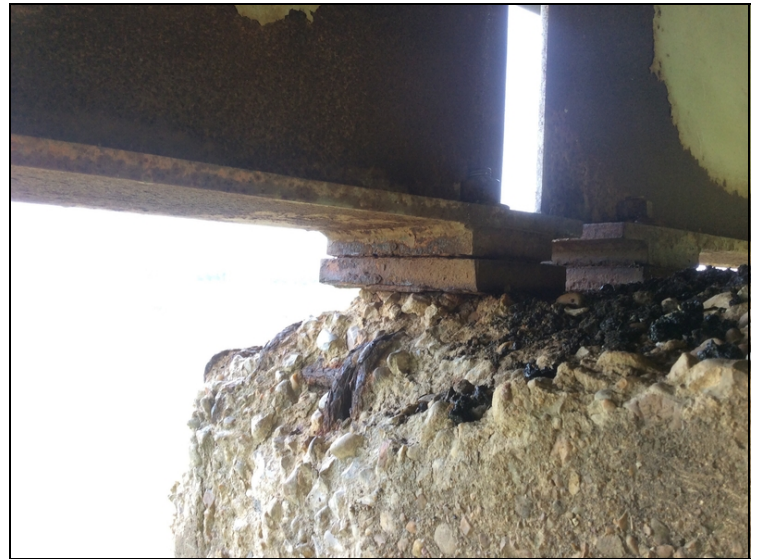
Bent 4 cap top at girder 3

Span 4 bent 4 cap under girder 3 has a 4' long x 6" high x 6" deep spall. Bottom of cap also has a 15" long crack with efflorescence & rust staining between piles 2 & 4.

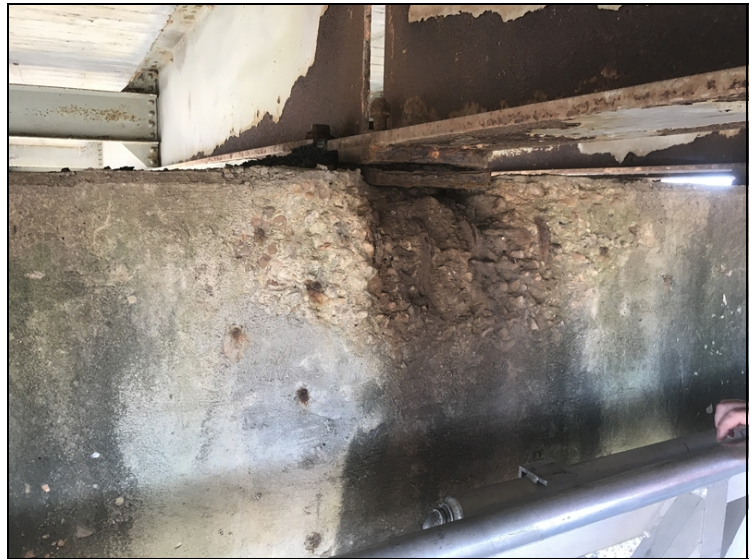
S3 B4

Span 3 bent 4 cap under bearing 3 has a 2.5' X 1' X 6" deep spall with 40% loss of bearing area, anchor bolt in cap is visible, masonry plate is settling away from girder and is movable by hand.
