District 10, Mississippi County

Bridge #03781(Routine)
SH 140-02- LM 9.08 over NATIONAL DITCH

Team Lead: Richard Jones Inspection Date: July 28, 2021

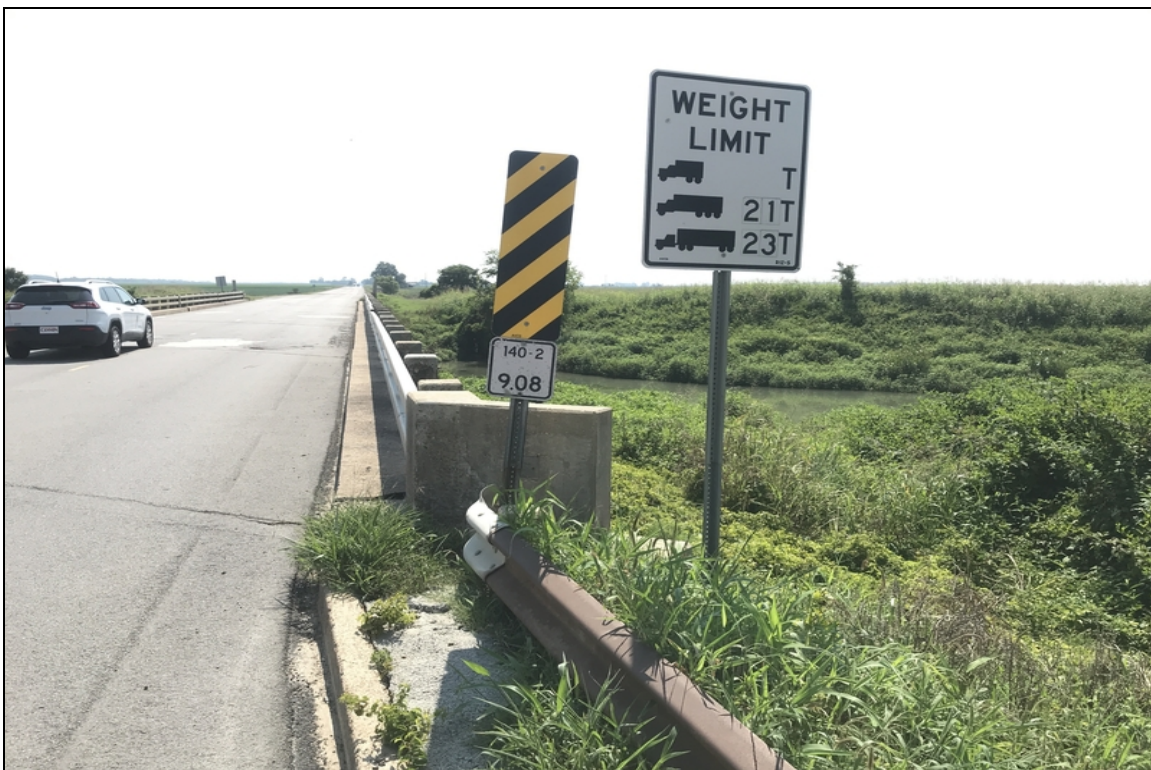
Load posting at beginning

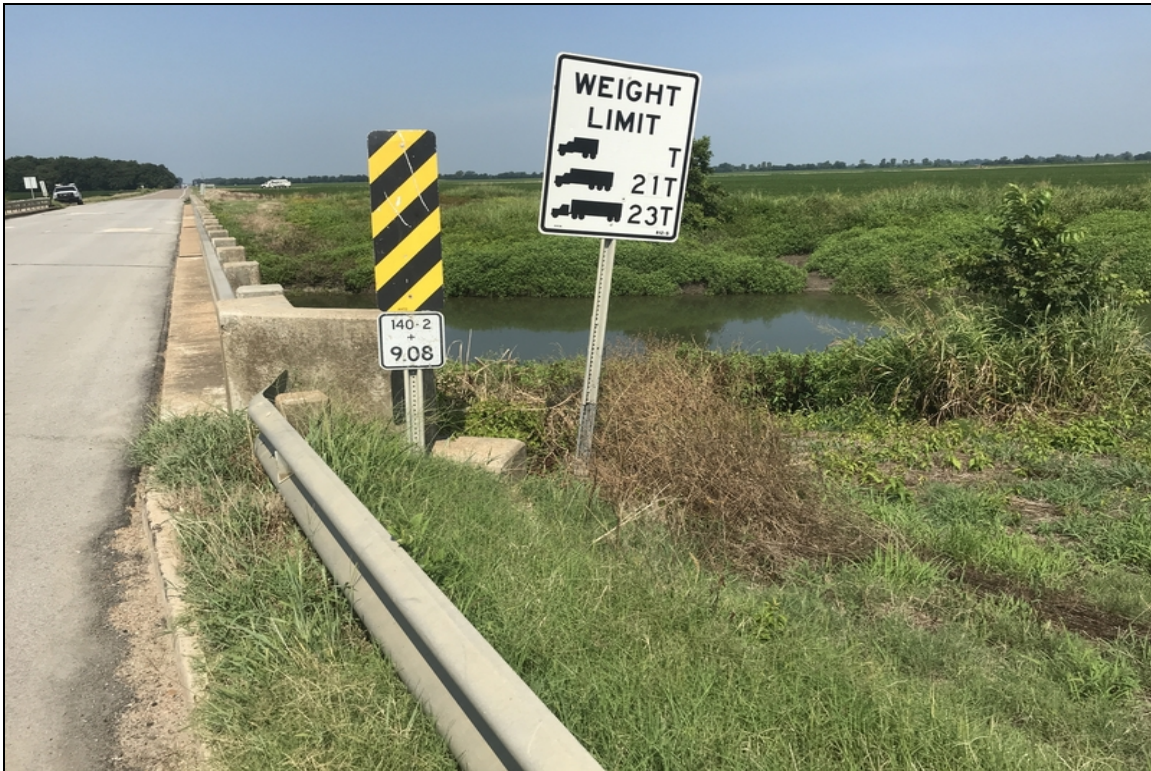
Load posting at end

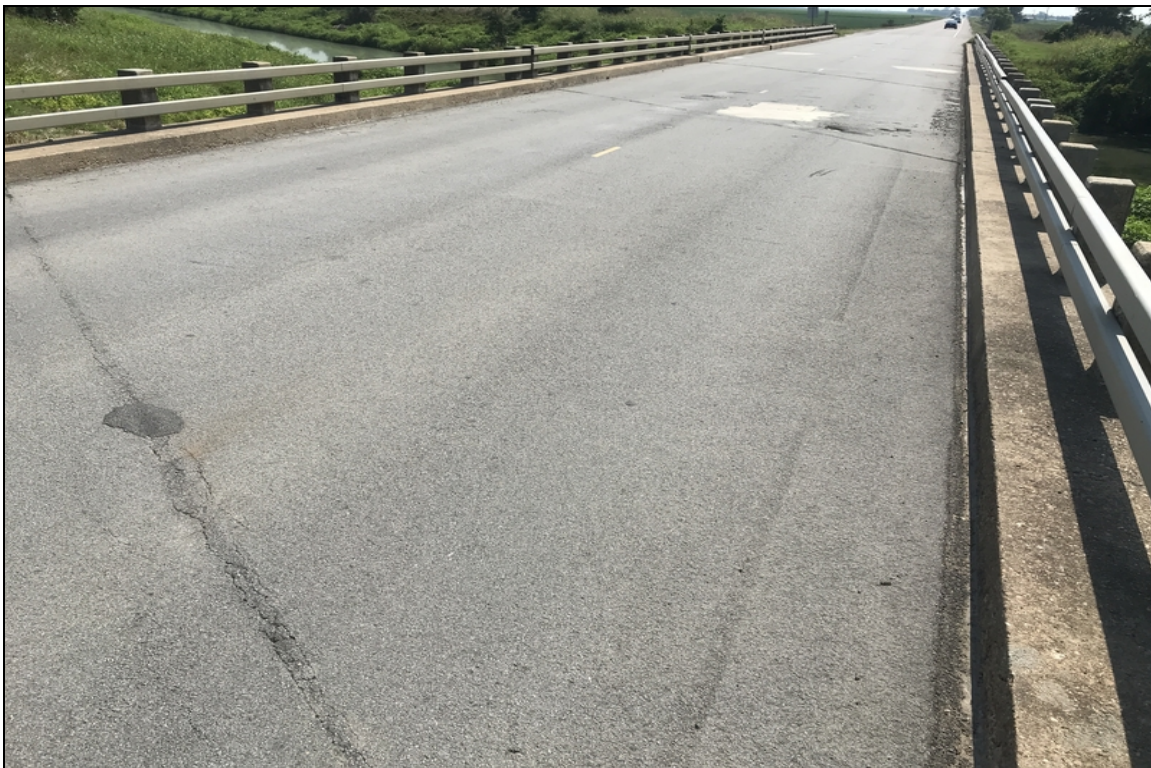
wearing surface

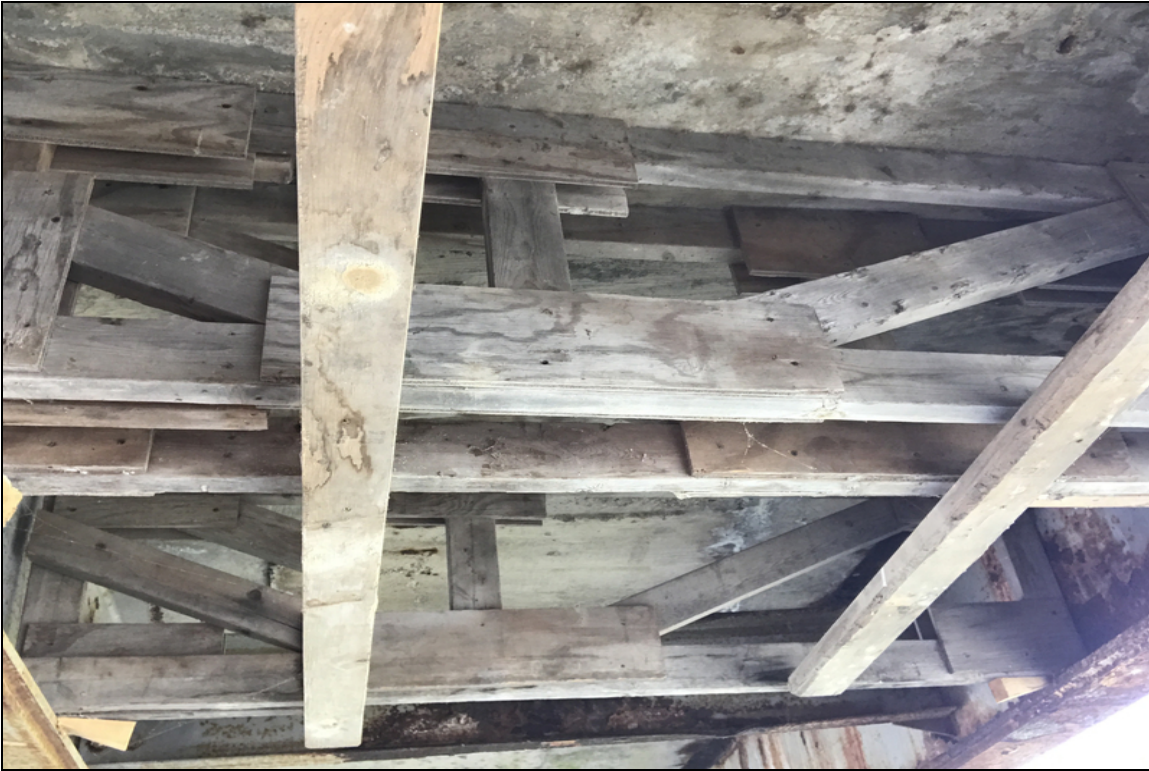
Span 2 bay 1 full depth patch

Wearing surface has spalls over joints. Deck has had partial or full depth failures at spans 2, 3, and 5 since it was overlaid.

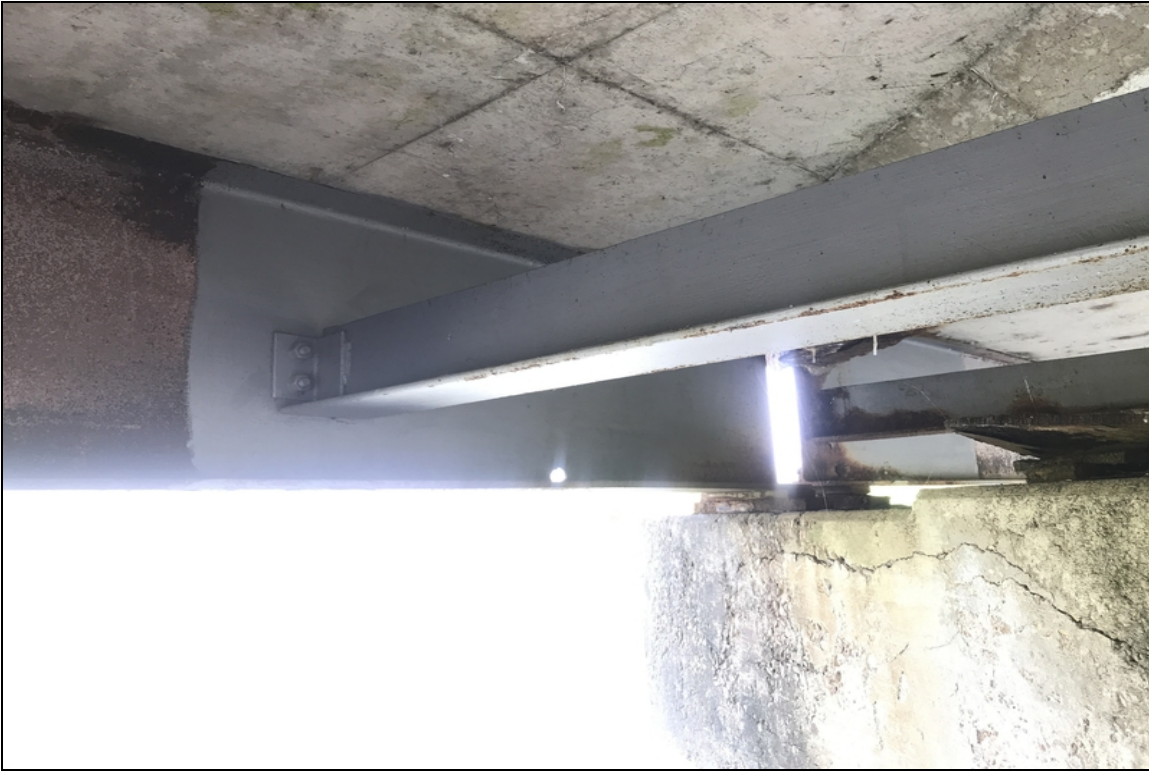
Span 3 bent 4 girder 1 was T-spliced in the past.

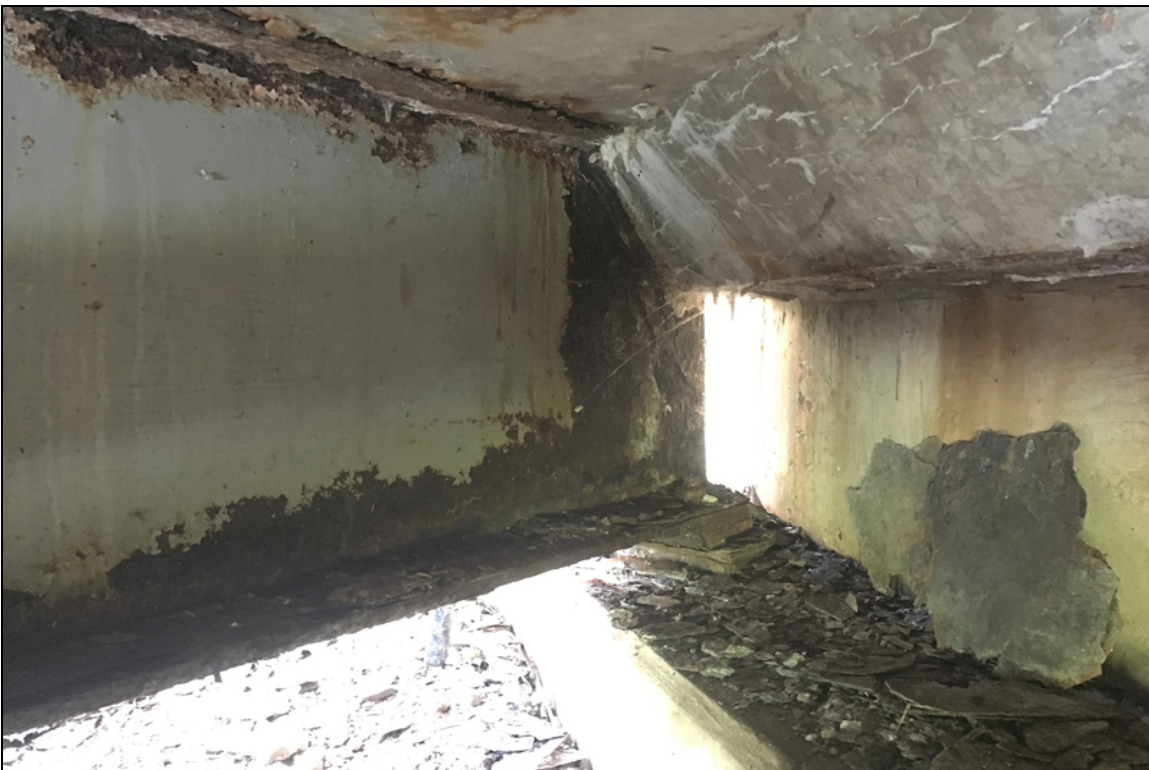
Span 5 bent 6 girder 1

Span 5 bent 6 girders 1 and 5 have flaking rust with moderate to heavy section loss at web below haunch and along bottom flange.

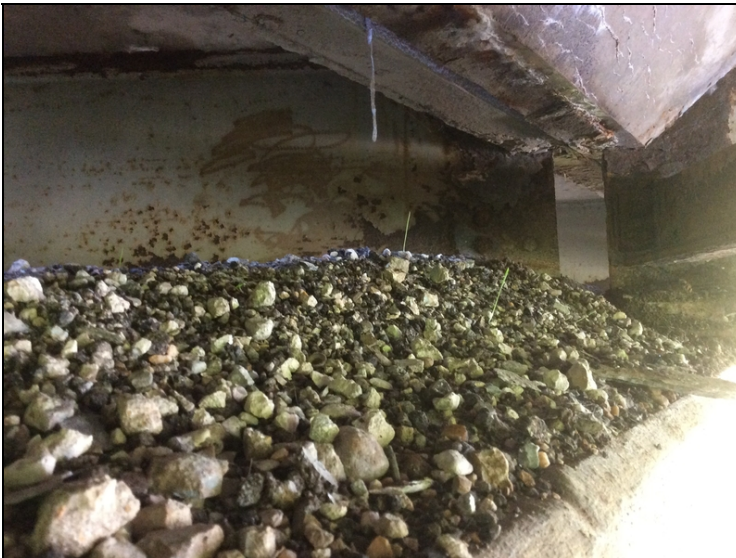
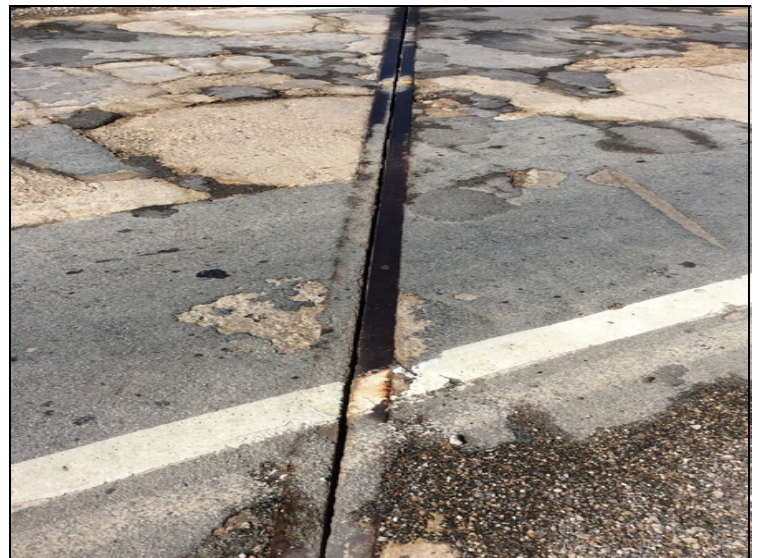
Compression seals are torn and separated with some portions missing allowing dirt build up on caps:

Bent 2 joint has 41' of seal missing see photo.

Bent 4 joint has 6' of seal missing

Bent 5 joint has 3' of seal missing

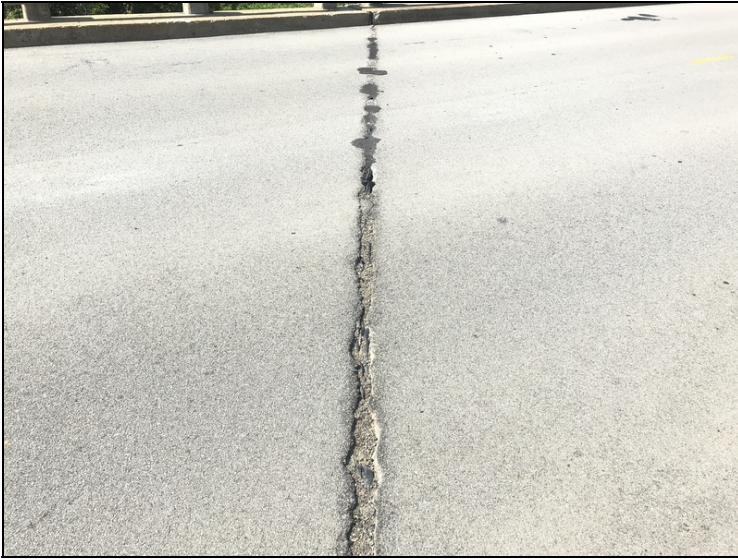
2021 - Typical joint

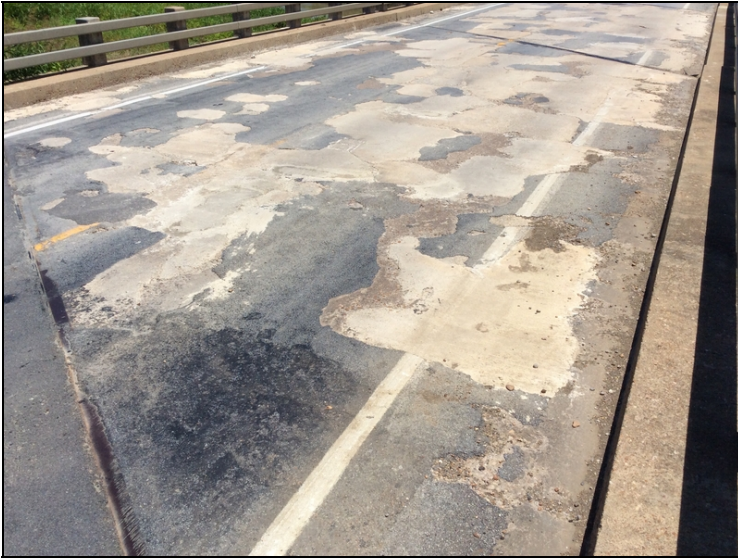
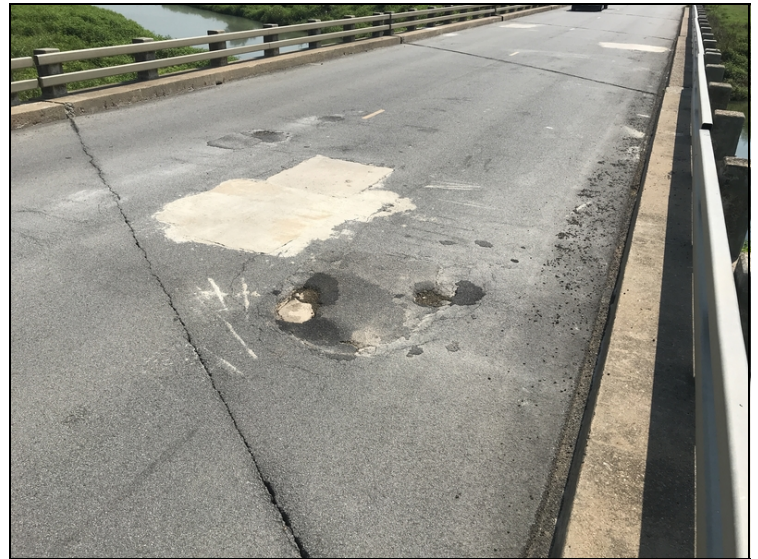
2021 - Span 2

Asphalt wearing surface has some cracked areas & a few potholes and impending failures. Deck has several large patches, delaminated areas and spalls. Patches are in poor condition. Over 50% of deck area patched and/or delaminated.

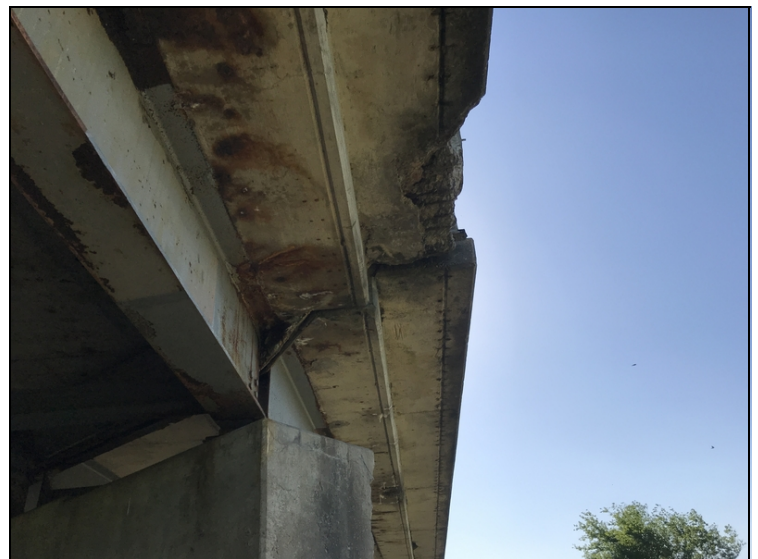
Soffit over B3 right side

Overhangs have longitudinal cracks, some with efflorescence. Overhangs have areas of concrete disintegration near drain openings and near joints over bents.

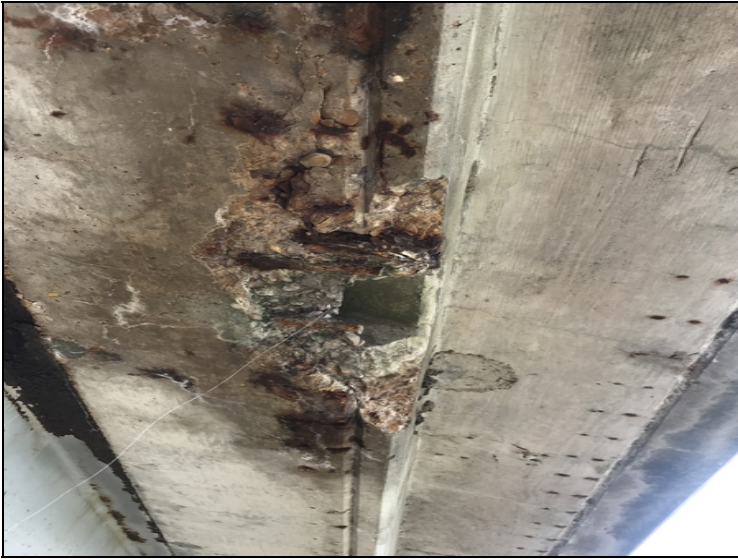
Typical weep

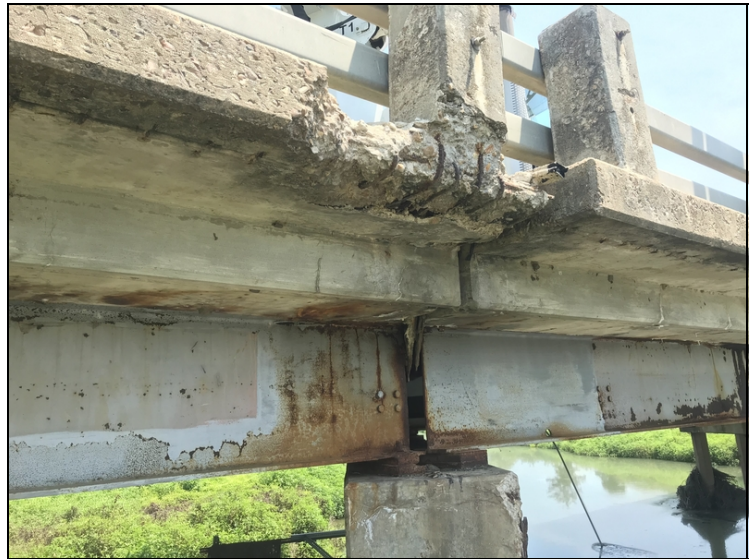
Bent 3 Rt

Span 2 Rt overhang near bent 3 has a 3' long area of concrete disintegration under bridge rail post.

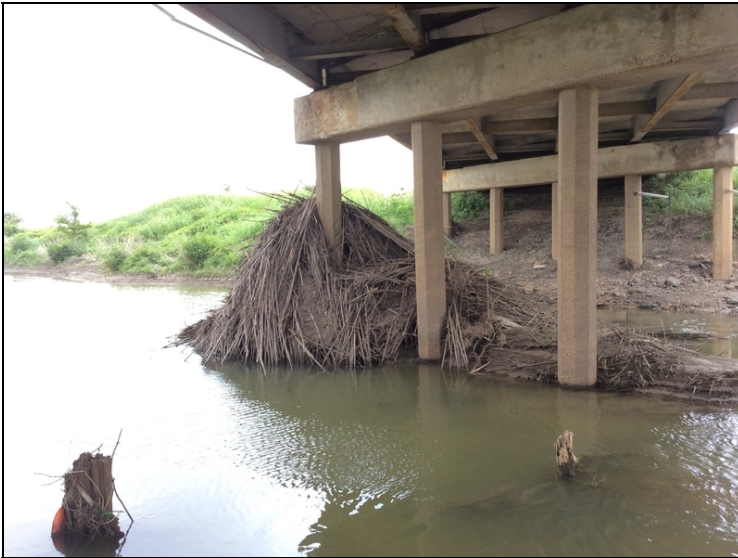
Large drift and sediment buildup on bent 4, see 2017 photo.

Minor drift on bents 2,3 & 5.

To Mississippi One Crew for review

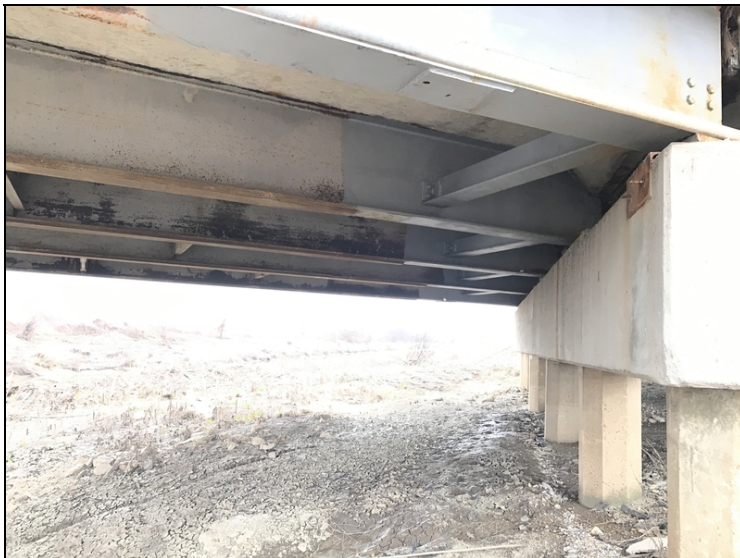
Span 2 Bent 2

Concrete caps at bents 2 - 5 have several vertical and horizontal cracks; some with efflorescence. Caps have a few small spalls with exposed rebar. Caps have several delaminated areas along horizontal cracks near top and bottom edges of caps.

Bent 2 cap has been cleaned and repaired by hbm 1/11/19

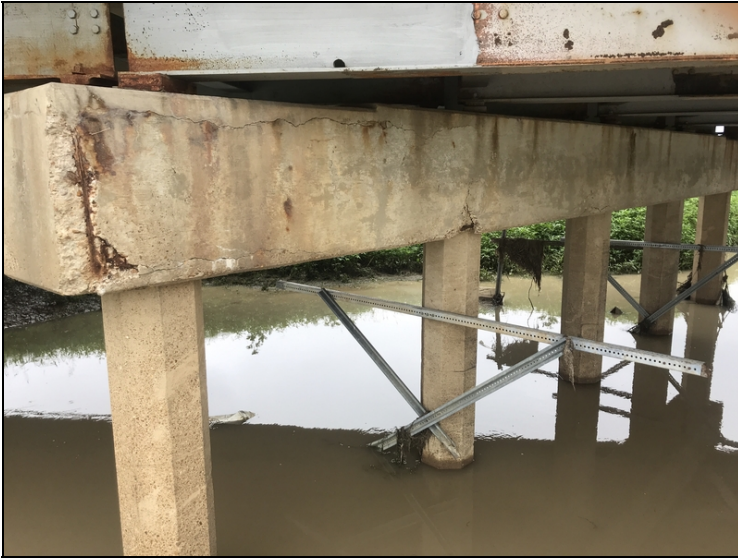
S3 side of b3 cap over piles 3, 4, & 5 delaminated with spalls and rebar exposed

Bent 3 cap has 15' of horizontal cracks. Cap has several delaminated areas along horizontal cracks near top and bottom edges of caps. Bottom of cap has 5' of spalls with rebar exposed.

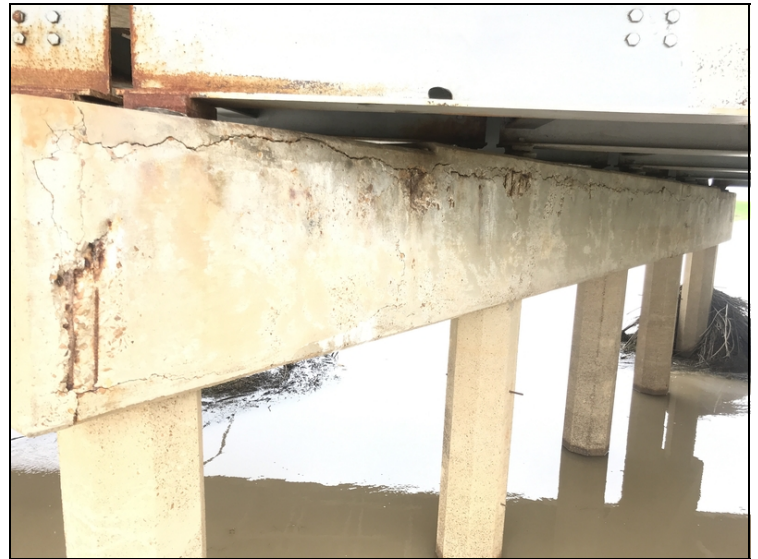
S4 side b4 cap cracks and rebar exposed

Bent 4 cap has an open horizontal crack 4" – 6" down from top of cap the entire length. Cap has spalls with rebar exposed near Lt and Rt ends. Cap has vertical cracks over piles 1-5. Cracks over piles 3 & 5 extend into top of cap.

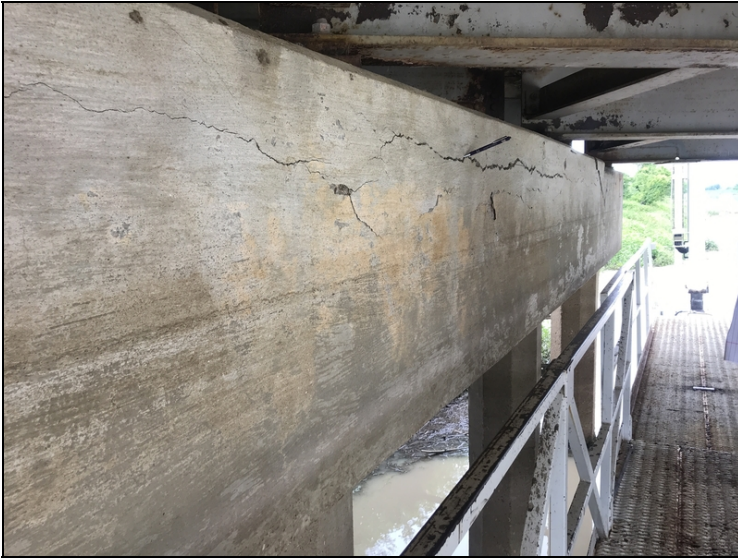
S4 b5 cap

Bent 5 cap has horizontal cracks and delaminated areas along back face near top. Cap has a spall with 2' of rebar exposed near girder 3.

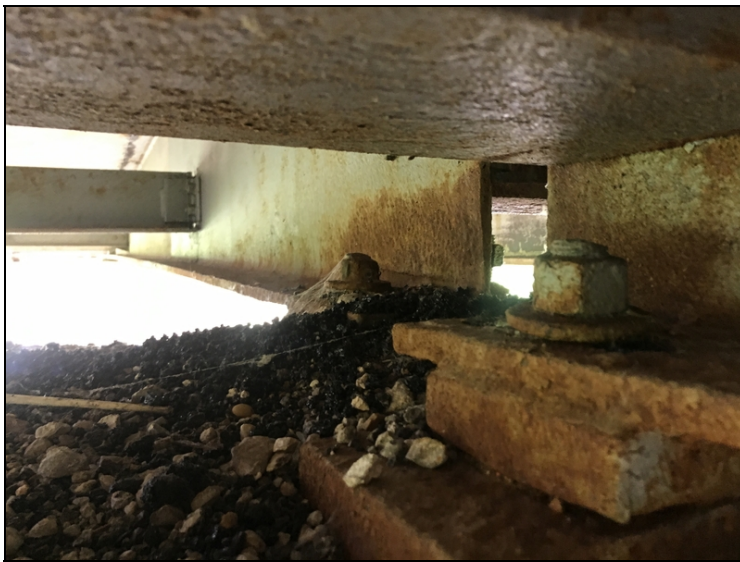
Span 2 bent 2 girder 2 has a 10.5" crack along bottom of web at end of girder. Web is bowed at diaphragm connection. Span 5 bent 5 girder 1 was T-spliced in the past. Web above splice has a 3.5" x 3" hole. Web has some possible out of plane bending at haunch.

S2 b2 g2 cracked

to Dist Bridge Crew for review and repair when schedule allows KAW 6/25/19

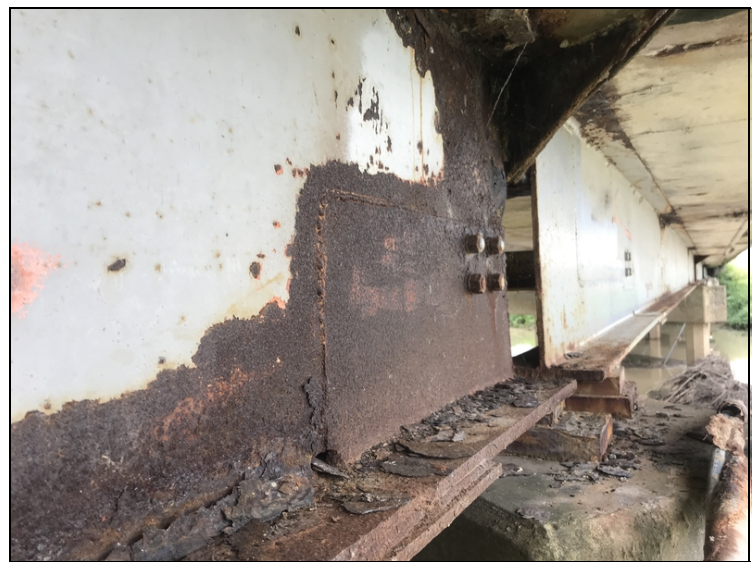
S5 b5 g1 crushing over tsplice

Span 5 bent 5 girder 1 was T-spliced in the past. Web above splice has a 3.5" x 3" hole. Web has some possible out of plane bending at haunch.

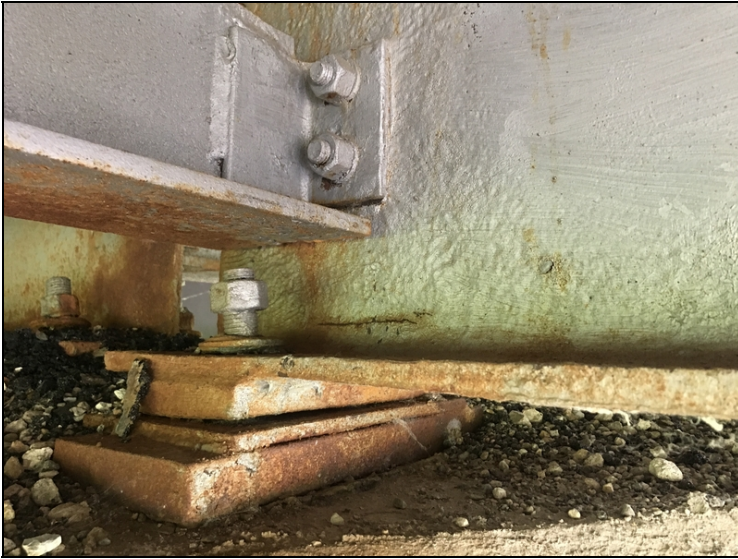
S2 b2 g2 cracked 8"

Span 2 bent 2 girder 2 has a 10.5" crack along bottom of web at end of girder. Web is bowed at diaphragm connection.

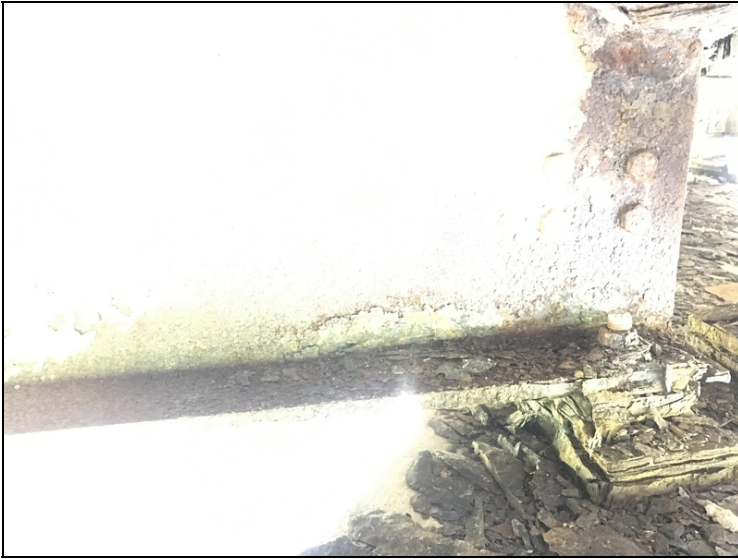
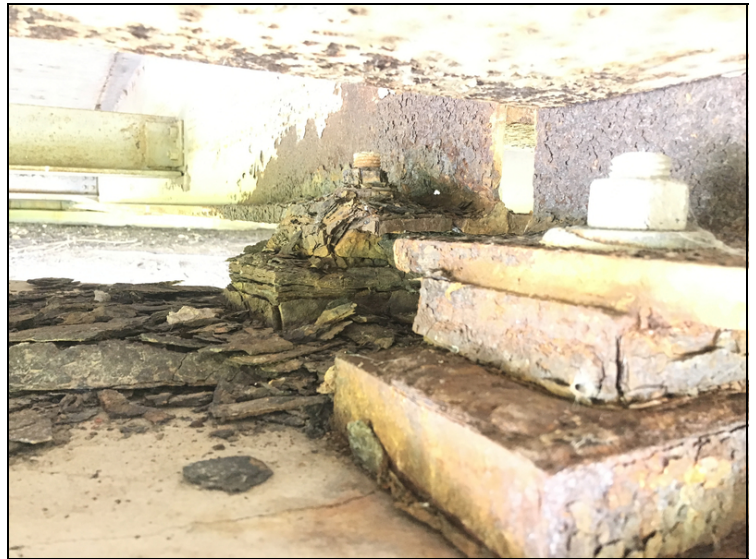
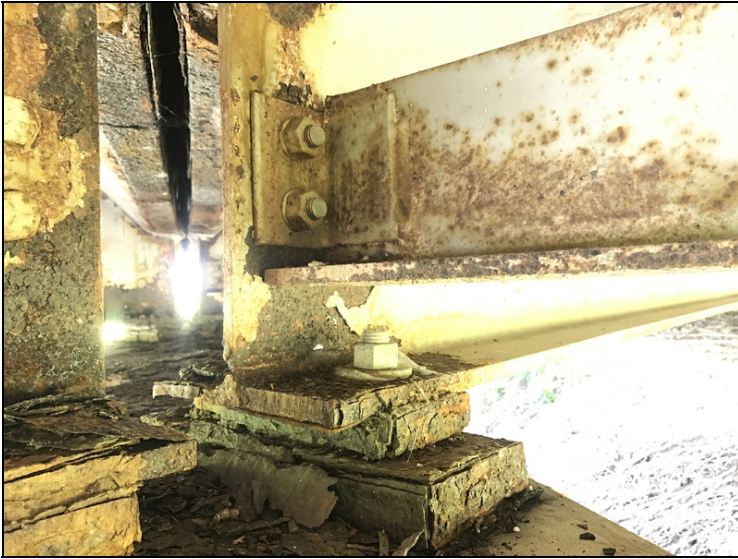
2021 - Span 5 bent 5 girder 3

Span 5 bent 5 girder 3 has an 8" crack along bottom of web at end of girder.

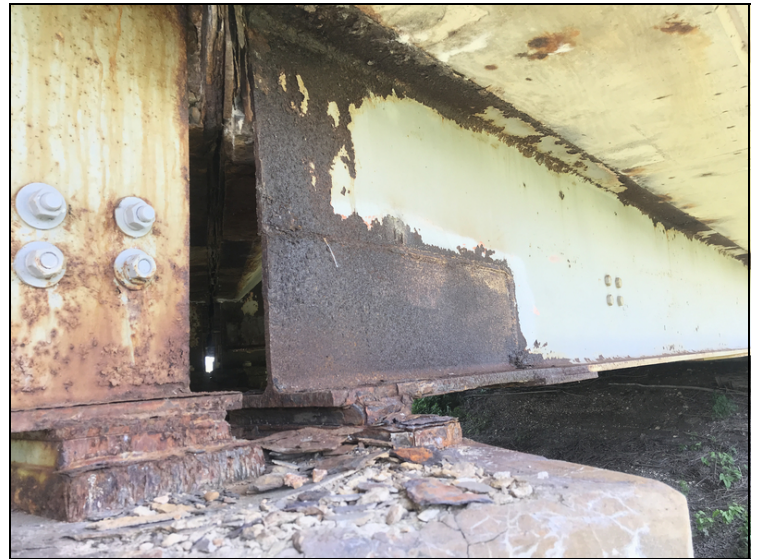
2021 - Span 5 bent 5 girder 5

Span 5 bent 5 girder 5 was T-spliced in the past. Web has some out of plane bending above splice.
