# Bridge Inspection Report

**A5445**  
**I-555NB-02-LM16.92**  
**over**  
**DITCH 60**

Structure Number: A5445

Facility Carried: I-555NB-02-  
LM16.92

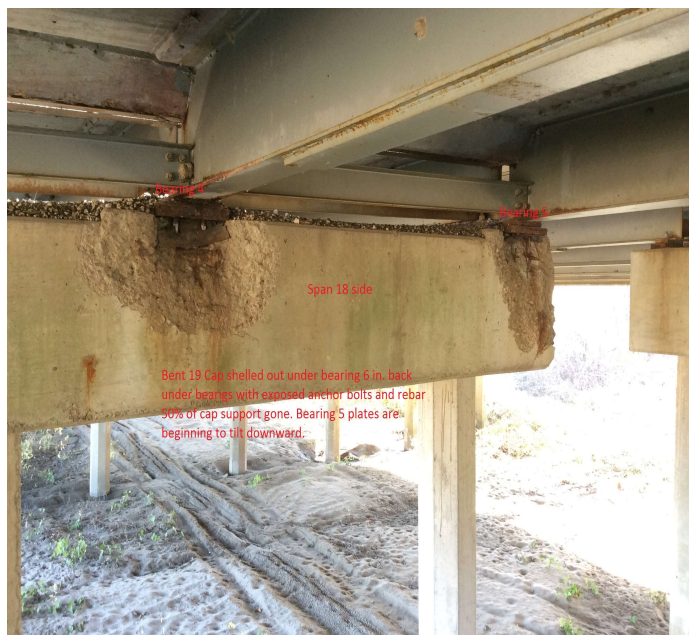
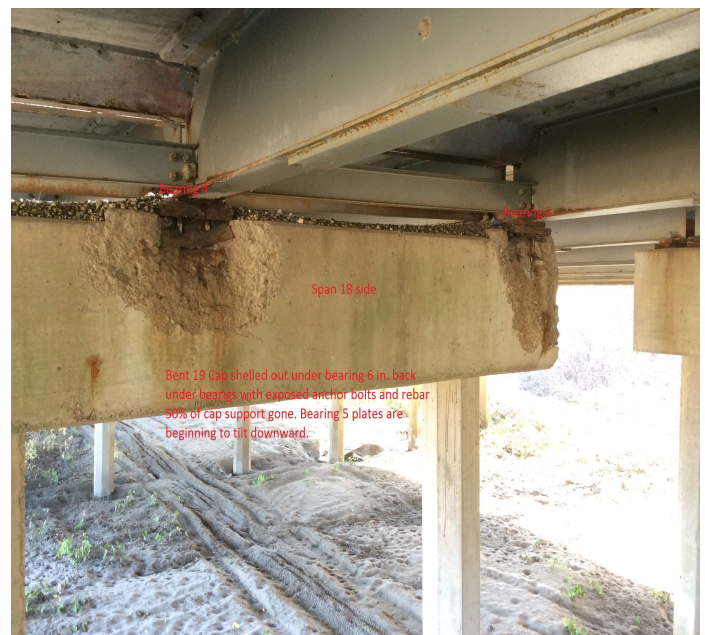
Span 18 side of Bent 19 Cap at Bearing 4 & 5 have a large shelled off area (2 ft. x 3 ft. with exposed rebar and anchor bolts. 50% (3 inches) loss of bearing support, see 2015 photo.

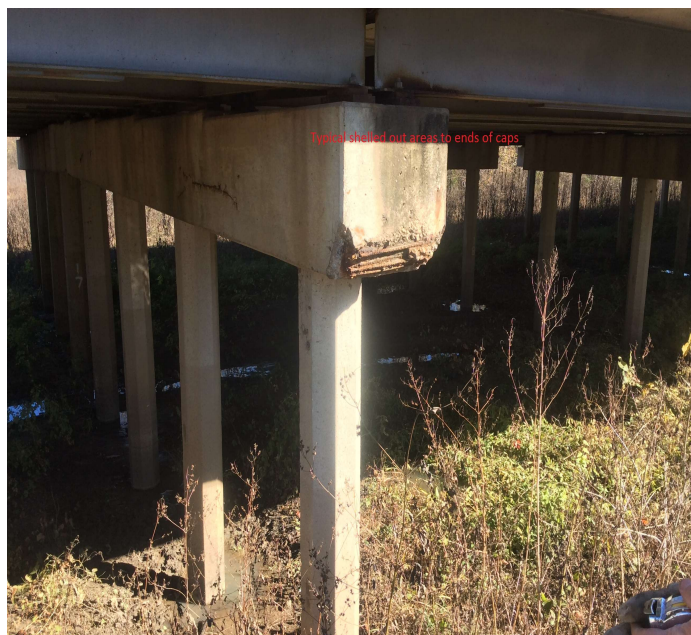
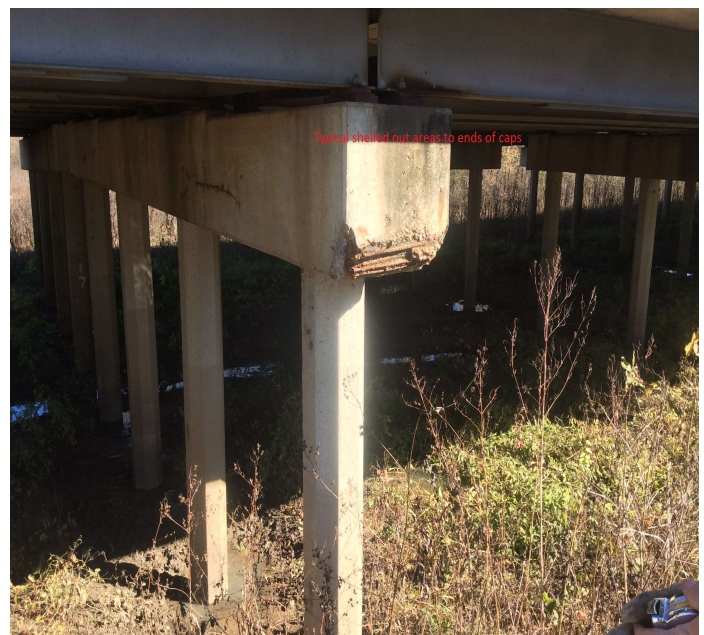
Caps Bents 2, 3,17, 19,22, 24,25,27,28,&30 has rebar exposed mainly by concrete coverage as built condition. Some cracking to caps and piles.

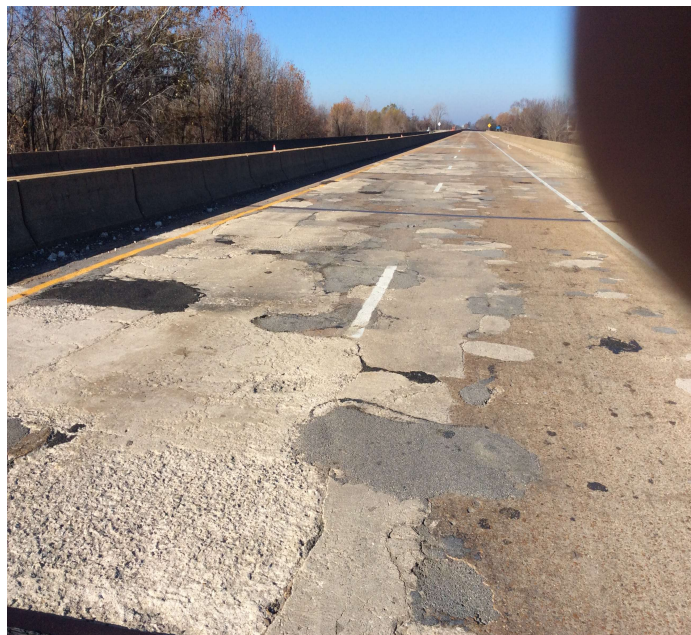
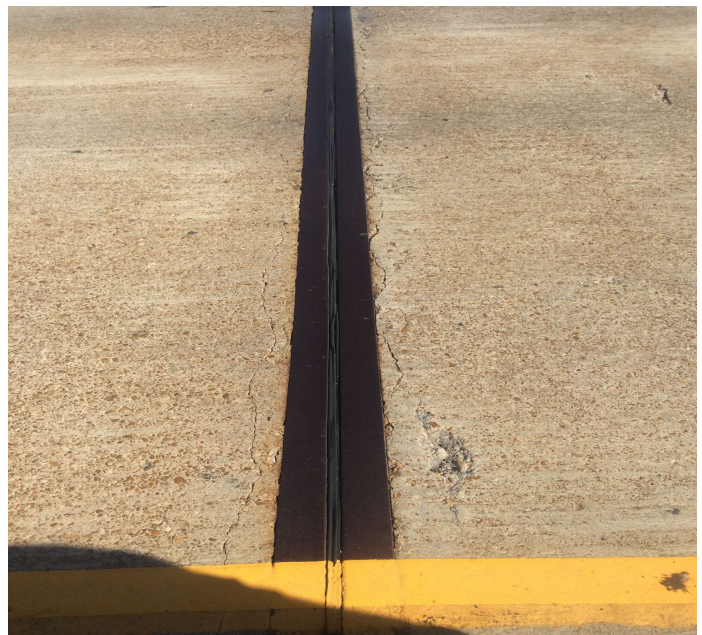
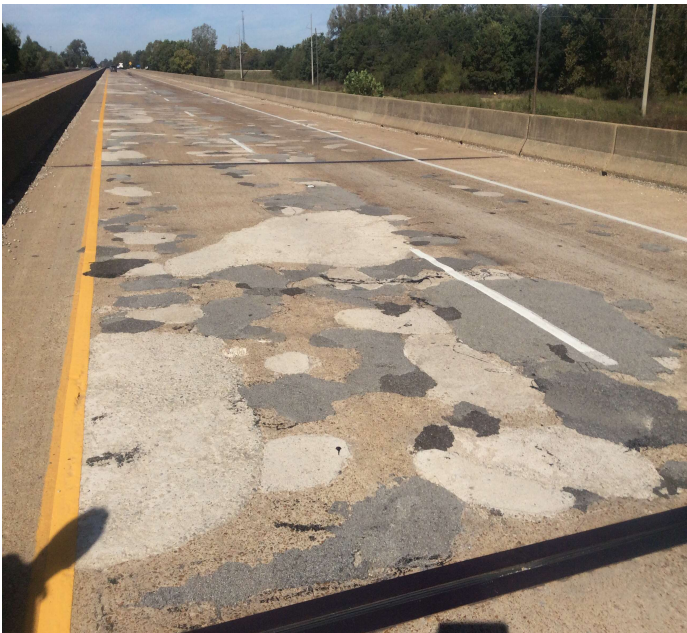
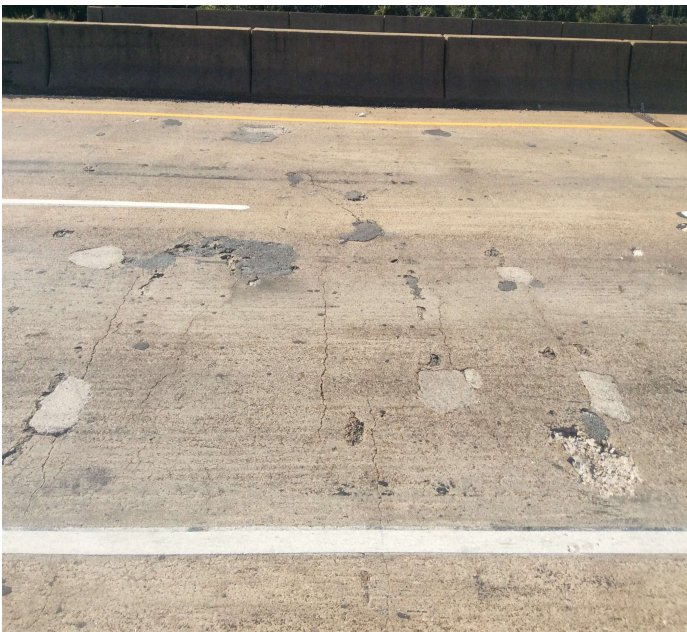
All spans top of deck have minor to moderate size and density cracks.

Heavy map cracking top of deck especially in wheel path, Spans 10 thru 12, 15 thru 17, 19 thru 27, 29 & 30. especially Rt. Lane

Top of deck all spans have numerous concrete and asphalt patch repairs with several existing spalled areas several patches are shelling out with rebar exposed.

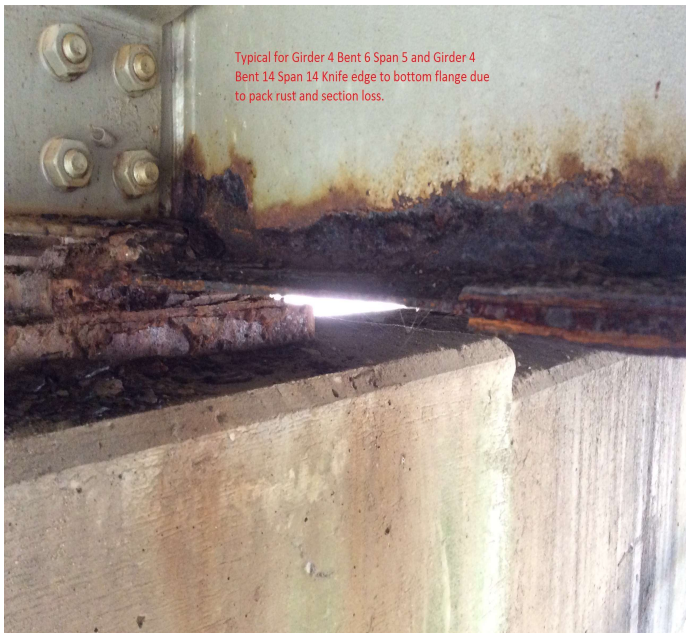
PHOTO 1 Description

Span 14 Girder 4 Bent 14 has 2 ft. on end of girder, bottom flange and web, is rusted with up to 1/8 in. section loss.

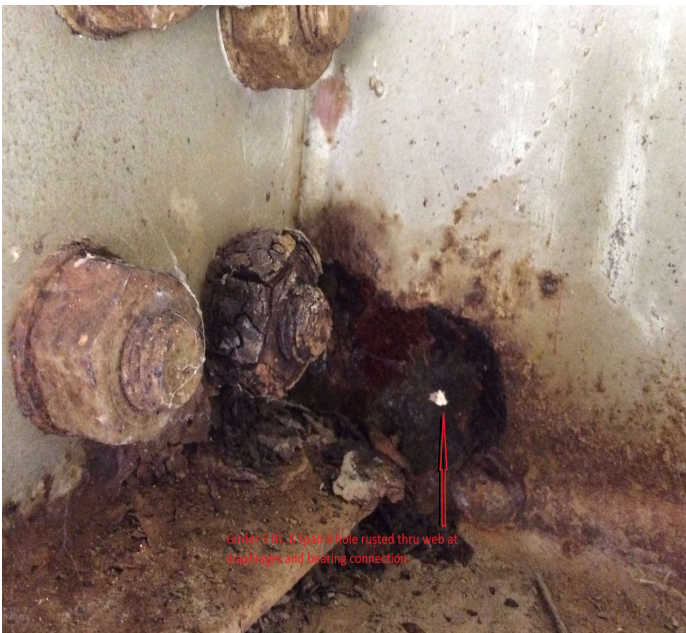
PHOTO 1 Description

Girder3 Span 8 Bent 8 Hole rusted thru web at diaphragm and bearing connection
