Bridge Inspection Report

B5445
I-555SB-02-LM16.92
over
DITCH 60

Structure Number: B5445

Facility Carried: I-555SB-02-
LM16.92

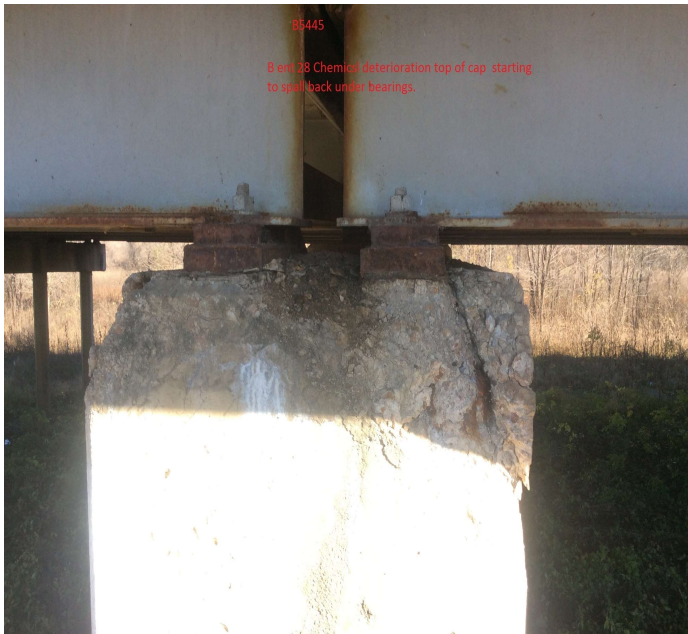
PHOTO 1 Description

Bt 28 cap

Rt. end top of cap at bearing has chemical deterioration with exposed rebar, no loss of bearing support at this time, see 2015 photo.

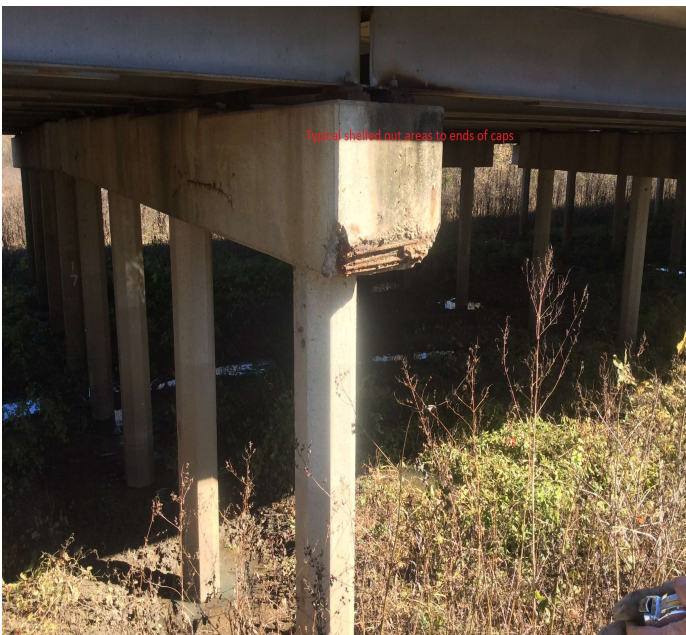
PHOTO 1 Description

Several caps have small shelled out areas with rebar exposed, some are mainly due to concrete coverage, Bents 2, 5, 6, 7, 9, 10, 11, 12, 14, 15, 16, 17, 18, 20, 22, 23, 24, 25, 26, 27, 28 and 29, 30 1 ft. typical.

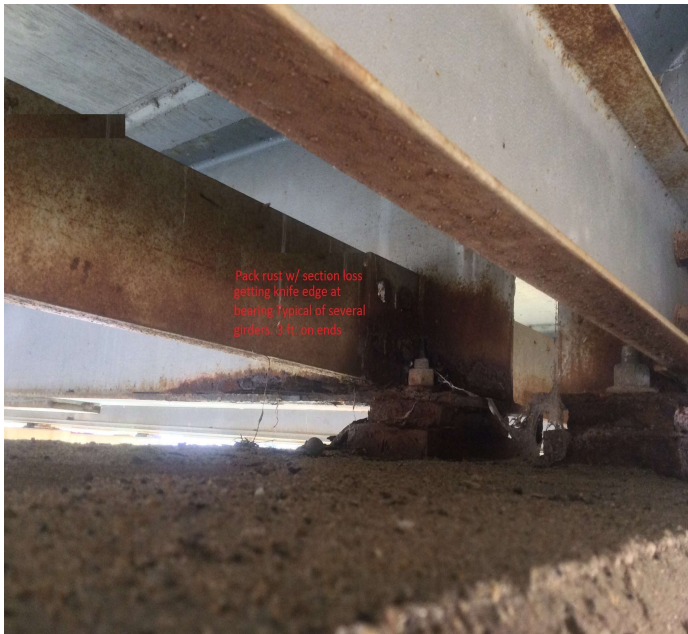
PHOTO 1 Description

Majority of Steel Girders have rust with light pitting.

Ends of Majority of Girders (3 ft. typical) are rusted with pitting and/or initial section loss, especially bottom flanges of Girders 1&5. (up to 1/8in section loss.)

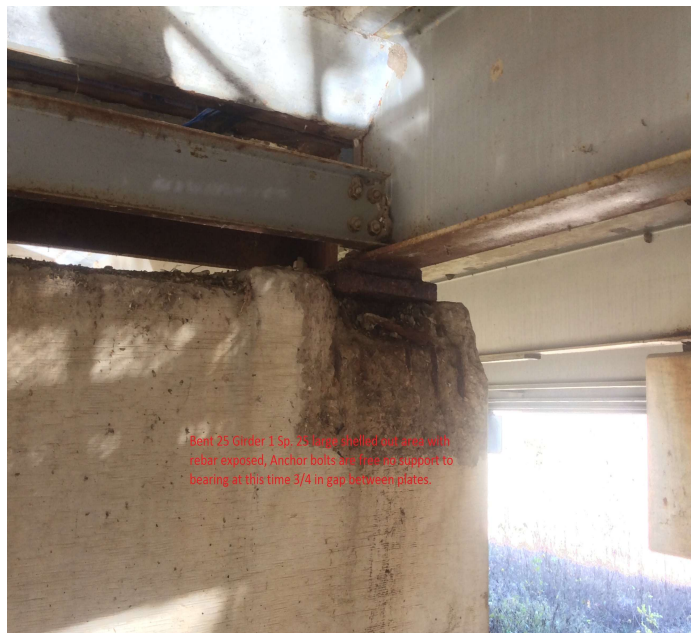
PHOTO 1 Description

Bent 25 left End of Cap has a shelled out area under Girder 1 of Bent 25 (2ft X18in X 8in deep), 50% of bearing floating. Bearing bolts are exposed, no support at this time see 2015 photo

Bridge Crew making other repairs at this time - will schedule repairs later - KAW
