# Bridge Inspection Report

**A5446**  
**I-555NB-02-LM16.51**  
**over**  
**DRAINAGE DITCH NO. 61**

Structure Number: A5446

Facility Carried: I-555NB-02-  
LM16.51

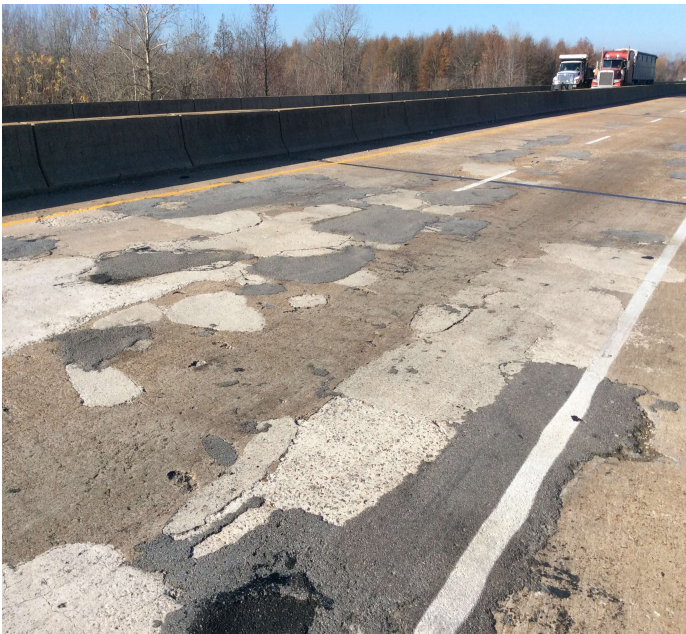
PHOTO 1 Description

Deck Spans 7,8,9,12,13,14,15,16,17

have map cracking and delamination areas/spalls patched areas with conc. and asphalt in poor condition and several shelled out areas, especially in wheel paths
