Bridge Inspection Report

A5447
I-555NB-02-LM15.93
over
SAND SLOUGH

Structure Number: A5447

Facility Carried: I-555NB-02-
LM15.93

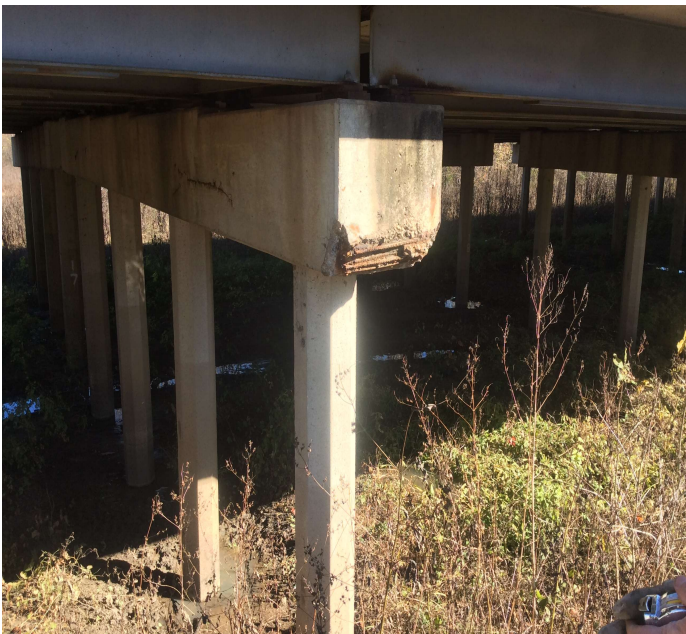
PHOTO 1 Description

Bent 2, 4, 5, 6, 10, 12, 13, 14, 15, 19, 20, 21, 22 Caps have shelled out areas with rebar exposed mainly due to concrete coverage.

Left end of Caps Bents 5, 7, 9, 13, 14 & 19 have shelled out areas, with exposed rebar.

Right end of Caps Bents 2, 6, 10, 19, 21 & 24 have shelled out areas, with exposed rebar.

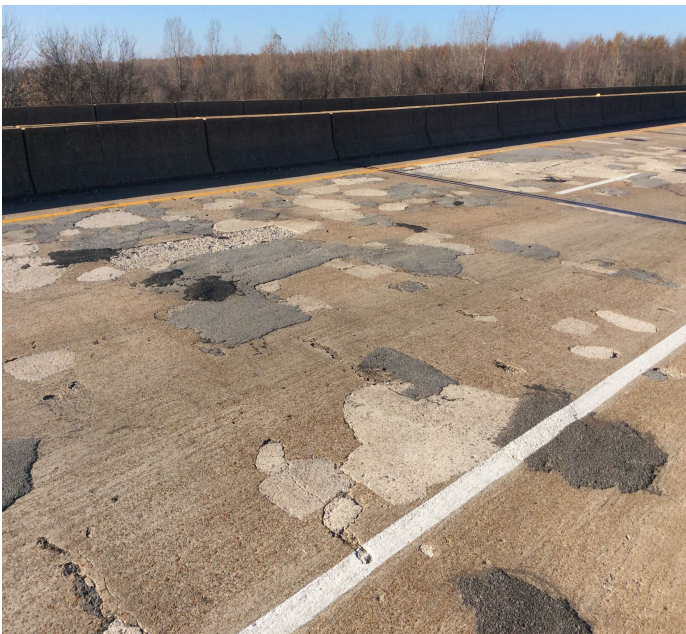
PHOTO 1 Description

Moderate size and density cracks top of deck, with several small spalled areas, some have rebar exposed, Spans 1 thru 25.
