# Bridge Inspection Report

**B5447**  
**I-55SB-02-LM 15.93**  
**over**  
**SAND SLOUGH**

## Bridge Inspection Report

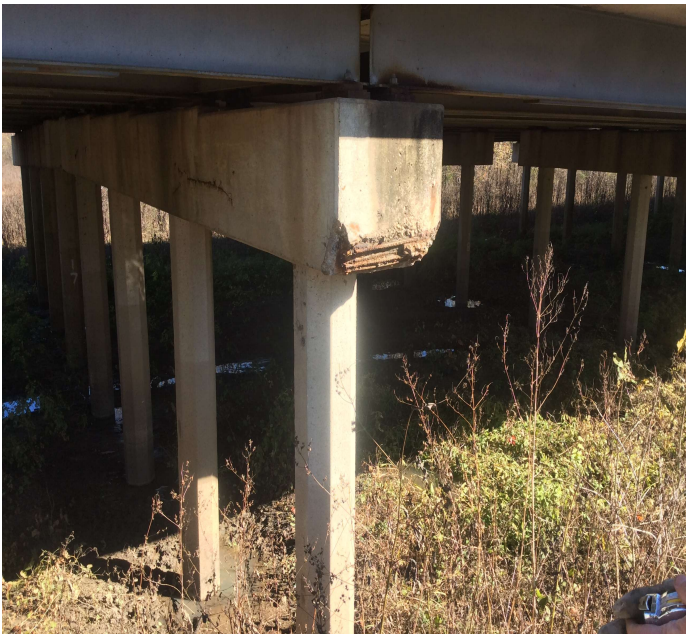
PHOTO 1 Description

Rt. end Bents 9,12,13 & 17  
Lt end caps Bents 13, 18 and 20  
Shelled out with exposed rebar

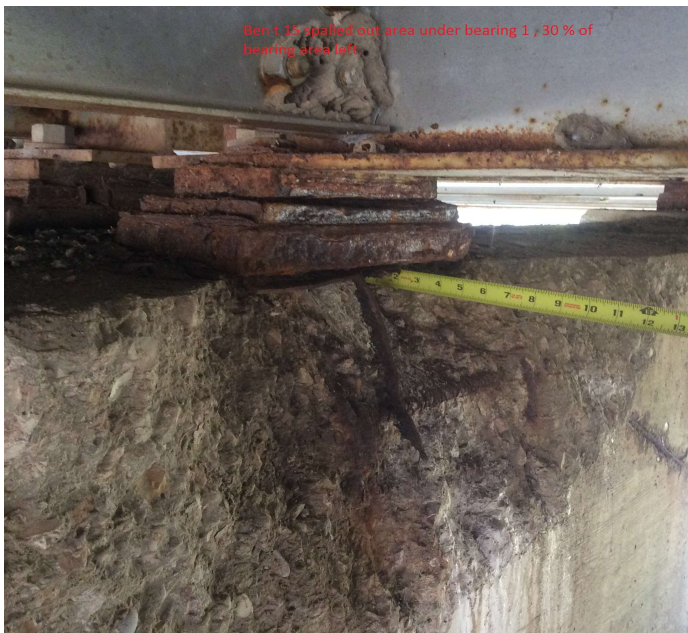
PHOTO 1 Description

Left End of Cap Span 15 Bent 15 has a 2ft x 1ft x 9in deep spall with rebar and bolts exposed. 50% of bearing is floating. See 2015 Photo.

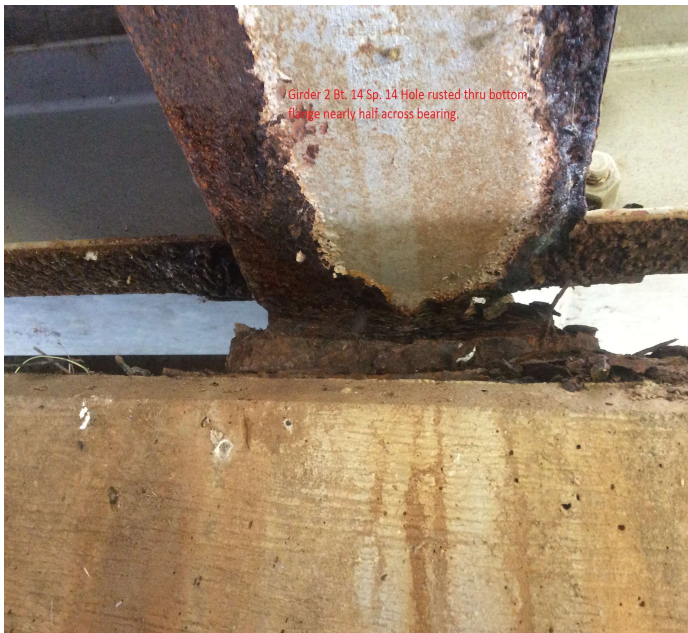
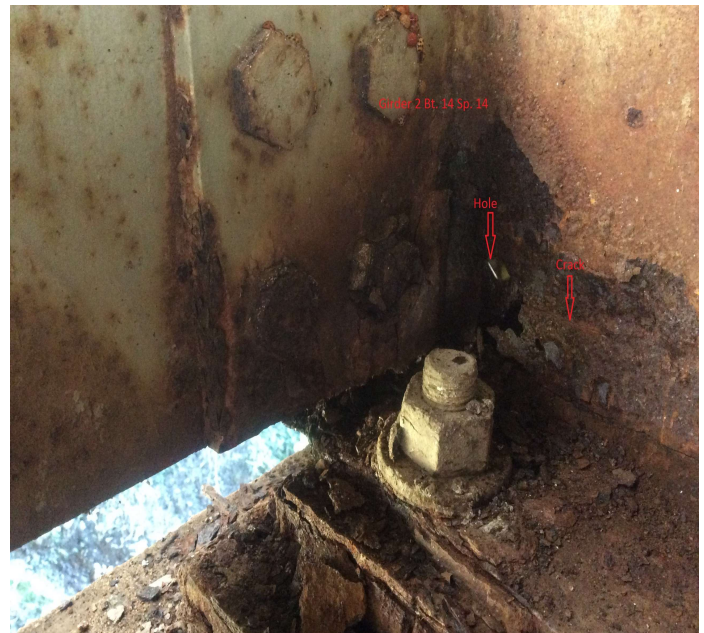
Girder 2 Span 14 Bent 14 Hole rust thru bottom flange at bearing appears to cracked

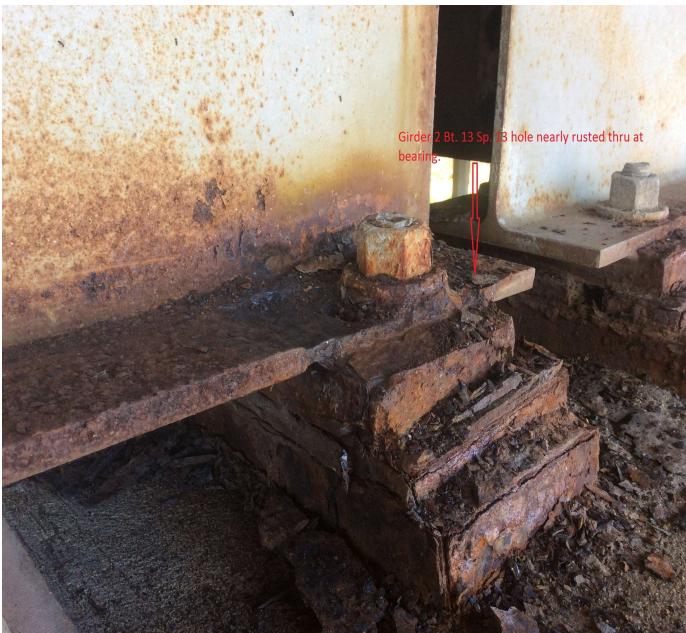
PHOTO 1 Description

Girder 2 Span 13 Bent 13 Hole nearly thru bottom flange at bearing

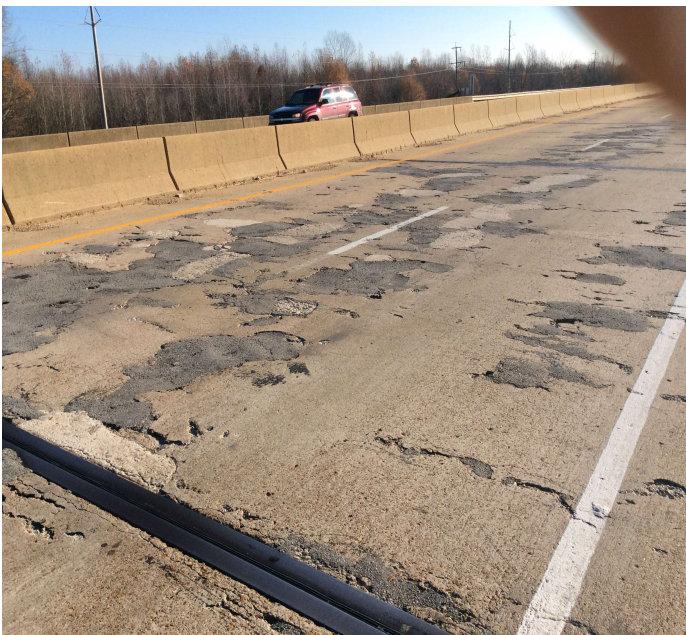
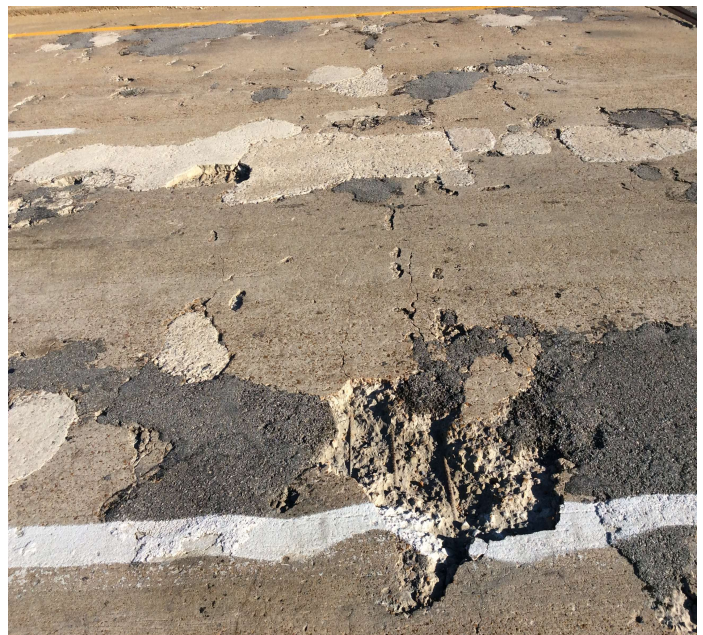
Spans 20,22,& 23 have Heavy transverse and map cracking with Delam. and spalls patched areas with some shelled out areas with rebar exposed.
