Bridge Inspection Report

B5448

I-555SB-02-LM15.26

FLOODWAY RELIEF

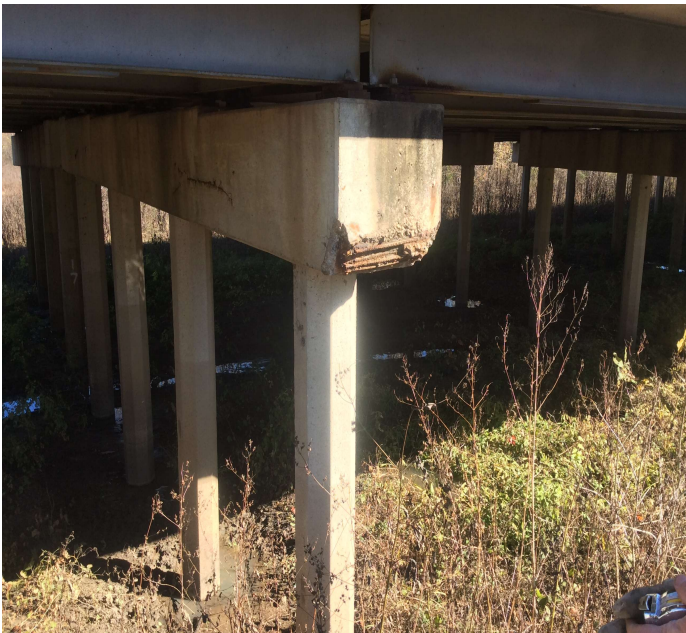
PHOTO 1 Description

Several Caps Bents 5 thru 9 has rebar exposed mainly due to concrete coverage.

Right End of bottom of Cap Bent 6 is shelled off with exposed rebar.

Right End of bottom of Cap Bent 12 is shelled off with exposed rebar see 2011 photo
