Bridge Inspection Report

B6043

I-555-02NB-LM22.96

CR 266-C- DITCH 23

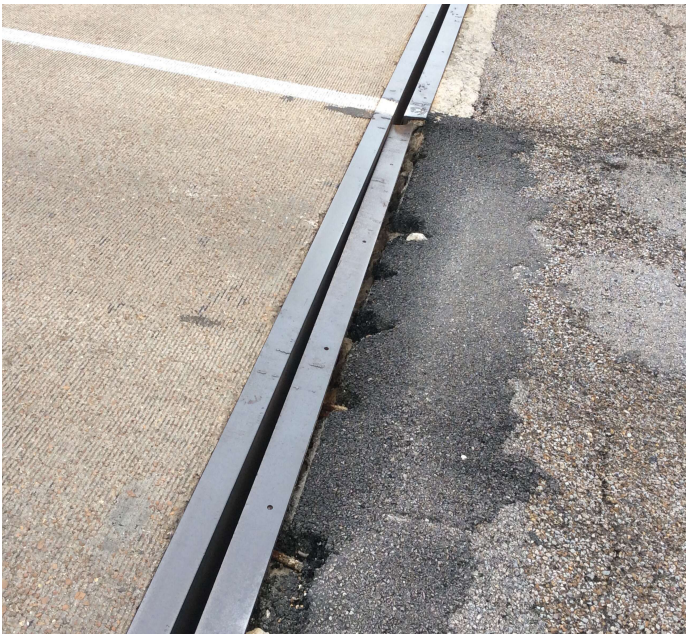
PHOTO 1 Description

Bent 1 Compression Seal has 40ft. that has fallen out and Road Iron broke and rattling.

Bent 4 Compression Seal has 14ft. missing and 18ft. of road iron removed.

Priority: B - Pressing; 6 month completion goal

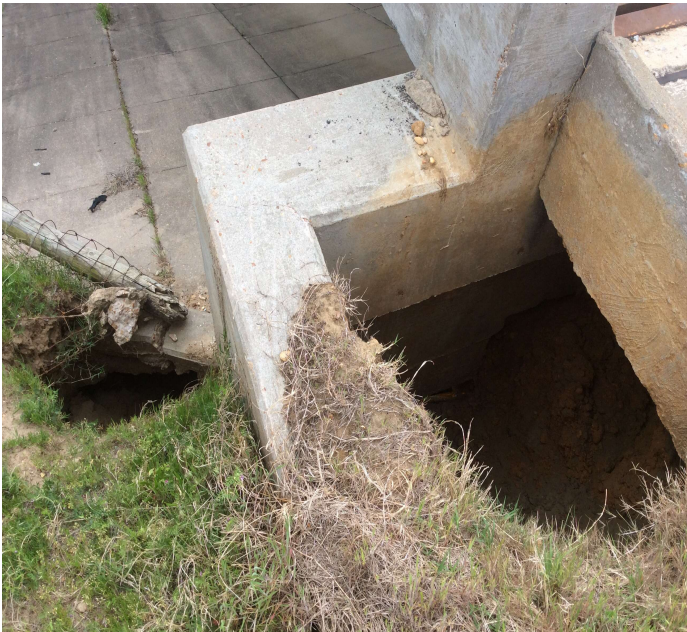
PHOTO 1 Description

North East Corner, Left side of Bent 1, Concrete Slope Protection has settled up to 12in. with approximately 6ft. deep void under concrete near cap, see 2016 photo.

North East Corner, Left side of Bent 1, Concrete Slope Protection has settled up to 12in. with approximately 6ft. deep void under concrete near cap

Priority: C - Important
