# Bridge Inspection Report

**A6172**  
**I-555, SB LNS**  
**over**  
**LITTLE BAY DITCH**

Structure Number: A6172

Facility Carried: I-555, SB LNS

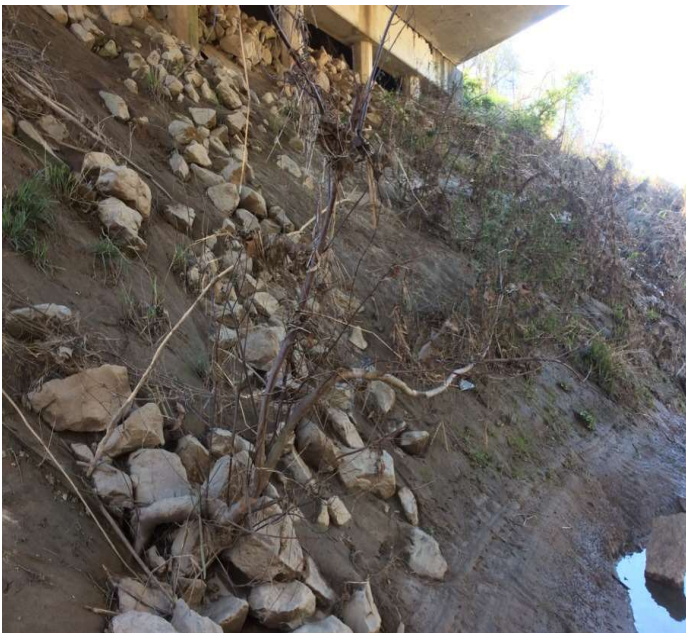
PHOTO 1 Description

Channel slopes have erosion with rip rap displacement under spans 2 and 4.

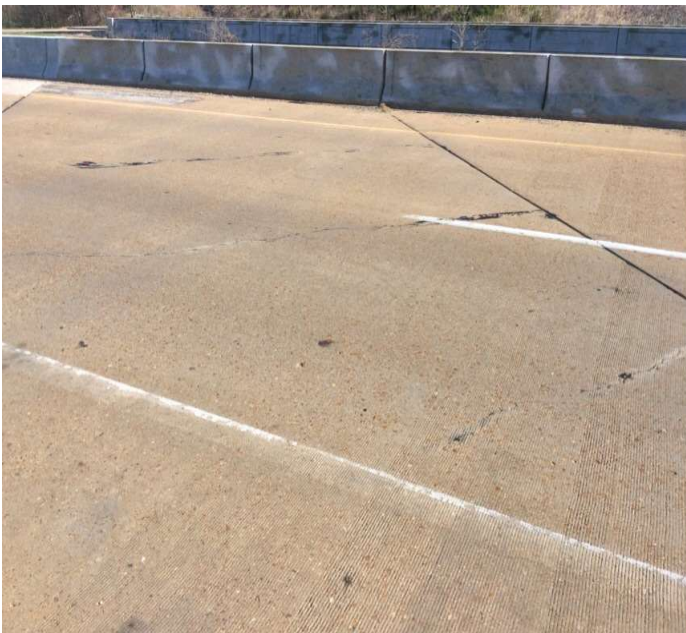
PHOTO 1 Description

Deck has several cracks. Some cracks have been sealed in the past, but seals are deteriorated
