Bridge Inspection Report

B6172
I-555, NB LNS
over
LITTLE BAY DITCH

Structure Number: B6172

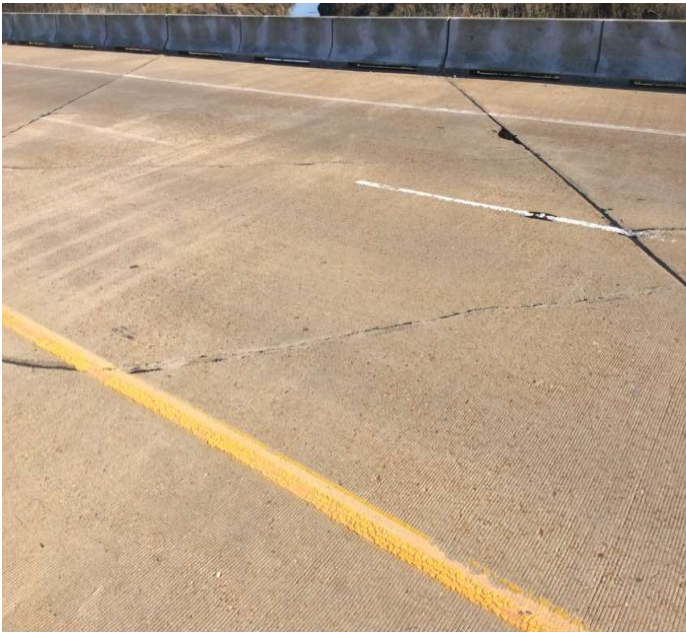
PHOTO 1 Description

Conc. Deck

Deck has several open unsealed cracks, some are thru slab with efflor.

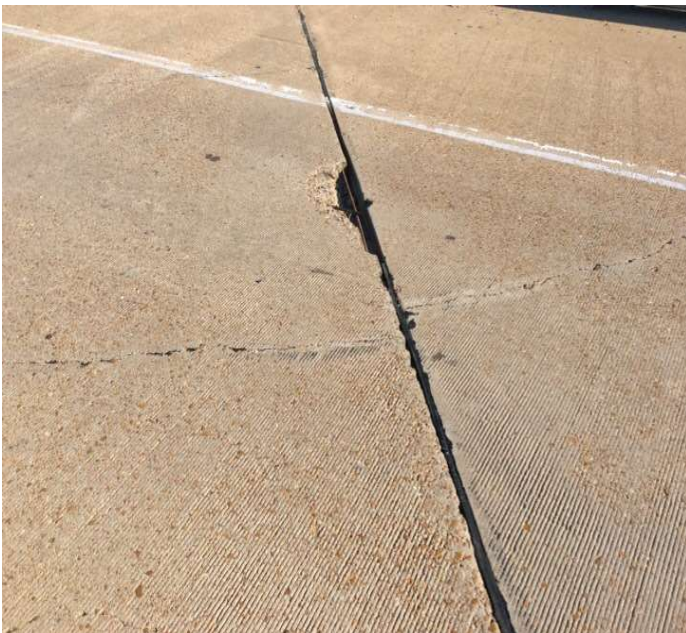
PHOTO 1 Description

Span 3 has a 3' x 1' spall with rebar exposed near joint over bent 4.
