# Bridge Inspection Report

**06279**  
**SH 1-SEC 17B**  
**over**  
**I-555-SEC 03**

Structure Number: 06279

Facility Carried: SH 1-SEC 17B

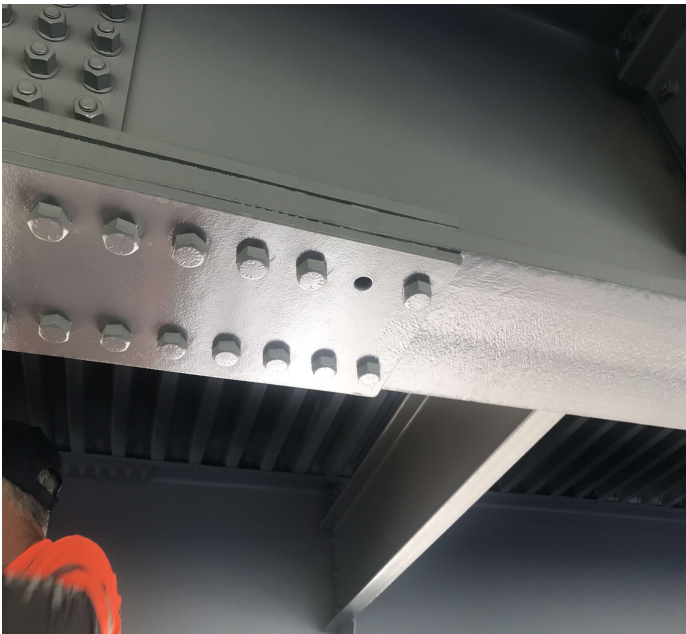
Span 3 Girder 3 Splice  
1 Bolt missing from bottom flange  
Photo added 9/17/2018 CCP.

PHOTO 1      Description      Span 3 splice 1 girder 3 missing bolt.

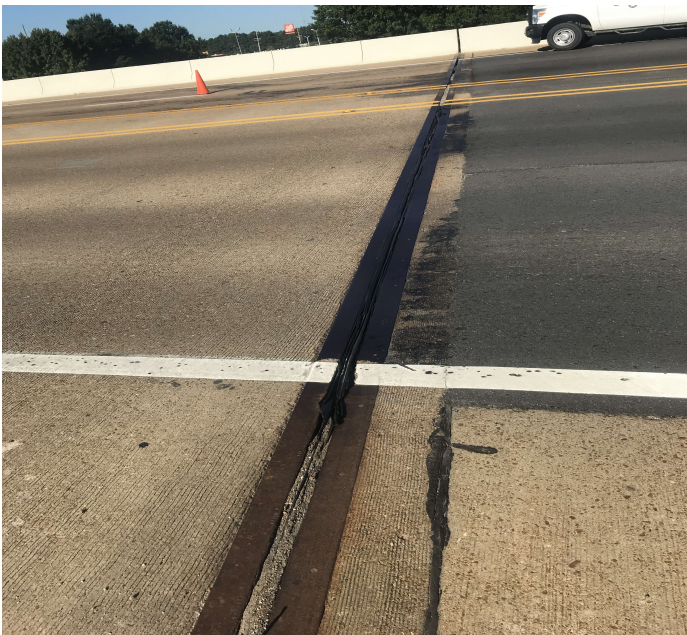
Compression seals over both end bents have near complete failure.

PHOTO 1      Description      Both joints seals have almost complete failure.

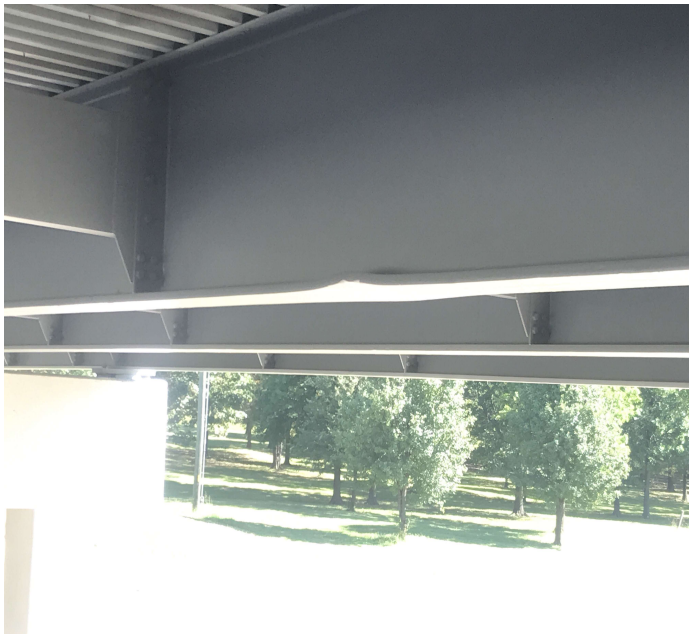
Has minor collision damage, approximately 15 ft. ahead of splice, Lt side of bottom flange is bowed up approximately 2 1/2 in. Photographed on 9/13/2018 CCP.

PHOTO 1      Description      Span 2 girder 8 old impact damage over outside lane.

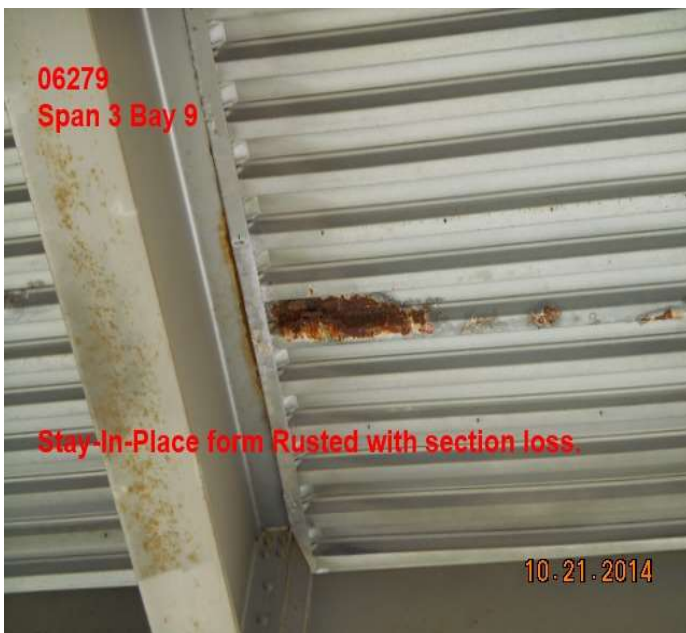
PHOTO 1 Description

Span 3 Bays 1, 2, 3, 5, 6, 7, 8 & 9 Stay-in-Place Forms  
Are rusted with some section loss, see 2014 photo of Span 3 Bay 9.

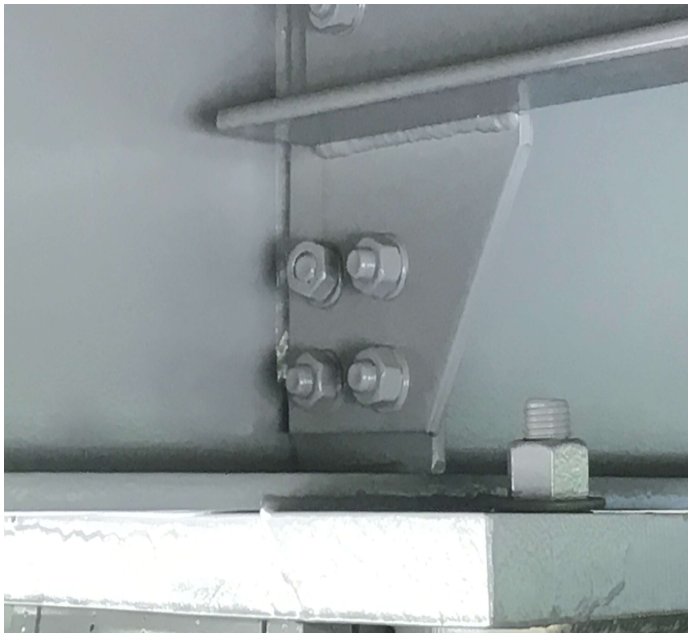
Span 1 Bent 2 between girders 4 & 5 diaphragm 1

PHOTO 1      Description      Bent 2 between girders 4 & 5  
diaphragm 1 loose bolt

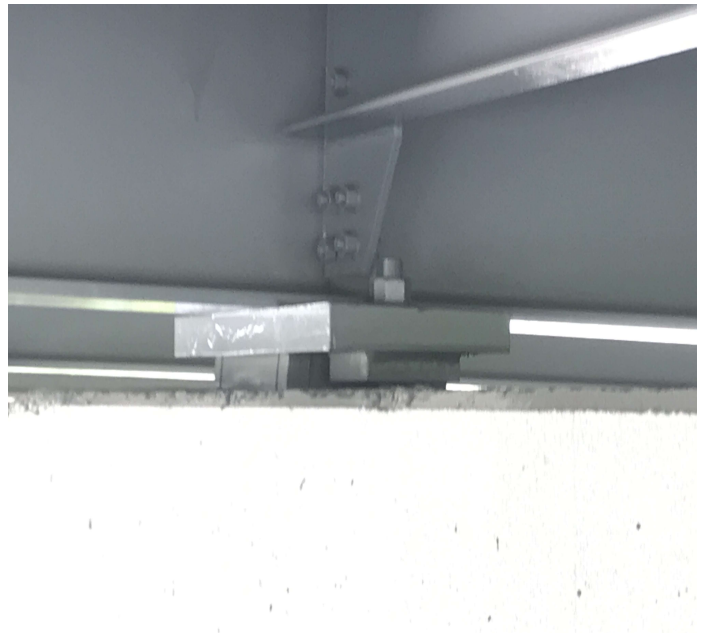
Span 1 bent 2 between girders 5 & 6 diaphragm 1

PHOTO 2      Description      Bent 2 between girders 5 & 6  
diaphragm 1 loose bolt

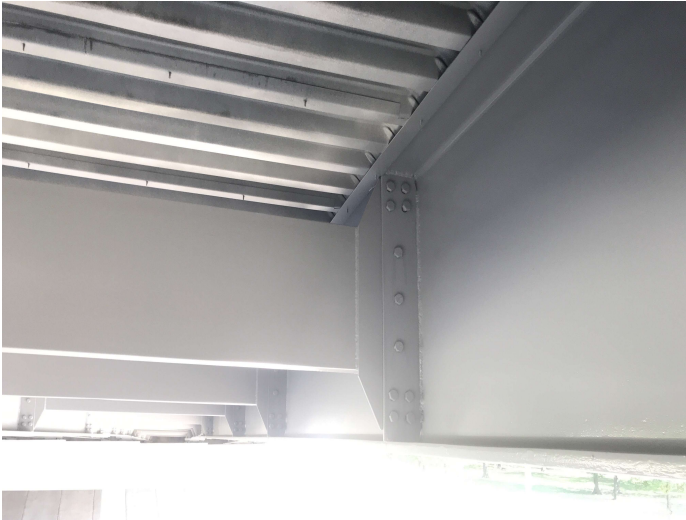
Span 3 between girders 7 & 8 diaphragm 2 right side all bolts are loose

PHOTO 3	Description	Span 3 between girders 7 & 8 diaphragm 2 right side bolts are loose.
---------	-------------	---

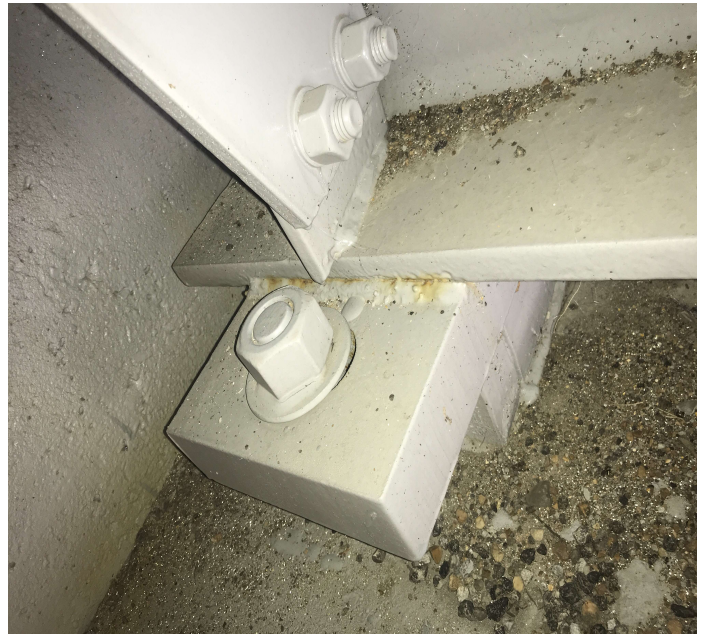
Span 1 bent 1 girder 8 lack of fusion of weld from sole plate to bottom flange of girder. photo 2018

PHOTO 2      Description      Span 1 bent 1 lack of fusion of weld  
from bottom of girder 8 to sole plate

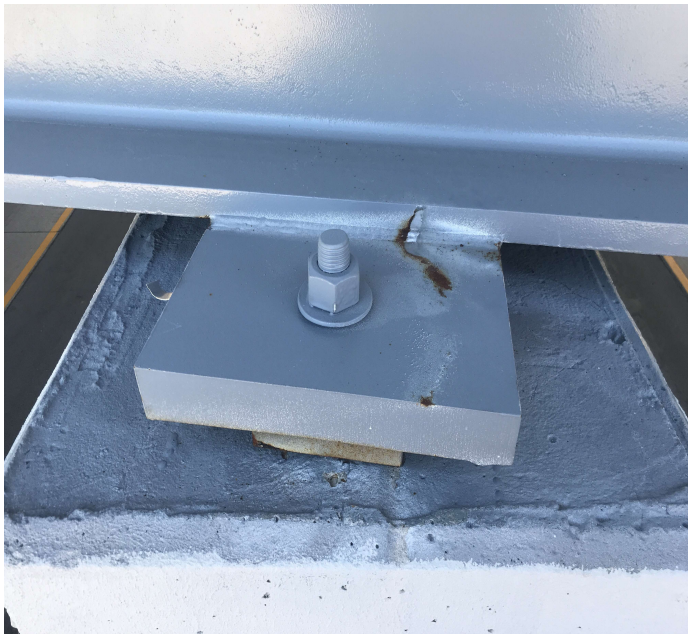
Super was repainted in November of 2017 job. no. 100963  
Several areas of the new paint starting to fail either by flaking or rust.  
photos 2018

PHOTO 1 Description Bent 3 left side rust on bearing. Photo to monitor.

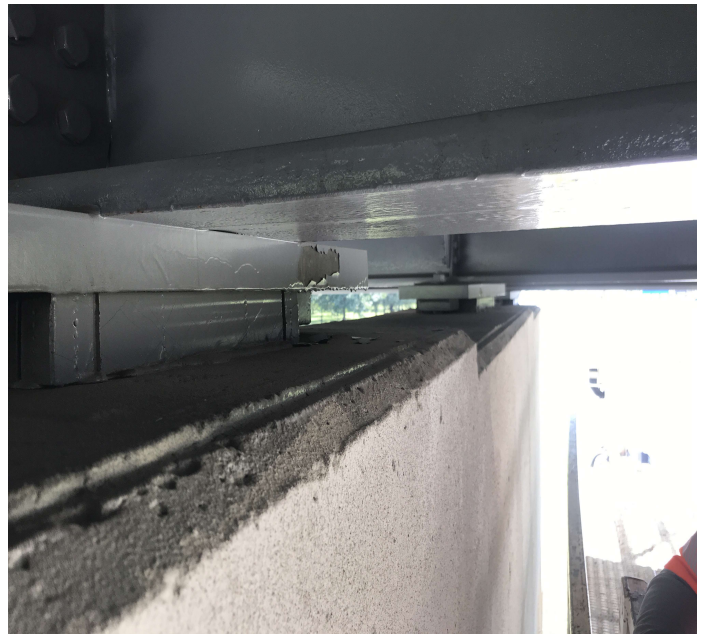
PHOTO 2 Description Bent 3 bearings paint flaking typical of bearings on this bent.

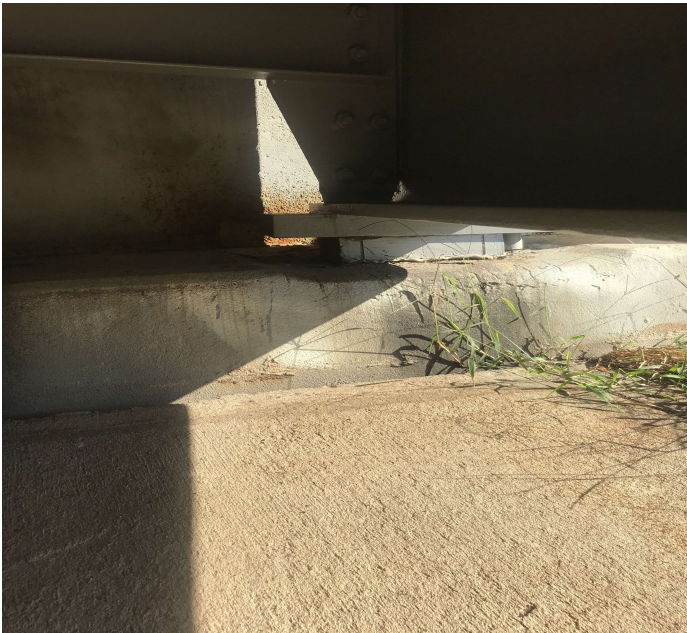
Span 4 bent 5 girder 10 bearing has missing anchor bolt on left side. photo 2018.

PHOTO 1      Description      Span 4 bent 5 bearing under girder 10 on left side has missing anchor bolt.

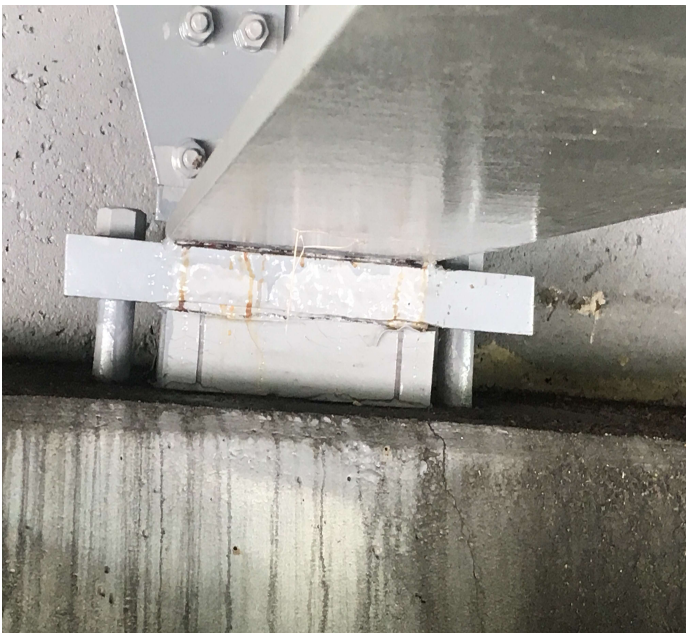
Span 1 bent 1 girder 5 pack rust forming between girder and bearing. photo 2018.

PHOTO 1      Description      Span 1 bent 1 girder 5 pack rust forming between girder and bearing.
