# Bridge Inspection Report

**06315**  
**CARAWAY RD-RT 12-C**  
**over**  
**I-555**

Structure Number: 06315

Facility Carried: CARAWAY RD-RT 12-C

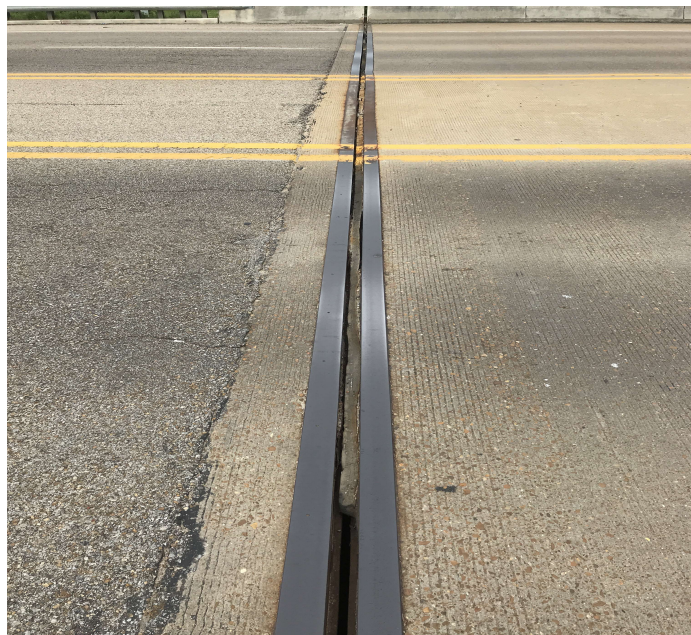
Compression seals have been replaced with poured joint seals. Poured joint seal has complete loss of adhesion at bents 1 and 5.

PHOTO 1      Description      Bent 1 joint

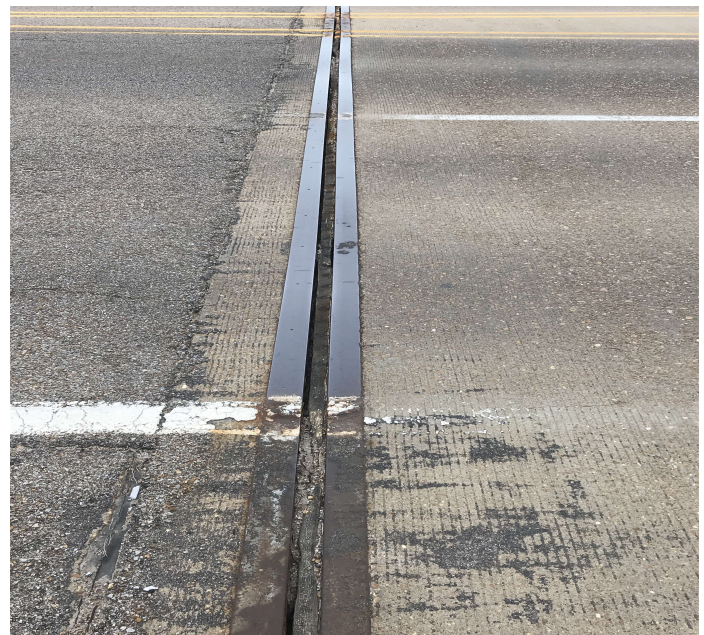
PHOTO 2      Description      Bent 5 joint

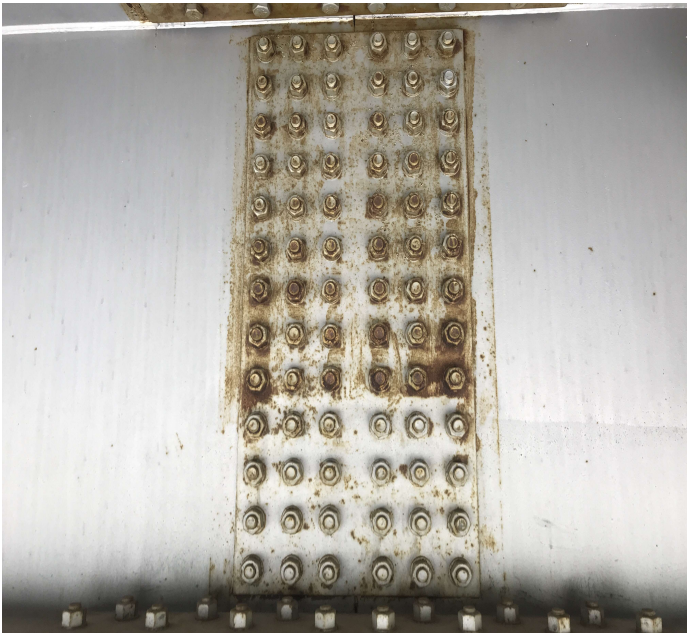
Girders have a few areas of freckled rust, especially at field splices.

PHOTO 1      Description      Span 2 girder 9 splice 1

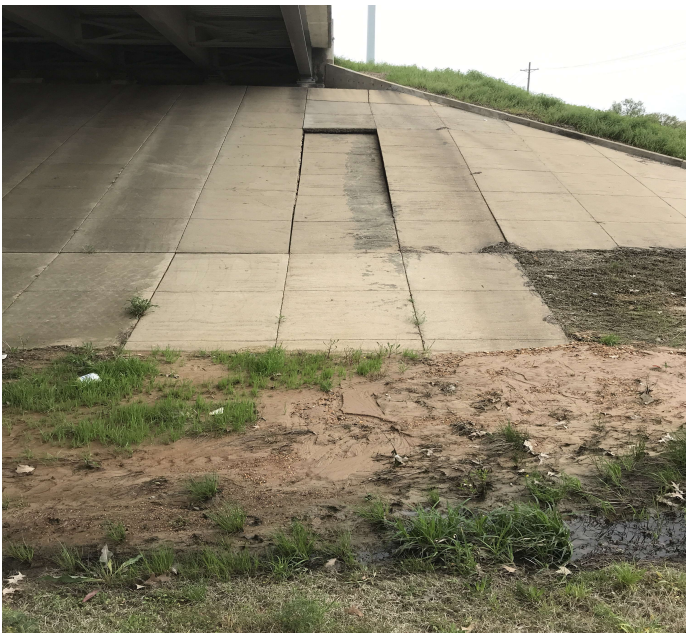
Bent 1 slope paving is undermined near Lt end. 5 sections are beginning to cave in.

PHOTO 1    Description    Bent 1 slope paving
