# Bridge Inspection Report

**06351**  
**WILLOW STREET**  
**over**  
**I-555, ML AND FR RDS**

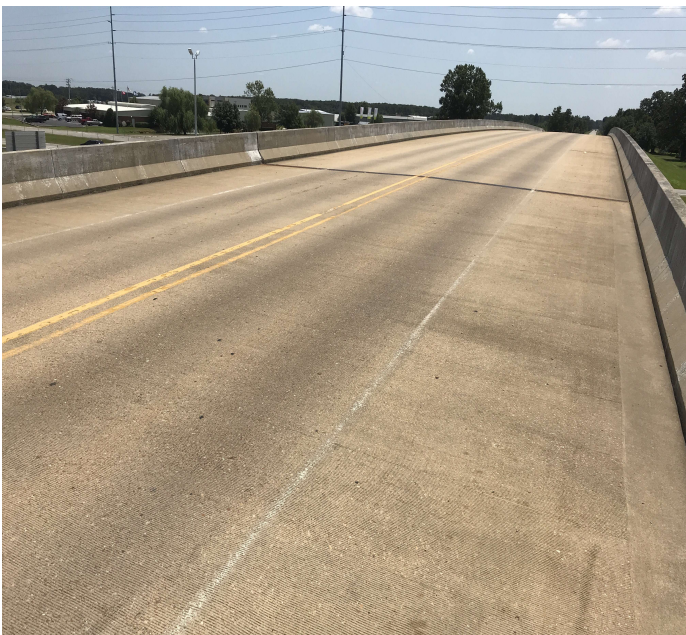
Deck has a few unsealed transverse and longitudinal cracks.  
Deck has areas of abrasion and minor traffic wear in wheel path.

PHOTO 1    Description    Overall view of deck

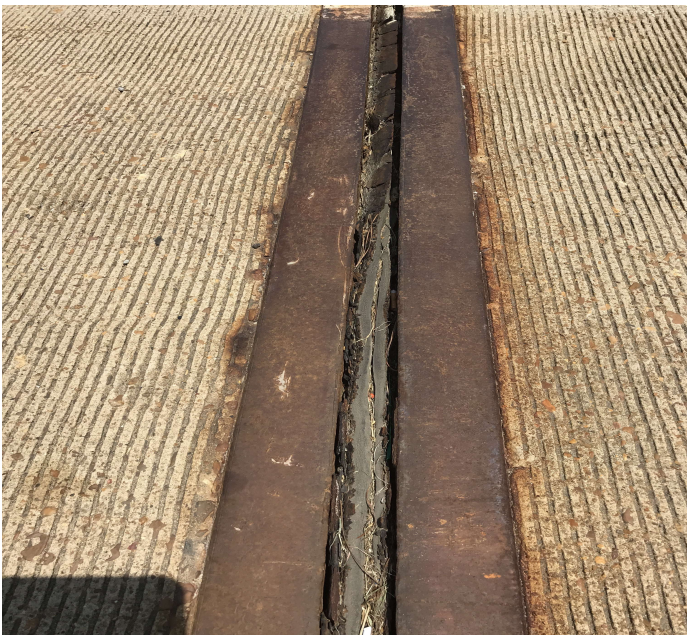
Poured joints at bents 1, 2, 6, and 7 are beginning to lose adhesion due to pack rust along road irons.

PHOTO 1    Description    Bent 6 joint
