# Bridge Inspection Report

**06352**

**US49 - Stadium Blv  
over  
I-555**

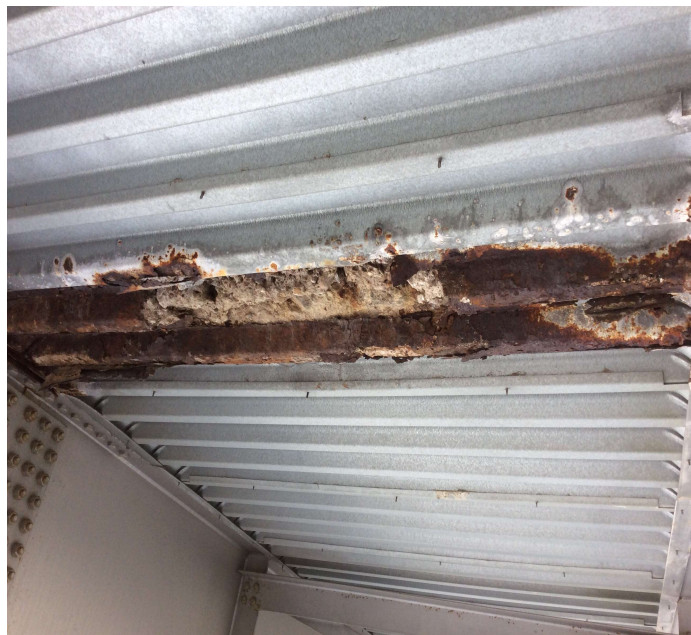
PHOTO 1 Description

Span 3 bottom of deck between girders 1 and 2 has a 3 ft. L x 1 ft. W x 3 in. deep spall in bottom of deck with exposed rebar. see 2016 photo.

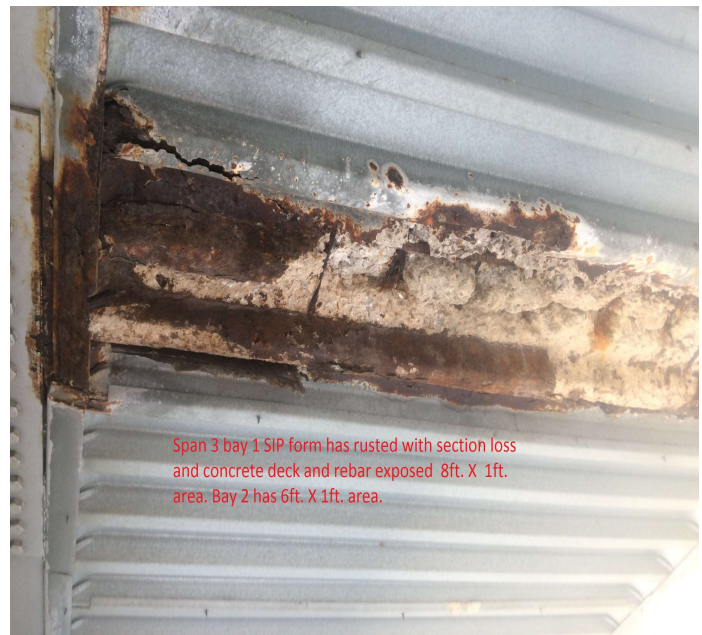
PHOTO 2 Description

Span 3 bottom of deck between girders 1 & 2, 2 & 3, and 3 & 4 has rust and section loss to stay in place forms due to leakage thru deck. Span 3 Bay 1 has a 8ft. L x 1 ft. W x 3 in. deep spall with exposed rebar, and Span 3 bay 2 has 6ft. L x 1 ft. W x 3in. Deep area with rebar exposed at these location. (See photo 2018).

Leakage thru deck at each sawed joint resulting in rust and loss of section on stay in place forms .

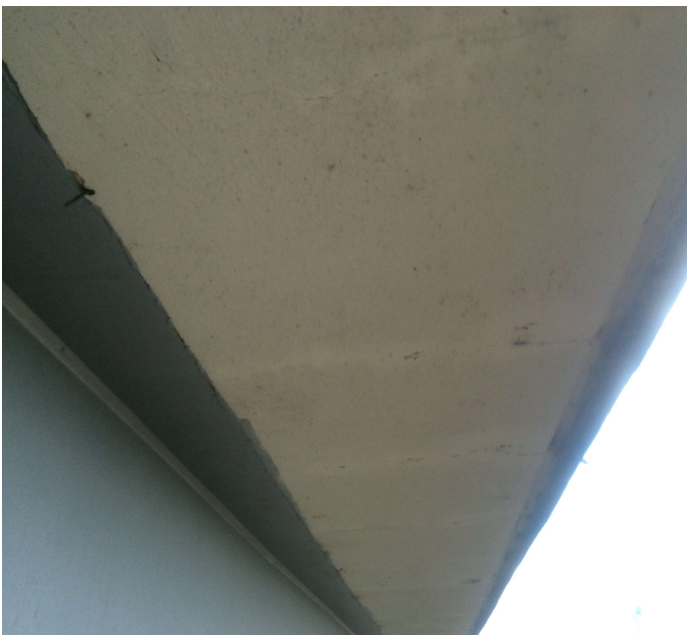
PHOTO 1    Description

Concrete deck  
has moderate width cracking with cracks thru deck with efflorescence in overhangs.

Concrete deck has several sealable cracks, see photo 2018. Overhangs have cracks thru deck with efflorescence, see photo 2018.

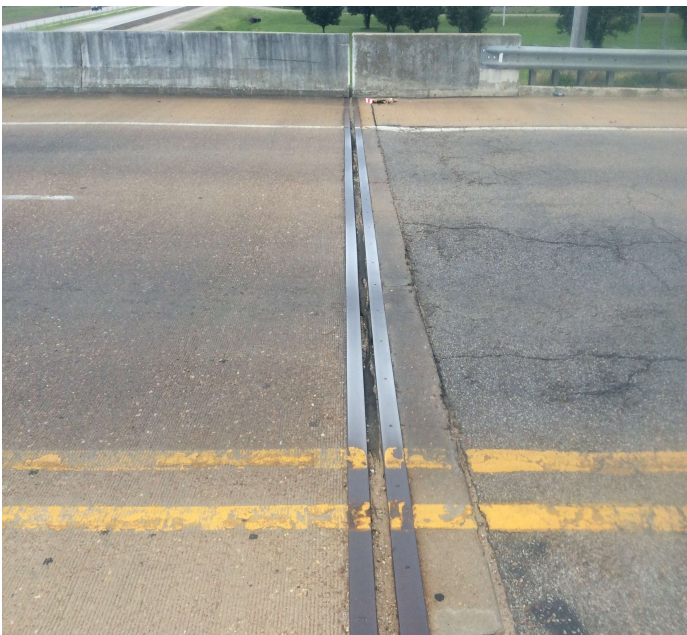
PHOTO 1 Description

Seals at bent 1 & 5 are pulling loose, allowing leakage with dirt and debris on to abutments.

Compression joint seal at bent 1 & 5 is pulling loose allowing leakage onto caps, especially bent 5.
