Bridge Inspection Report

06412

US 49, SEC 4, SW DR

I-555-SEC 03

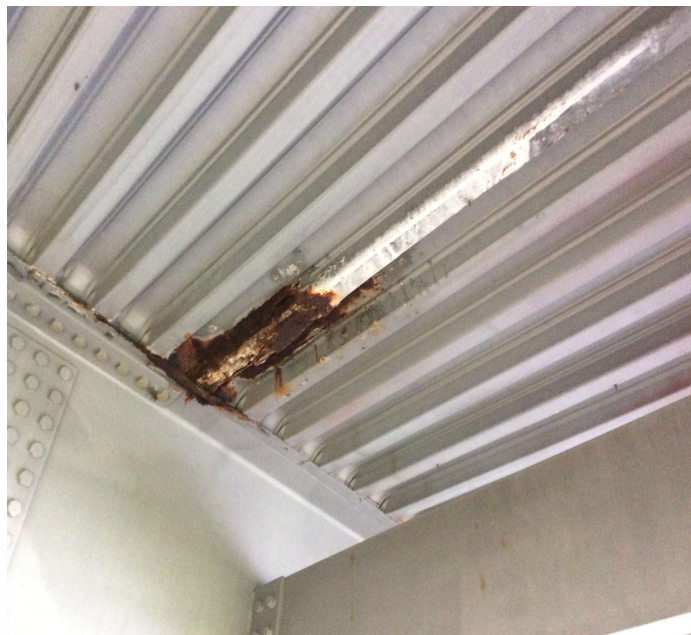
PHOTO 1 Description

Concrete deck has a few minor unsealed cracks. Sp 3 sawed joint location is not sealed.

Leakage thru sawed joints has resulted in rust and section loss in stay in place forms Spans 2,3,& 4, See photo 2018.

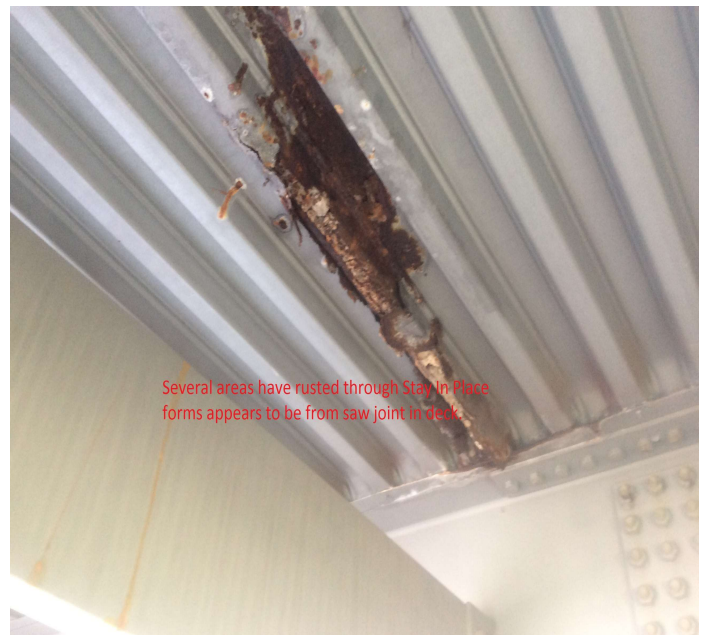
PHOTO 2 Description

Stay in place forms are rusted with some section loss due to leakage thru deck at sawed joint locations on span 3 and 4.

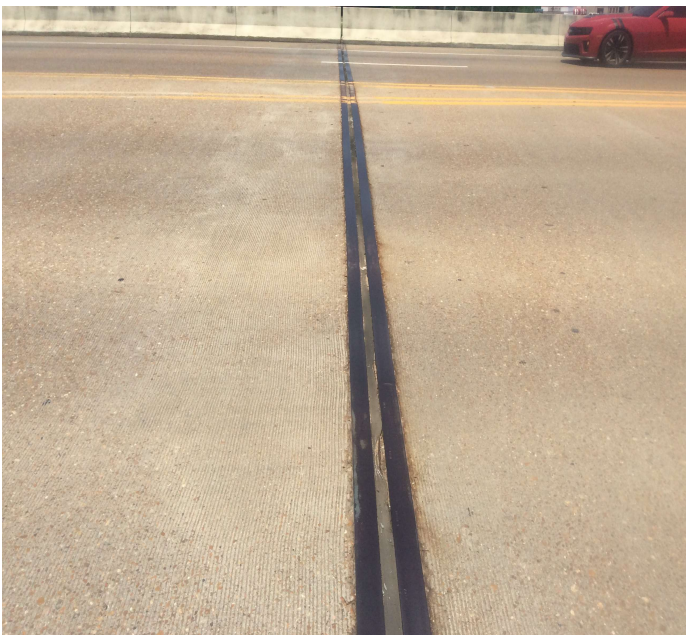
PHOTO 1 Description

Compression seals
Compression seal at Bt 2,4 and 5 are beginning to lose adhesion.

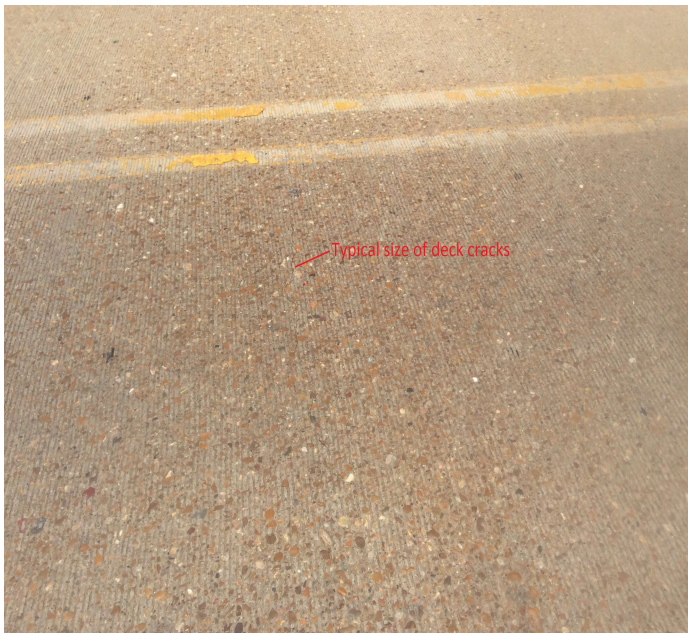
PHOTO 1 Description

Sealable cracks top of deck. See photo 2018

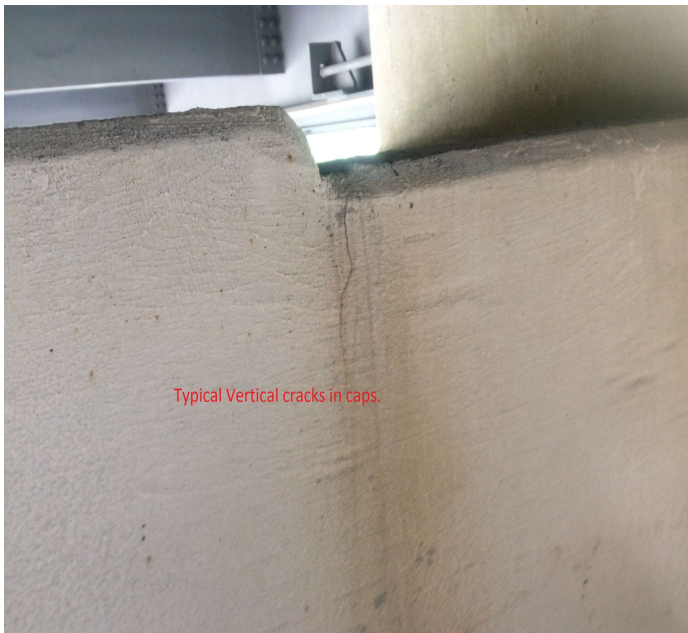
PHOTO 1 Description

Concrete caps Bents 2,3,4,& 5 have some moderate width vertical cracking 1ft long. See photo 2018
