Bridge Inspection Report

B5202
I-555 NB-03-39.80
over
WHITEMAN DITCH

Structure Number: B5202

Facility Carried: I-555 NB-03-39.80

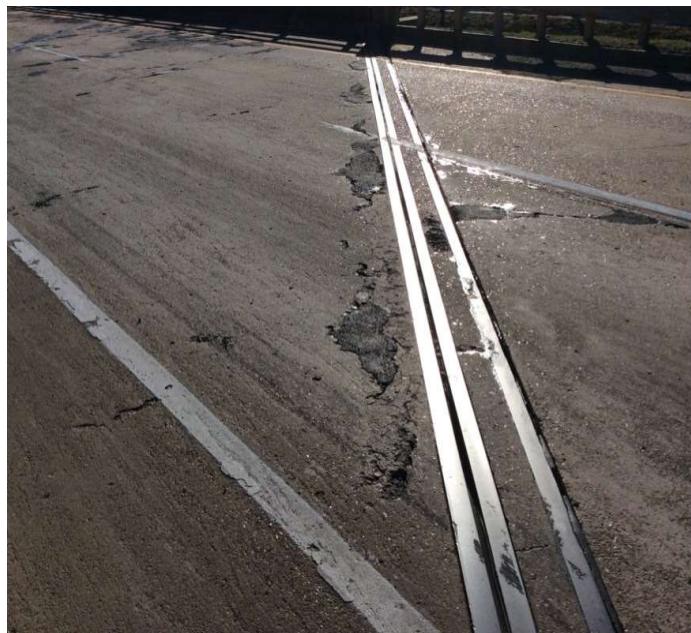
Concrete deck has several unsealed transverse cracks, delaminated areas, and large spalls; some with rebar exposed. Deck has several asphalt and concrete patches in fair to poor condition.

PHOTO 1 Description Spalls along joint over bent 1

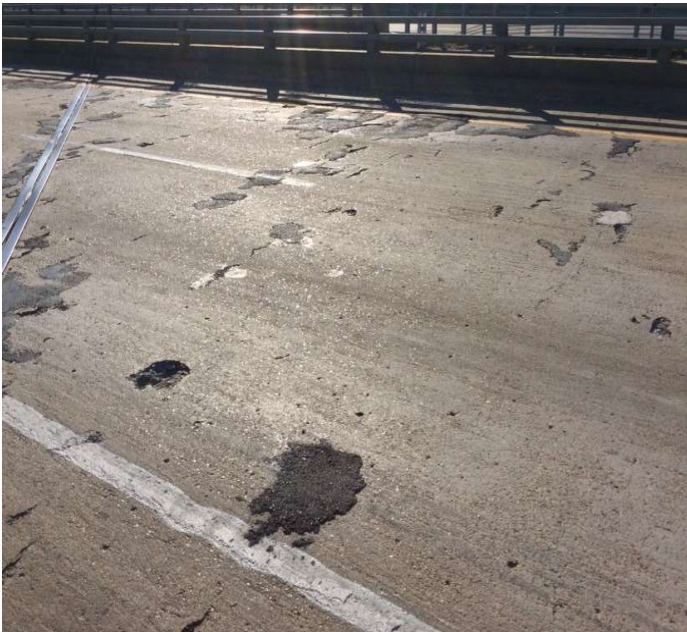
PHOTO 4 Description Deck at span 1

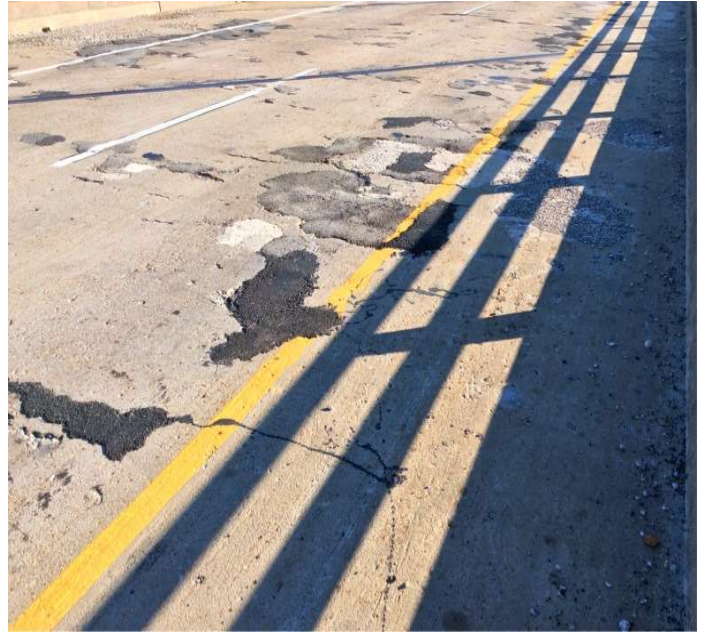
PHOTO 5 Description Deck at span 1

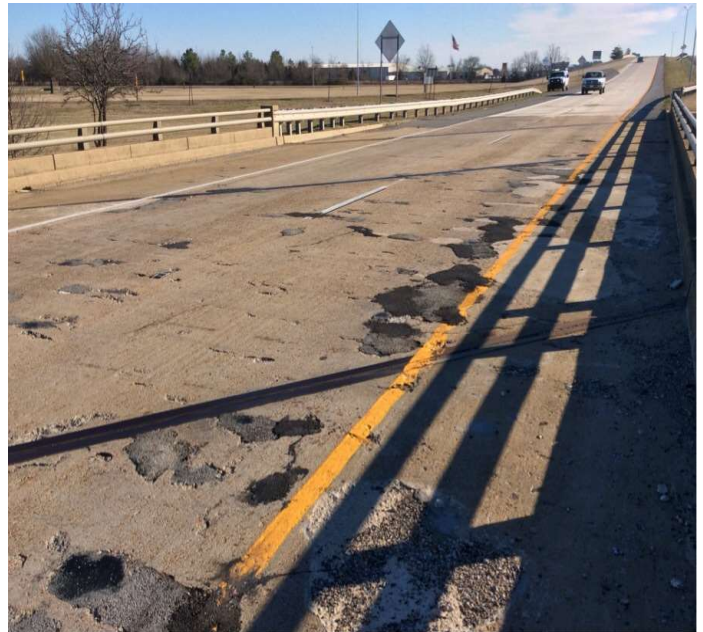
PHOTO 6 Description Deck at span 2

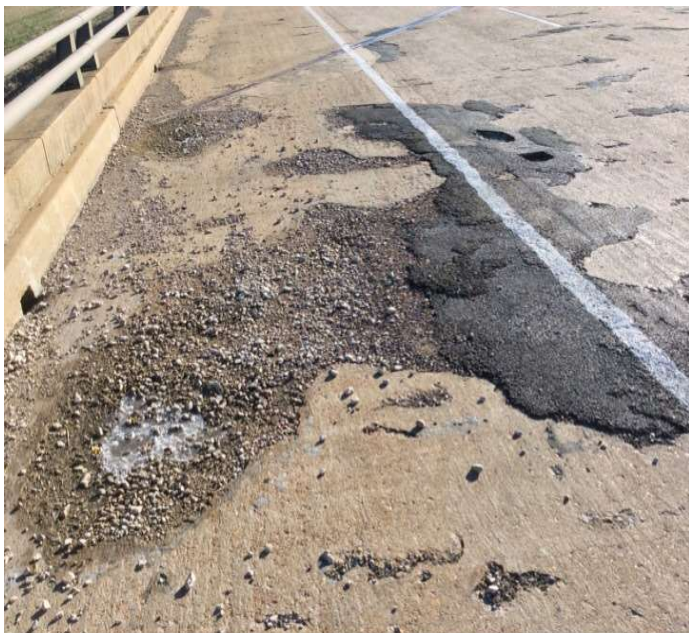
PHOTO 7 Description Lt gutter at span 2

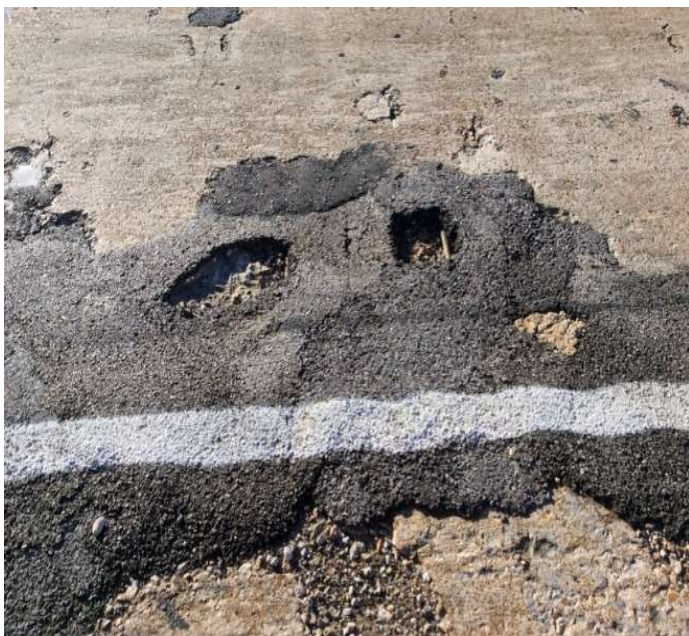
PHOTO 8 Description Rebar exposed at span 2

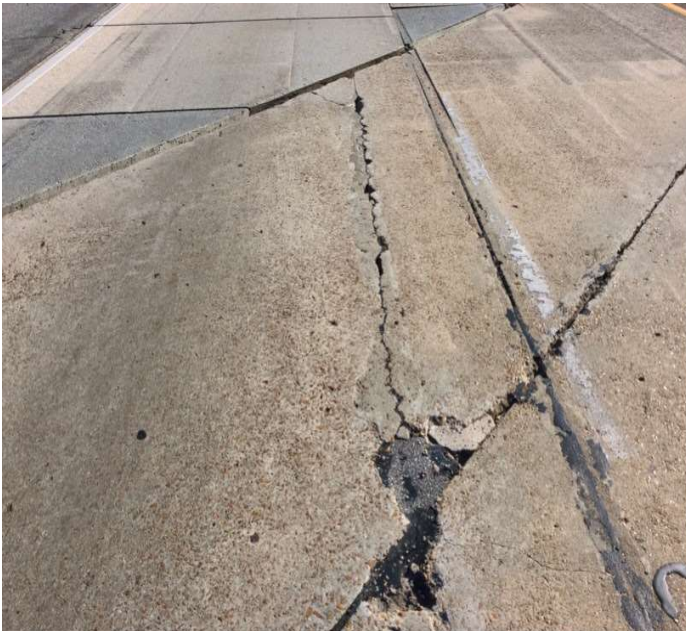
Approach slabs have a few large unsealed cracks.

PHOTO 1 Description Approach slab at bent 4 end of bridge

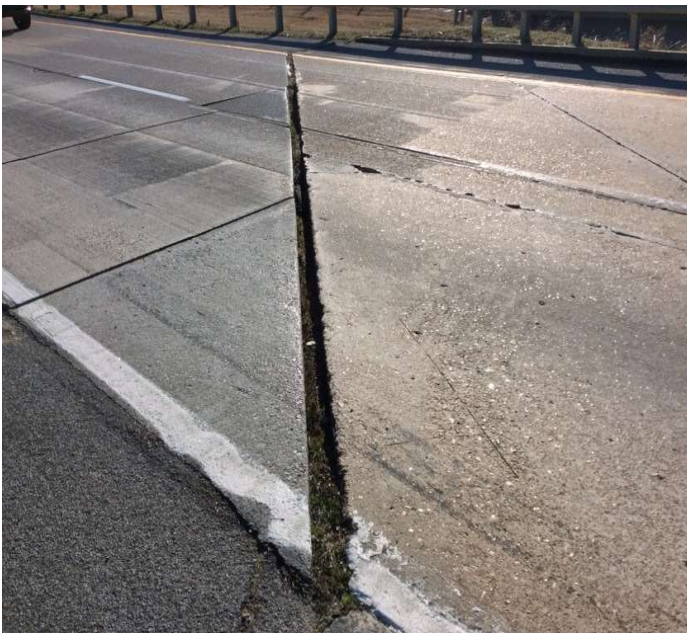
Approach slab at bent 1 end of bridge has 4.5" gap between approach slab and approach roadway.

PHOTO 1 Description Gap between approach slab and approach roadway
