Bridge Inspection Report

A5203
I-555-03-SB LNS
over
Union Pacific R/R

Structure Number: A5203

Facility Carried: I-555-03-SB LNS

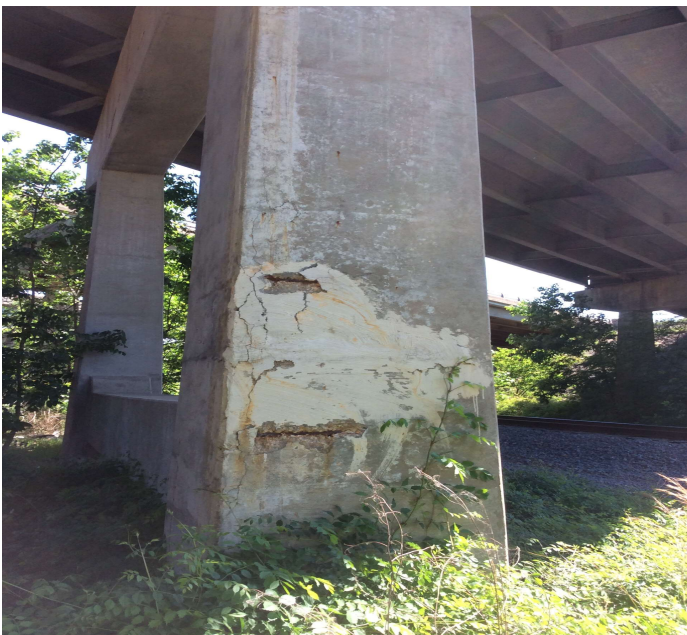
PHOTO 1 Description

Bent 3 conc. column 1

2 ft. area of vertical cracks and impending spall located 5 ft. below bottom of cap.

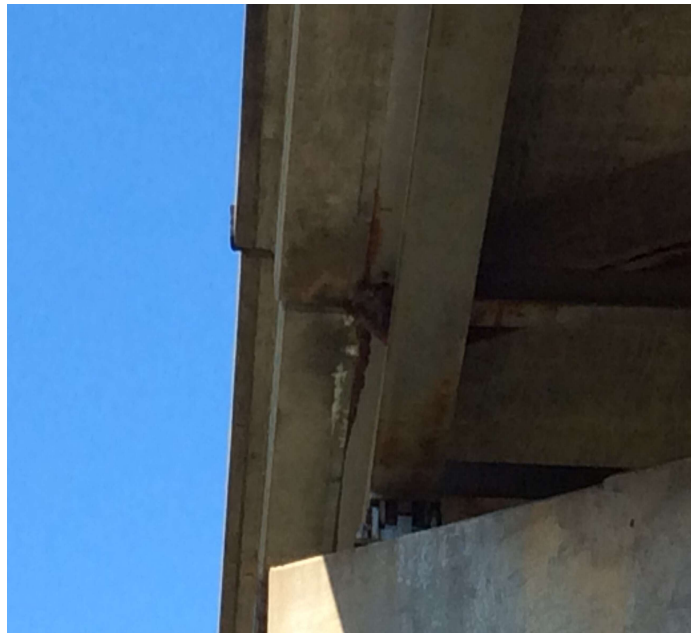
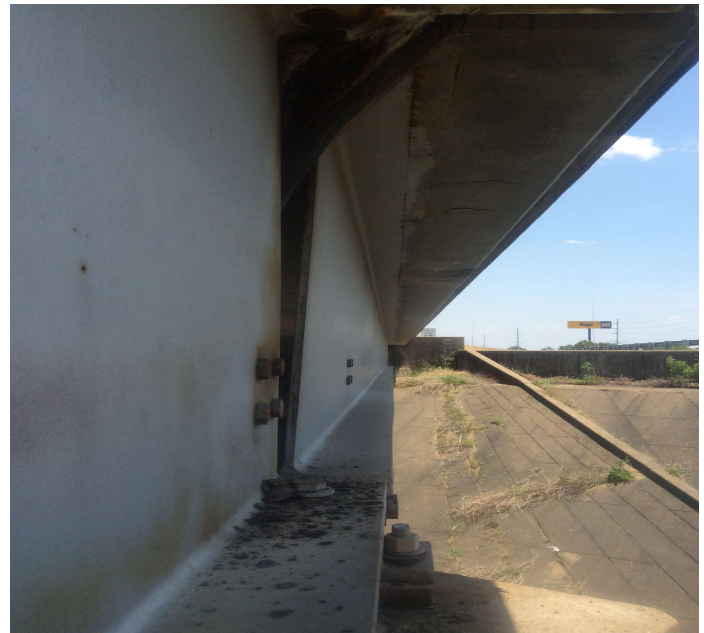
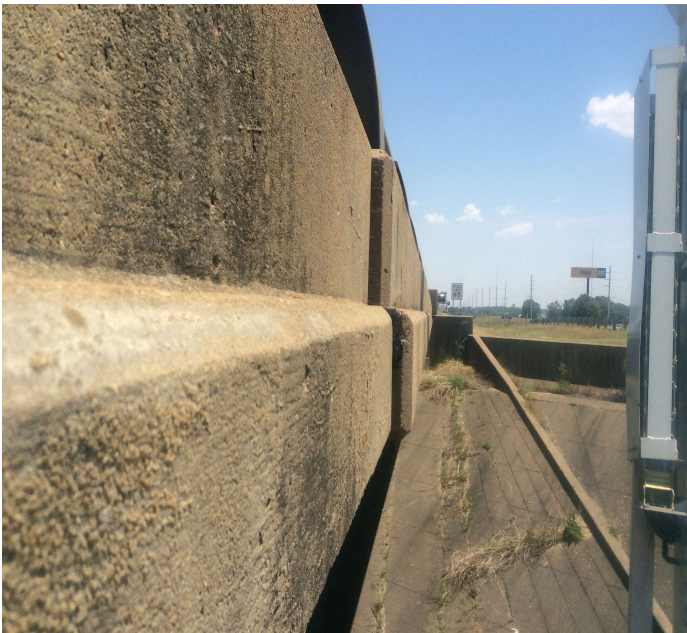
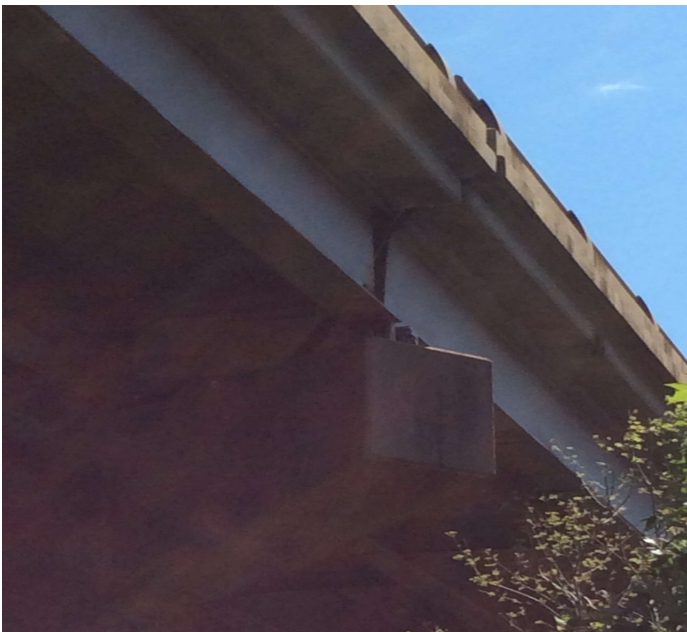
Span 1 Girder 1

Girder is out of plumb 1 in. in 12 in. or 4 degrees, See 2018 photo.

Span 2

Sp 2 has a lateral shift of 1 1/4 in. at bent 2 or 20 degrees. See 2018 photo.

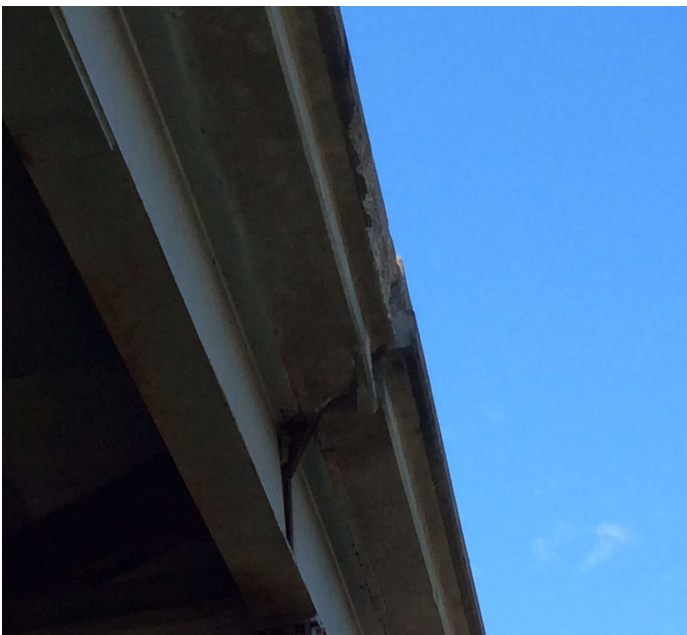
PHOTO 1 Description

Span 2 Right curb and overhang at bent 3.
5 ft. spalled with no exposed rebar. See 2016 photo.

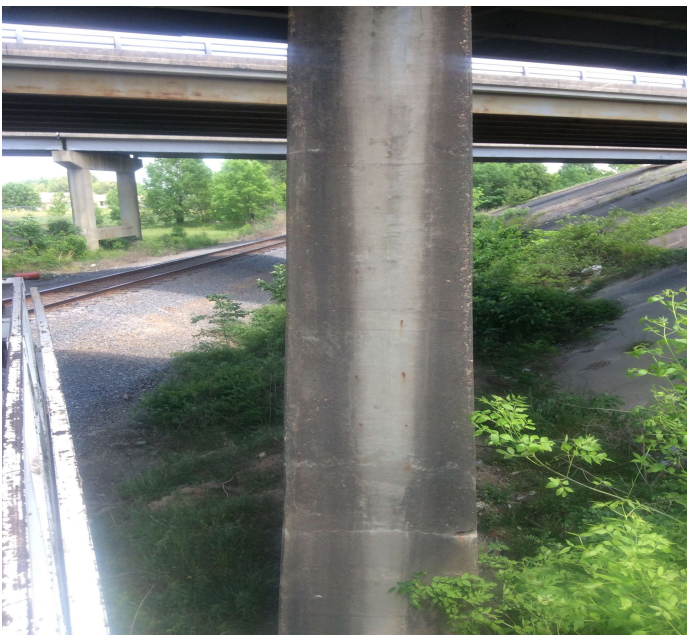
PHOTO 1 Description

Bent 2 concrete columns 1 have horizontal cracking with efflorescence and vertical crack, no exposed rebar. See photo 2018
