Bridge Inspection Report

B5203
I-555-03NB-LM40.29
over
Union Pacific R/R

Structure Number: B5203

Facility Carried: I-555-03NB-LM40.29

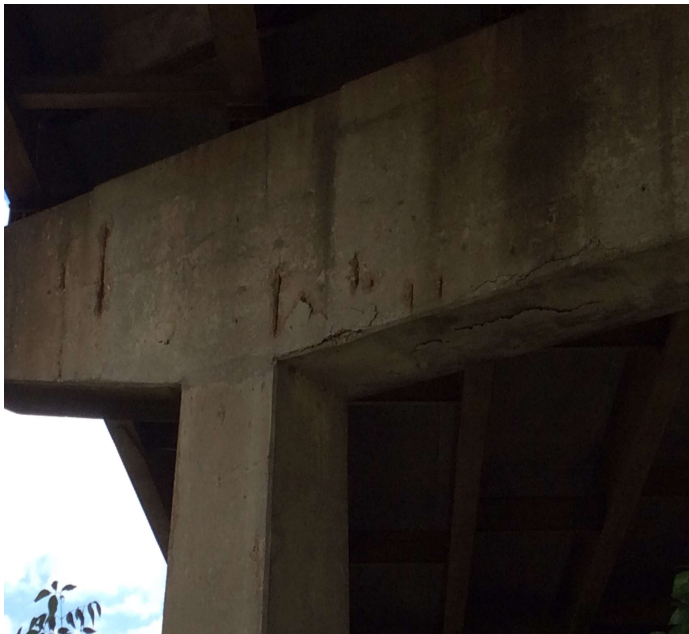
PHOTO 1 Description

Bt. 2 Conc. Cap on Sp. 2 side.

20 ft. horz. crack 3 in. up from bottom of cap.

5 ft. horz. crack 3 in. down from top of cap between Column 1, & 2. See 2016 photo.

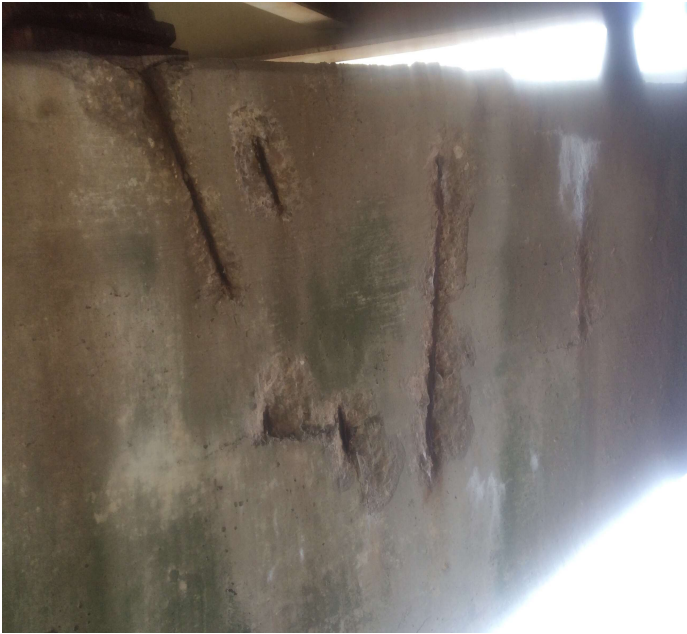
PHOTO 1 Description

Bt. 2 Conc. Cap on Sp. 1 side.

2 ft. X 4 ft. area of small spalls with exposed rebar at column 1.

2 ft. X 2 ft. X 2 in. deep spall with exposed rebar at column 2,

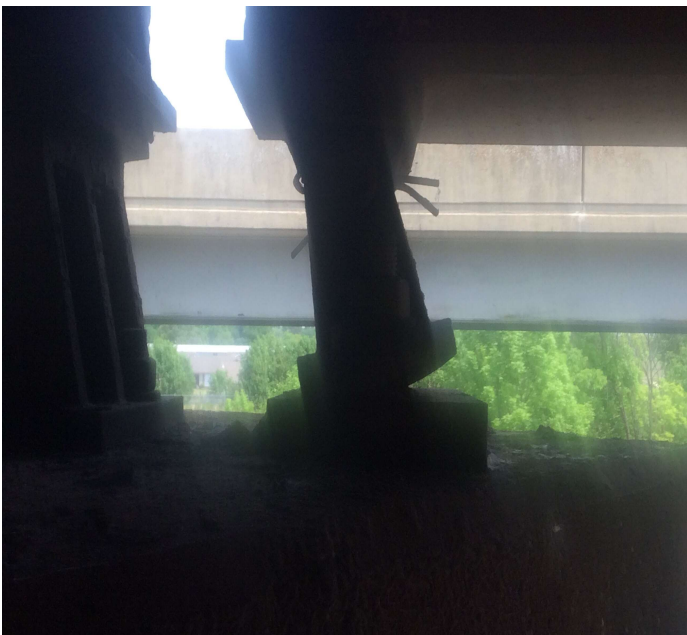
PHOTO 1 Description

Bents 2, & 3 Rocker Bearings.
are rust covered with pitting and are tilted up to 15 degrees.

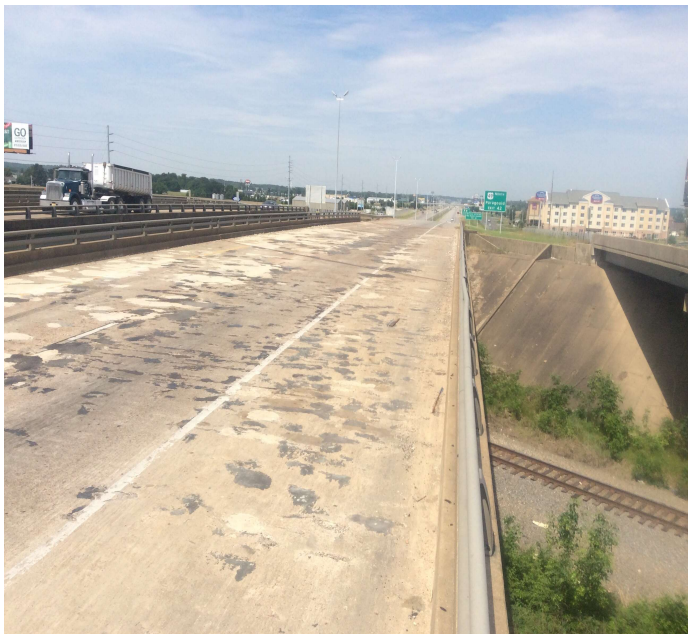
PHOTO 1 Description

Concrete deck has some delamination with a few spalls with some exposed rebar, 252SF of exposed rebar visible. Majority of deck has new concrete and / or epoxy patch repairs that are in good to fair condition at this time. Old patches are loose and beginning to shell out exposing some rebar and small and large portion of concrete debris in gutter lines. See 2018 photos.

Deck received an asphalt overlay in 2018.

this bridge is scheduled for rehabilitation next year. KAW

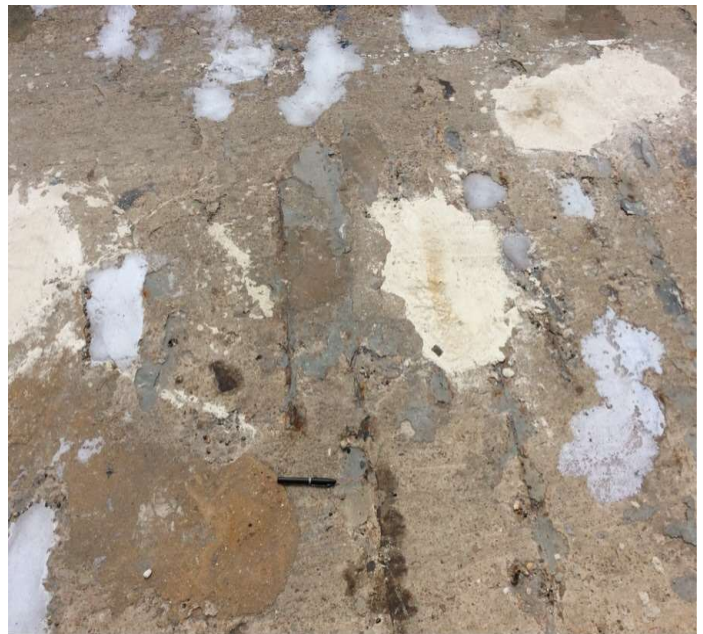
PHOTO 2 Description Deck spalls with rebar exposed

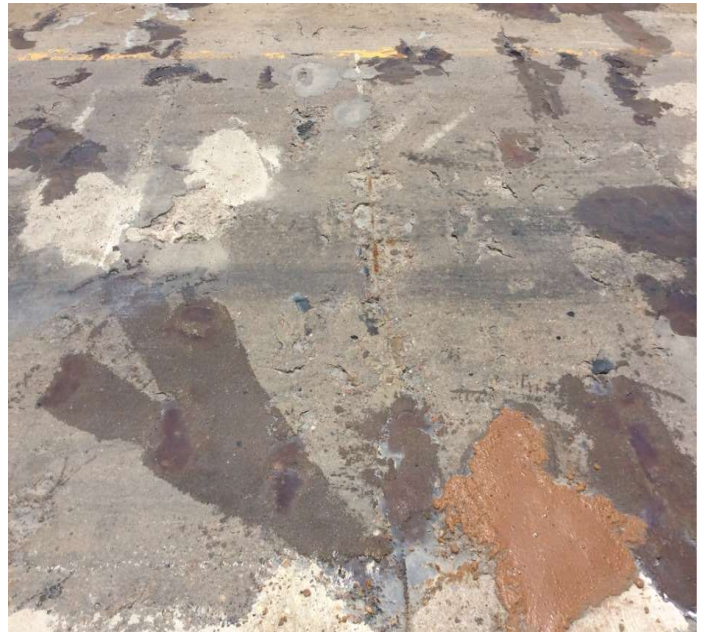
PHOTO 6 Description Deck spalls with rebar exposed
