Bridge #02923(Routine)

SH 25-06- LM 13.27 over CYPRESS CREEK

Location: 13.46 M NE INDEPENDENCE C

Team Lead: James Adams Inspection Date: September 04, 2019

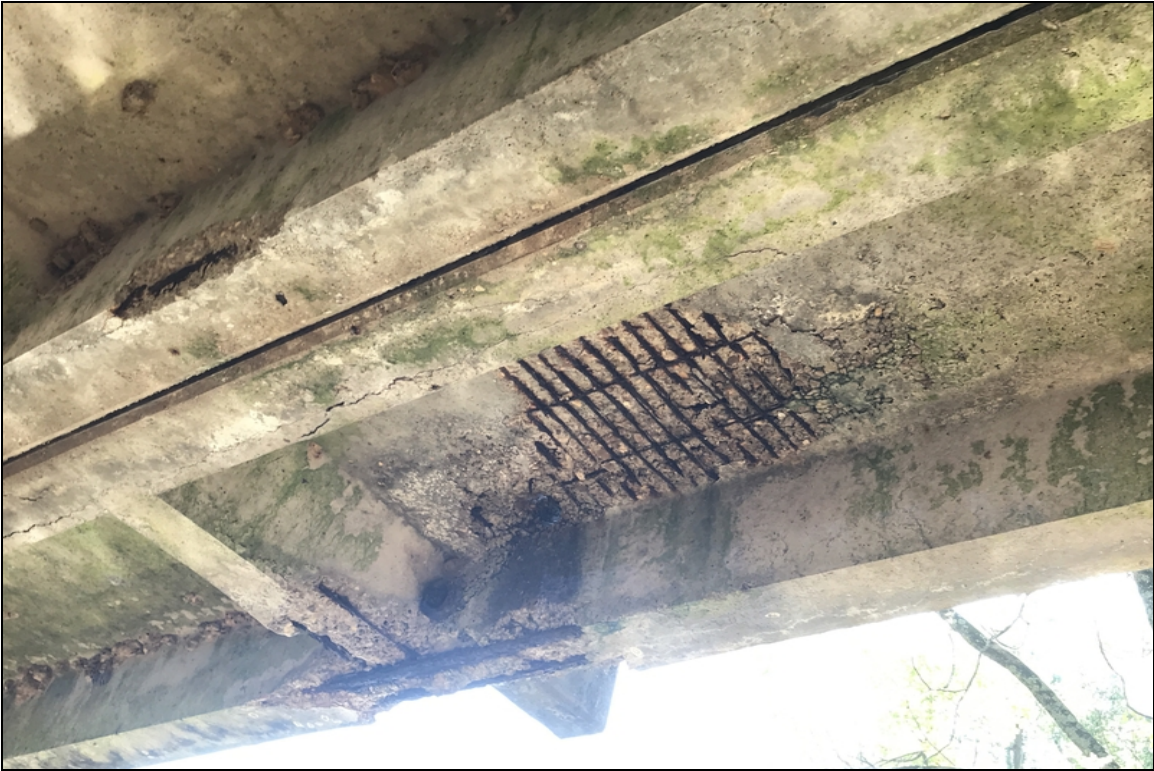
Span 2 unit 7 2019

Both approach roadways have up to 1.5 in. of settlement. Bridge Rail has up to 90% paint deterioration with surface rust. Asphalt overlay has a few cracks between units with a small spall in asphalt wearing surface. Bottom of deck span 2 unit 7 has a 3ft. x 3ft. honeycomb area with exposed rebar, see 2019 photo.

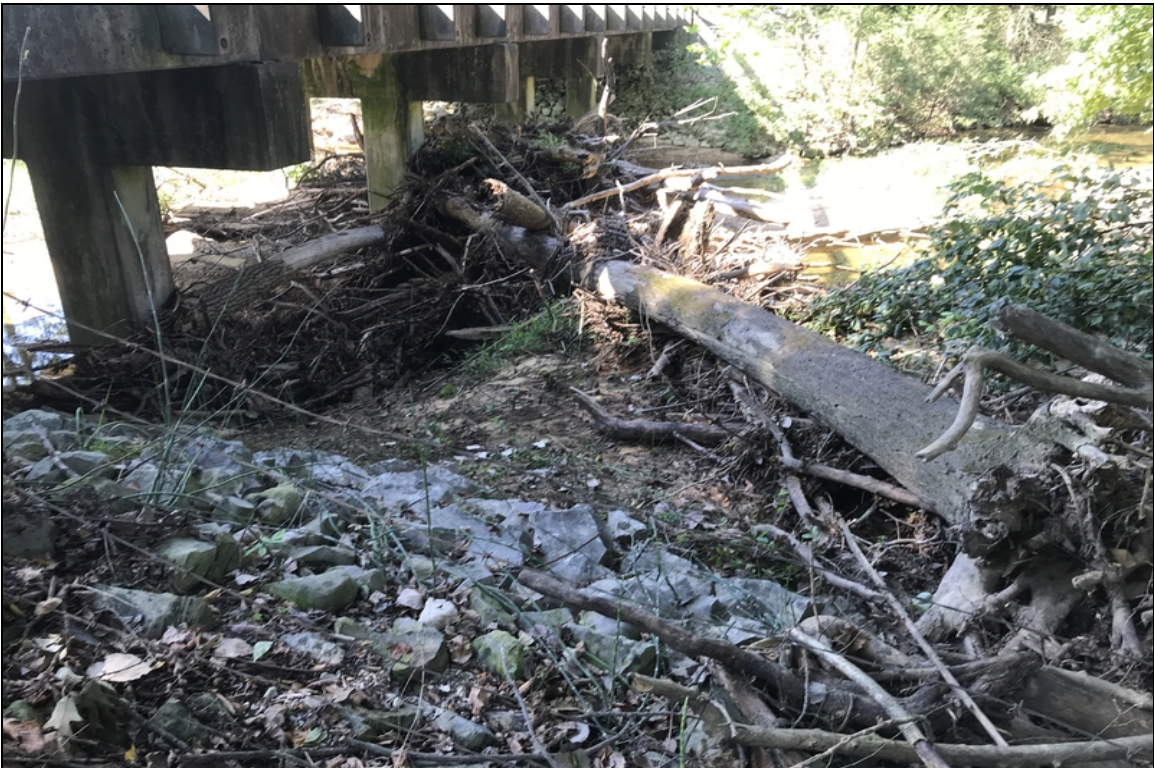
Drift LT SIDE

Bent 5 cap right end has 1 ft. of exposed rebar. Bent 3 columns 1&2 has some exposed rebar. Bent 4 column 2 has some exposed rebar. Bent 5 columns 1&2 are cracked. Large drift across & under spans 3, 4 & 5, see 2019 photos. Footings are keyed into solid rock.

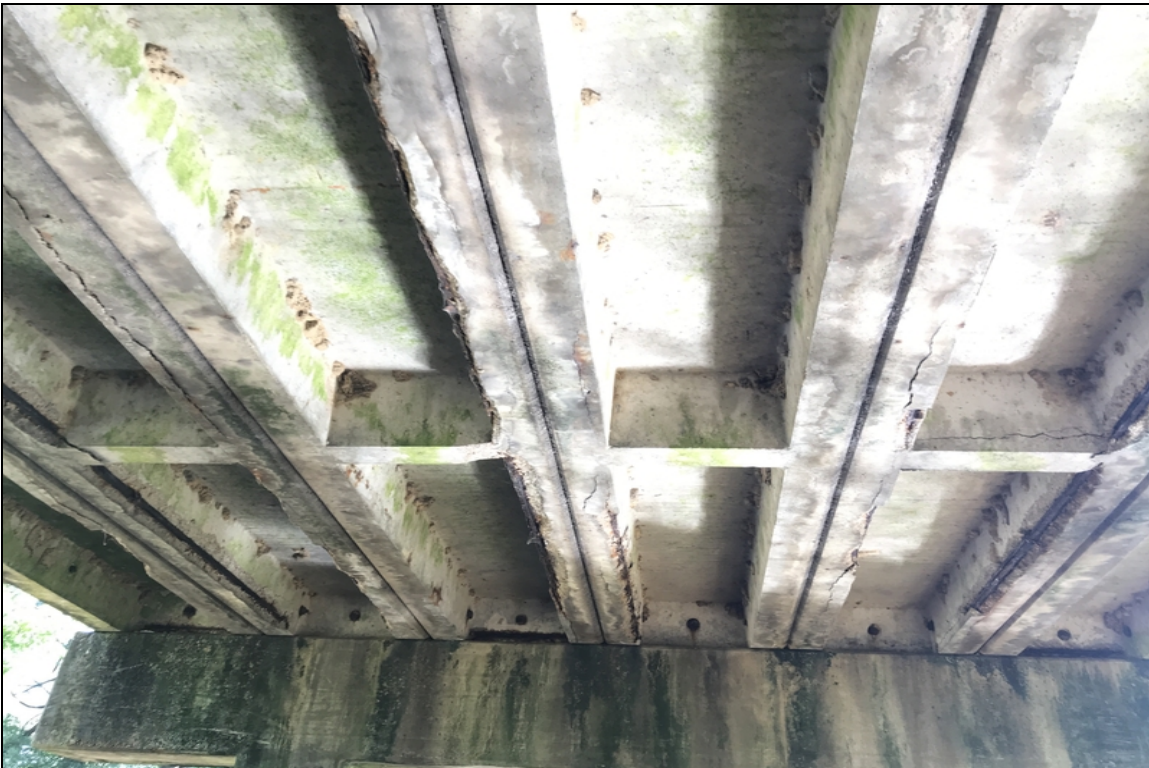
Span 2 soffit 2019

Span 1 unit 1 has 19ft. of cracks  
Span 1 unit 2 has 15ft. of exposed rebar & 4ft. of cracks  
Span 1 unit 3 has 15ft. of cracks  
Span 1 unit 4 has 10ft. of cracks  
Span 1 unit 5 has 10ft. of cracks  
Span 1 unit 6 has 12ft. of exposed rebar & 7ft. of cracks  
Span 1 unit 7 has 15ft. of cracks  
Span 2 unit 1 has 3 ft. of exposed rebar & 15ft. of cracks  
Span 2 unit 2 has 18ft. of exposed rebar & 1ft. of cracks  
Span 2 unit 3 has 17ft. of exposed rebar & 2ft. of cracks  
Span 2 unit 4 has 8ft. of exposed rebar & 11ft. of cracks  
Span 2 unit 5 has 15ft. of exposed rebar & 4ft. of cracks  
Span 2 unit 6 has 1 ft. of exposed rebar & 6ft. of cracks  
Span 2 unit 7 has 3ft. of exposed rebar & 15ft. of cracks  
Span 3 unit 1 has 15ft. of exposed rebar & 4ft. of cracks  
Span 3 unit 2 has 9 ft. of exposed rebar & 10ft. of cracks  
Span 3 unit 3 has 10ft. of exposed rebar & 9ft. of cracks  
Span 3 unit 4 has 15ft. of exposed rebar & 4ft. of cracks
