Bridge #M0603(Routine, Underwater type 2)

SH 25-06- LM 1.39 over CANEY CREEK

Team Lead: James Adams **Inspection Date:** October 15, 2019

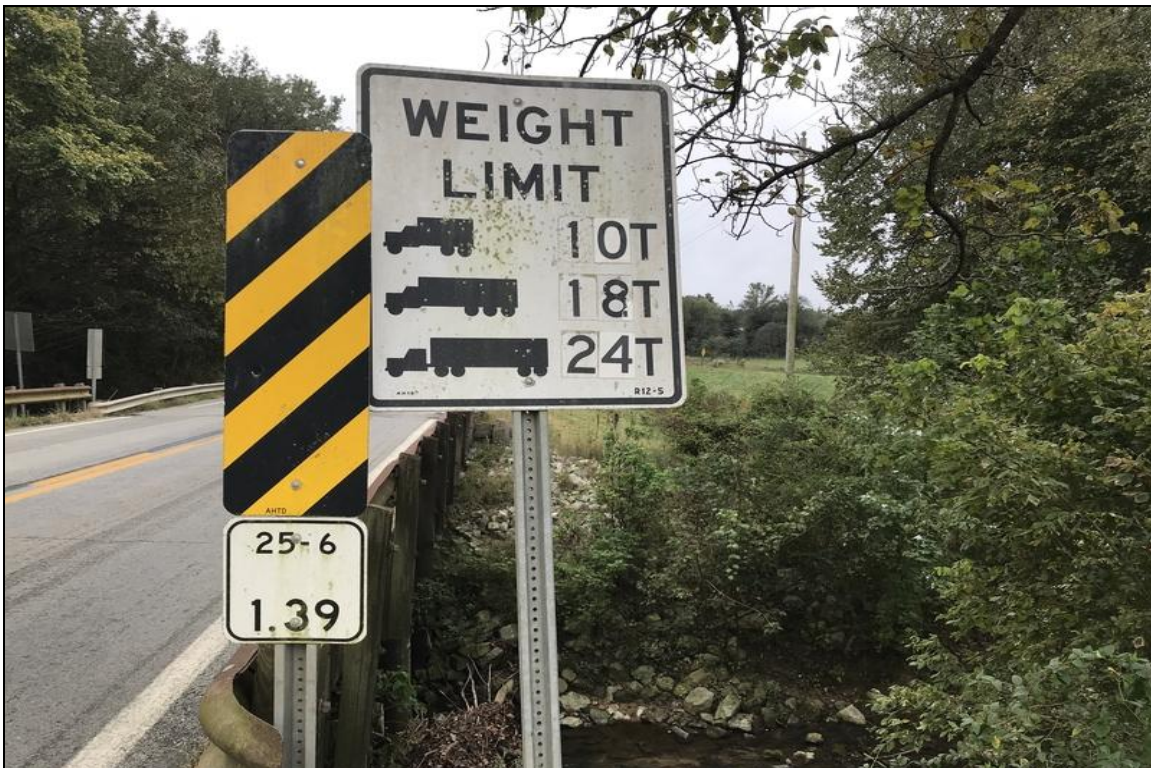
End posting incorrect Code 9&5

Ending bridge end posting is posted incorrectly. Right approach guard rail at bent 1 has embankment erosion undermining guardrail and edge of roadway.

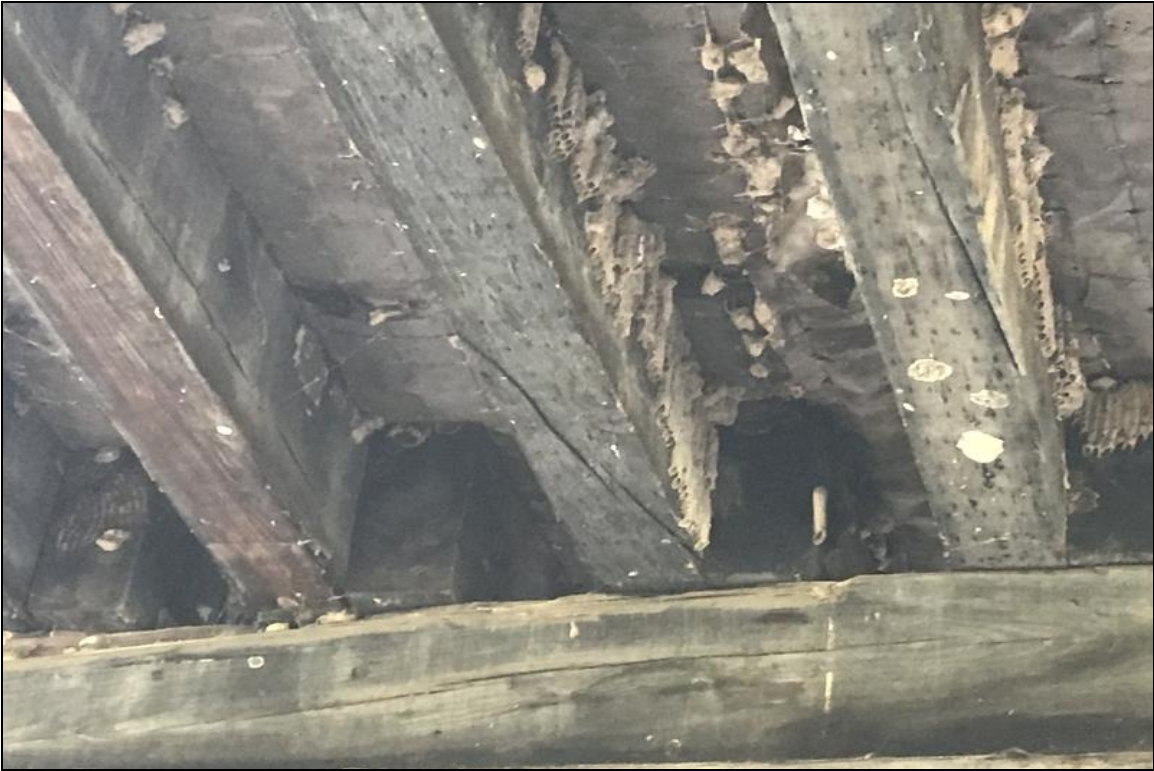
Span 3 girder 10 at bent 3 2019

Span 3 bent 3 girder 10 has a 6 in. deep check on the bottom corner near bent 3 & 4, see 2019 photo.

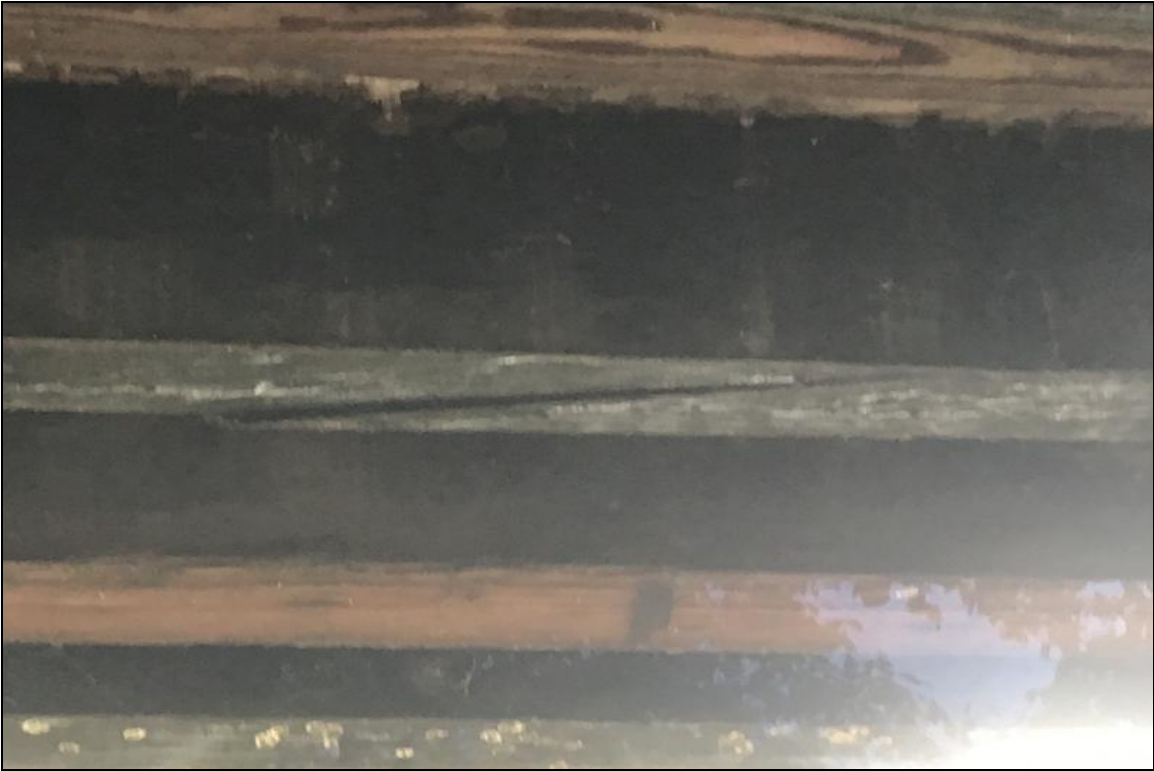
Span 3 girder 13 at bent 4 2019

Span 3 girder 13 has a split with delamination through girder near bent 4, see 2019 photo.

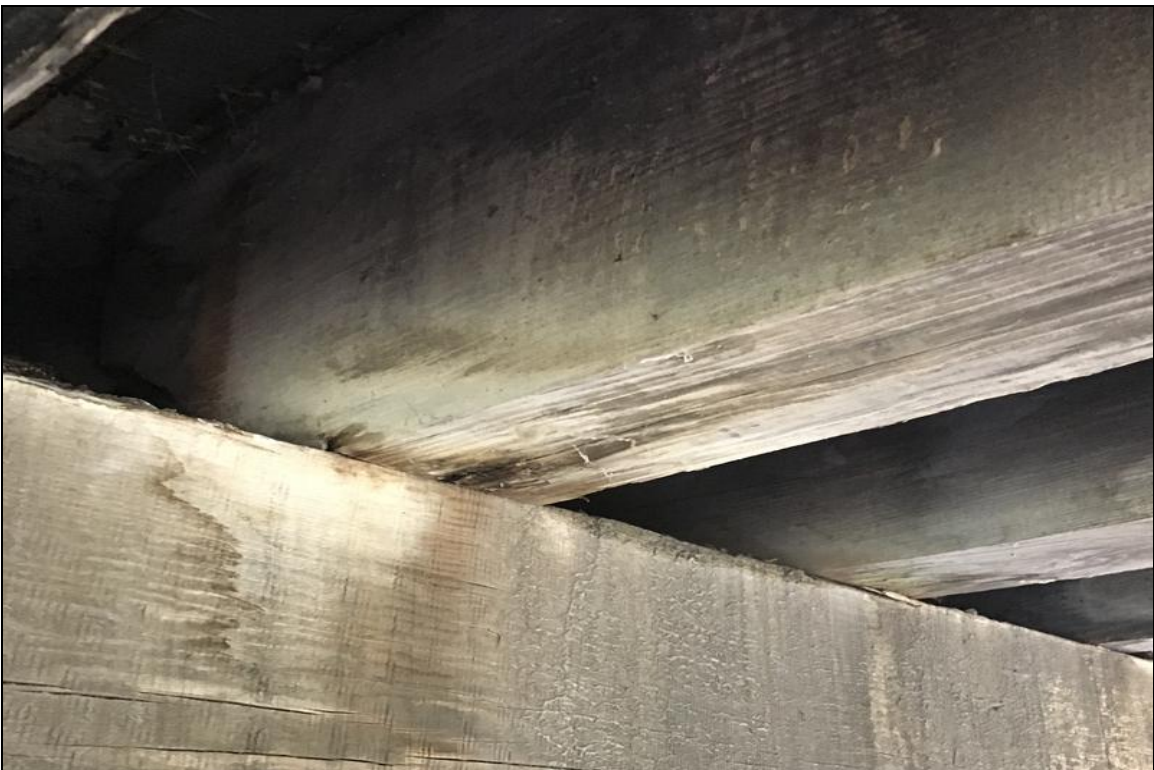
Span 4 girder 11 at bent 5 2019

Span 4 girder 11 at bent 5 is decayed and hollow at end on bottom of girder, see 2019 photo.

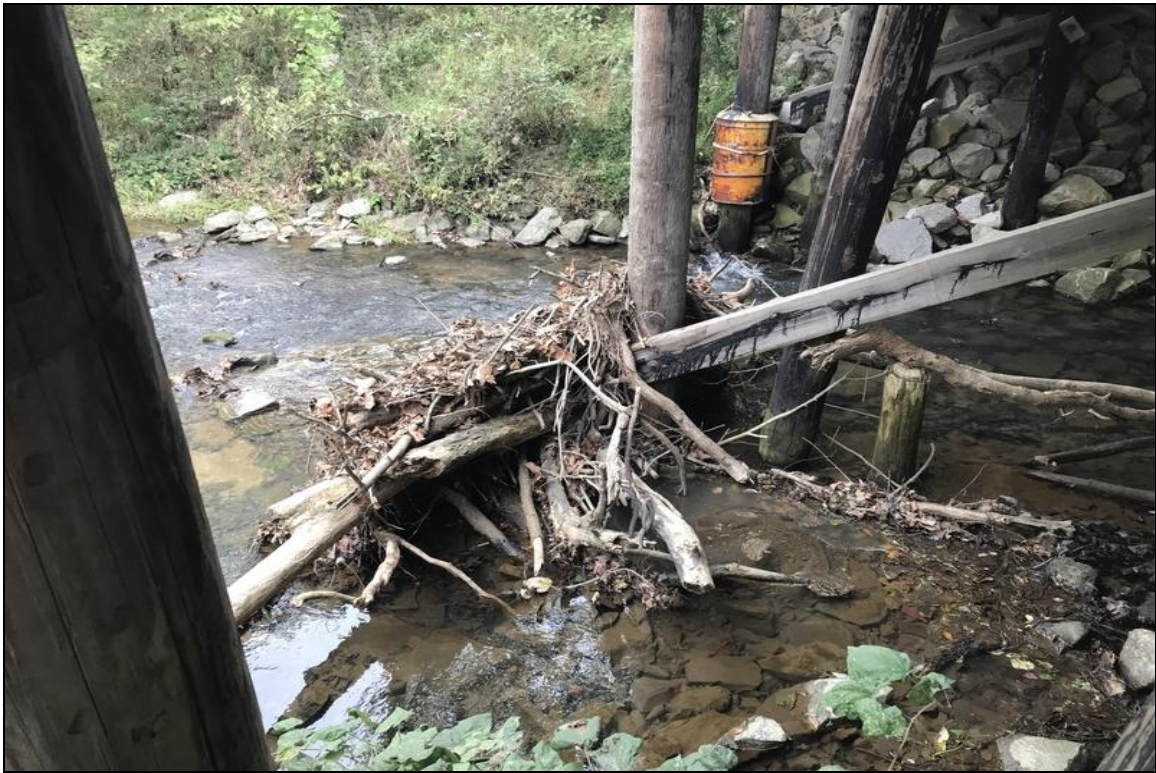
Bent 3 drift LT SIDE 2019

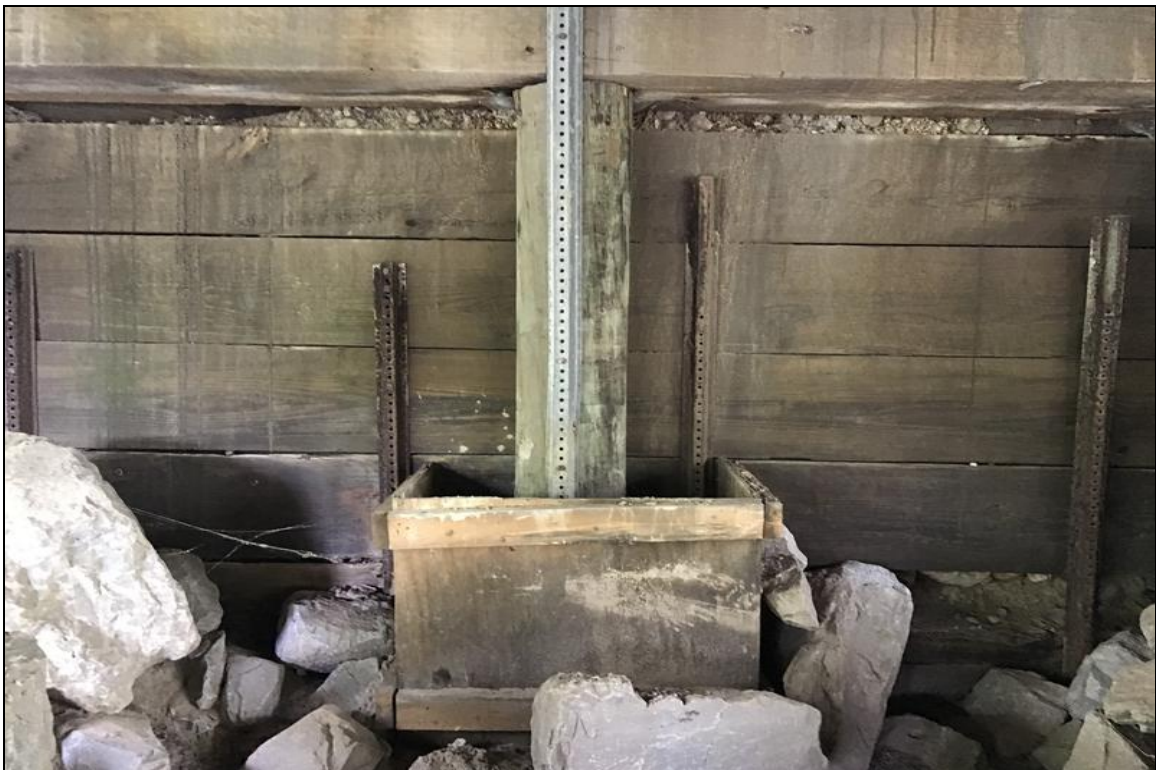
Bent 5 pile 3 replaced 2019

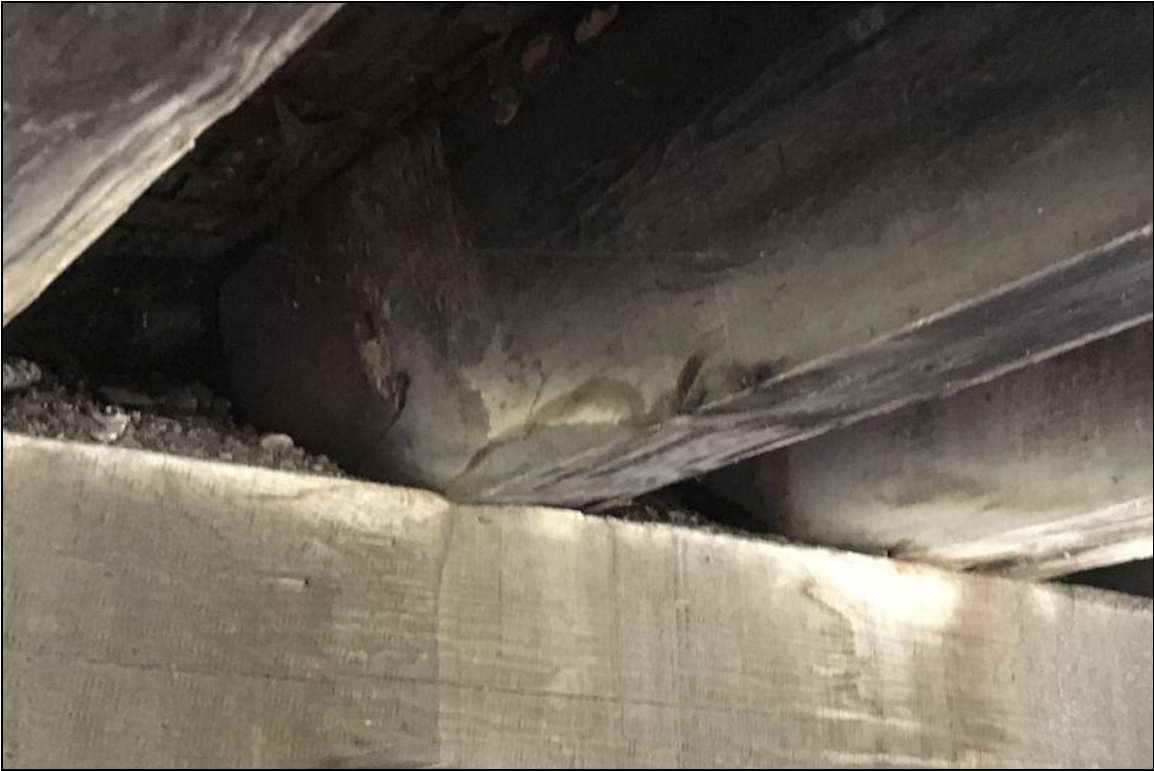
Span 4 girder 10 at bent 5 2019

Span 4 girder 10 at bent 5 is decayed on the end with some crushing over cap. See 2019 photo.

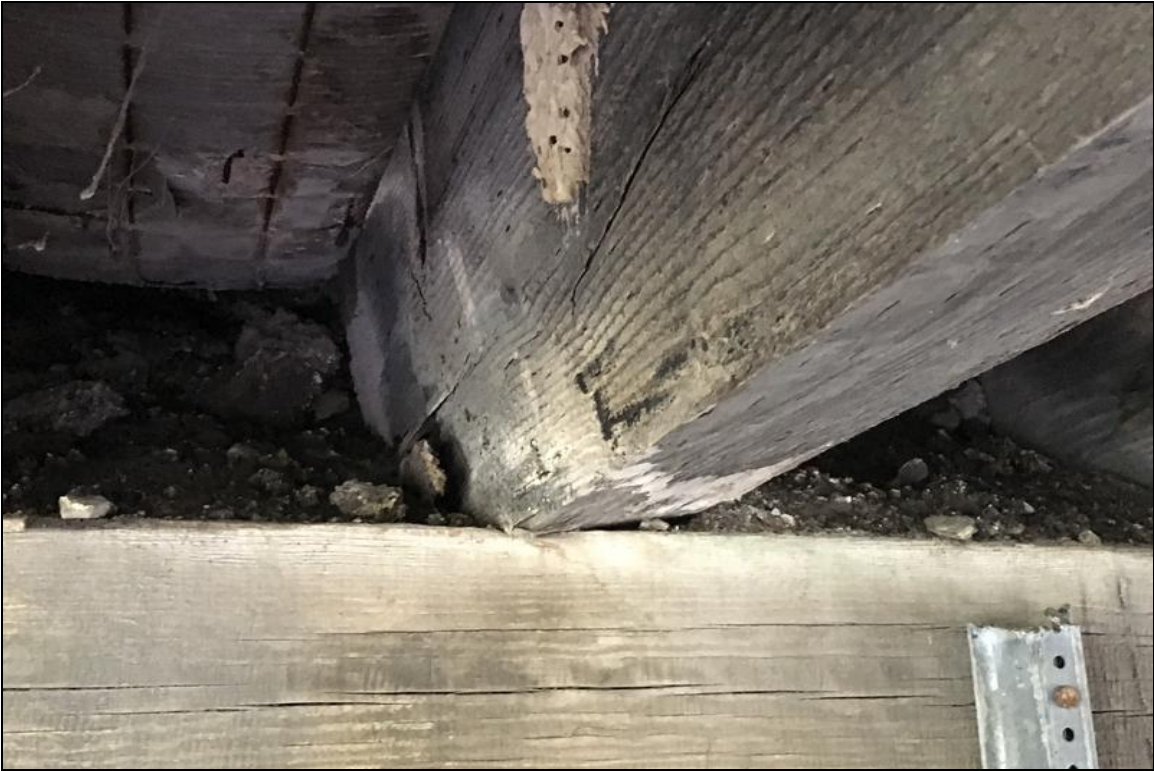
Span 4 girder 7 at bent 5 2019

Span 4 girder 7 at bent 5 is decayed with some possible crushing over cap. Girder is leaning to one side over cap. See 2019 photo.

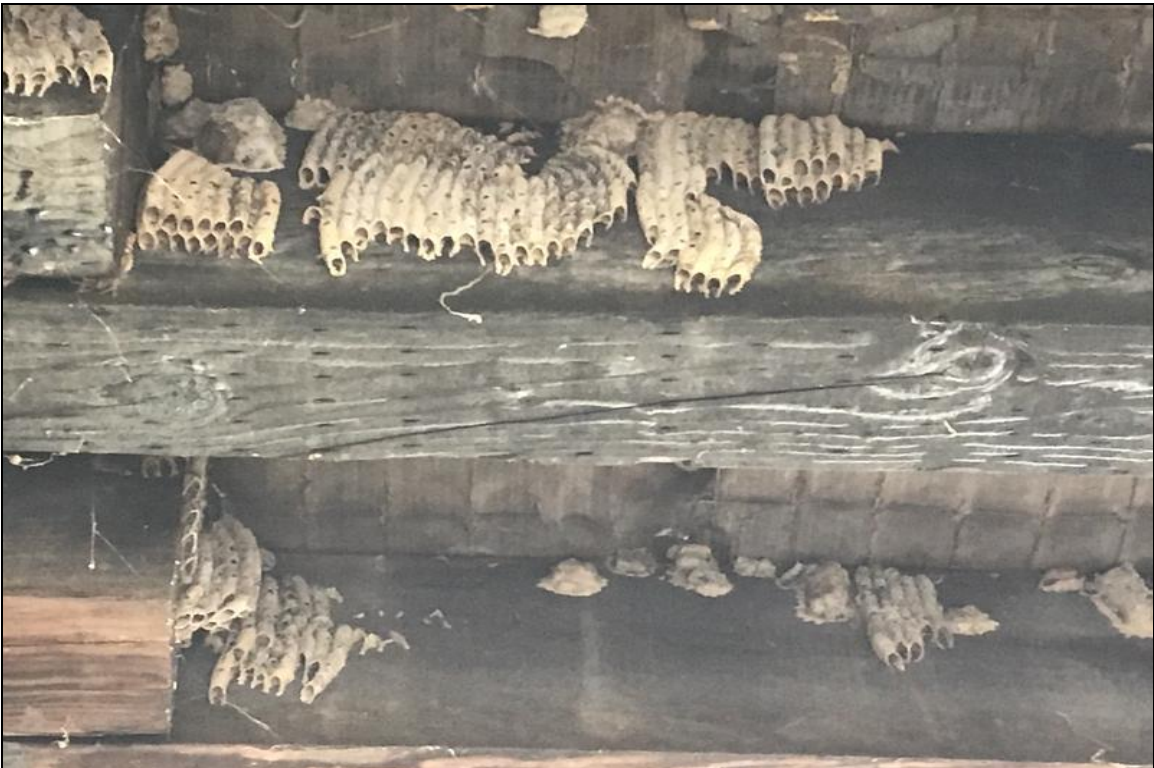
Span 3 girder 10 at bent 4 2019

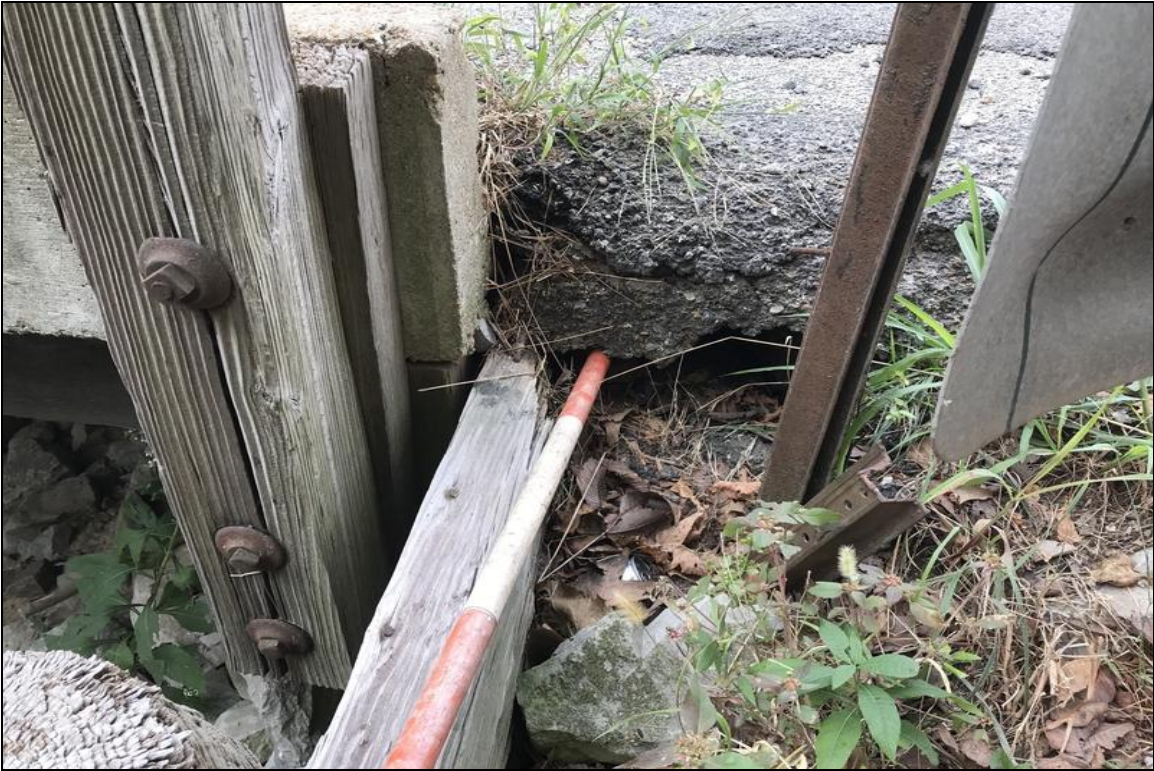
Bent 5 RT END approach roadway 2019

Right end of bent 5 roadway is beginning to undermine 1 ft. back under 6 in. deep, see 2019 photo.
