Bridge #03747 (Routine)

US 49B over TOWN DITCH

Location: 3.09 M S Jct. 49B & 49

Team Lead: Tim Myrick Inspection Date: March 15, 2018

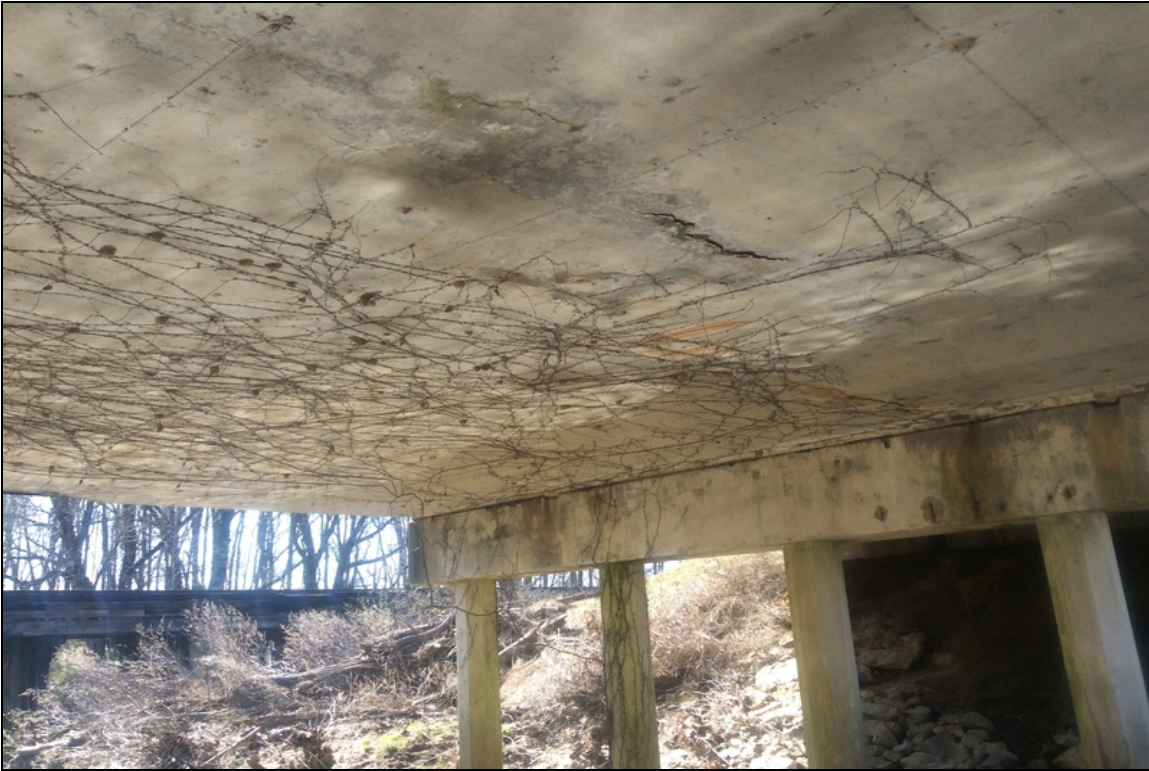
Underneath deck view

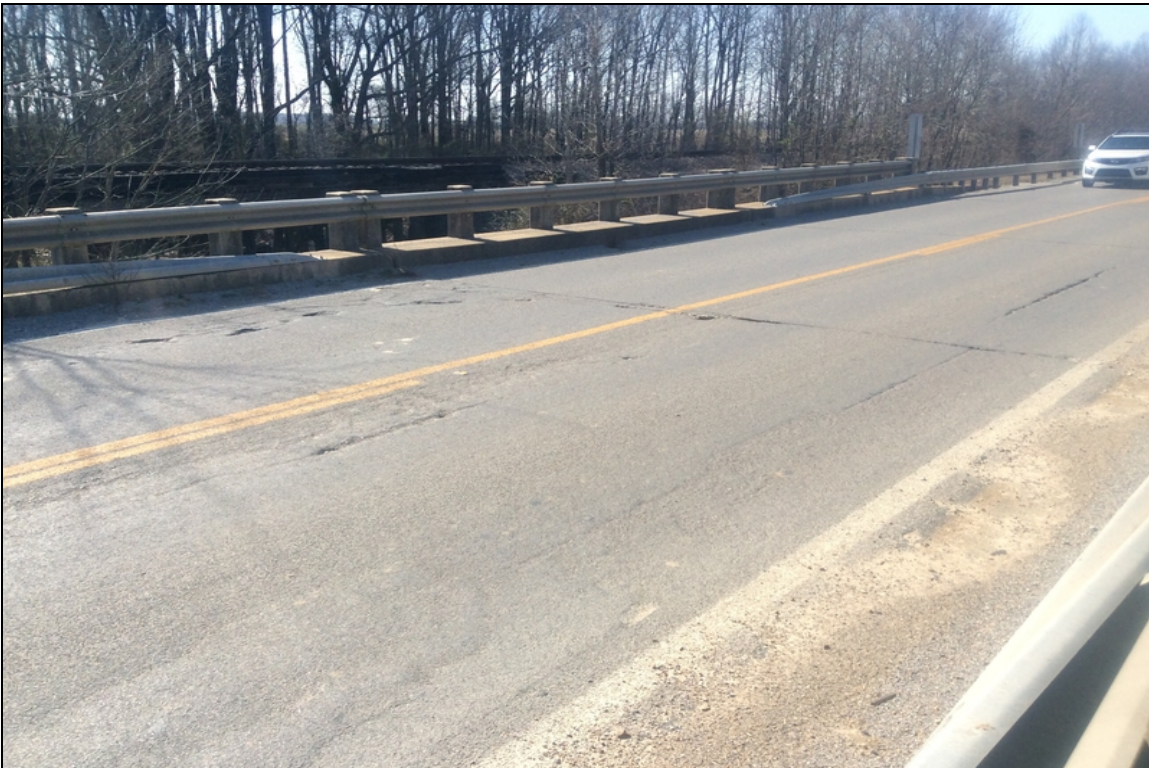
Deck view

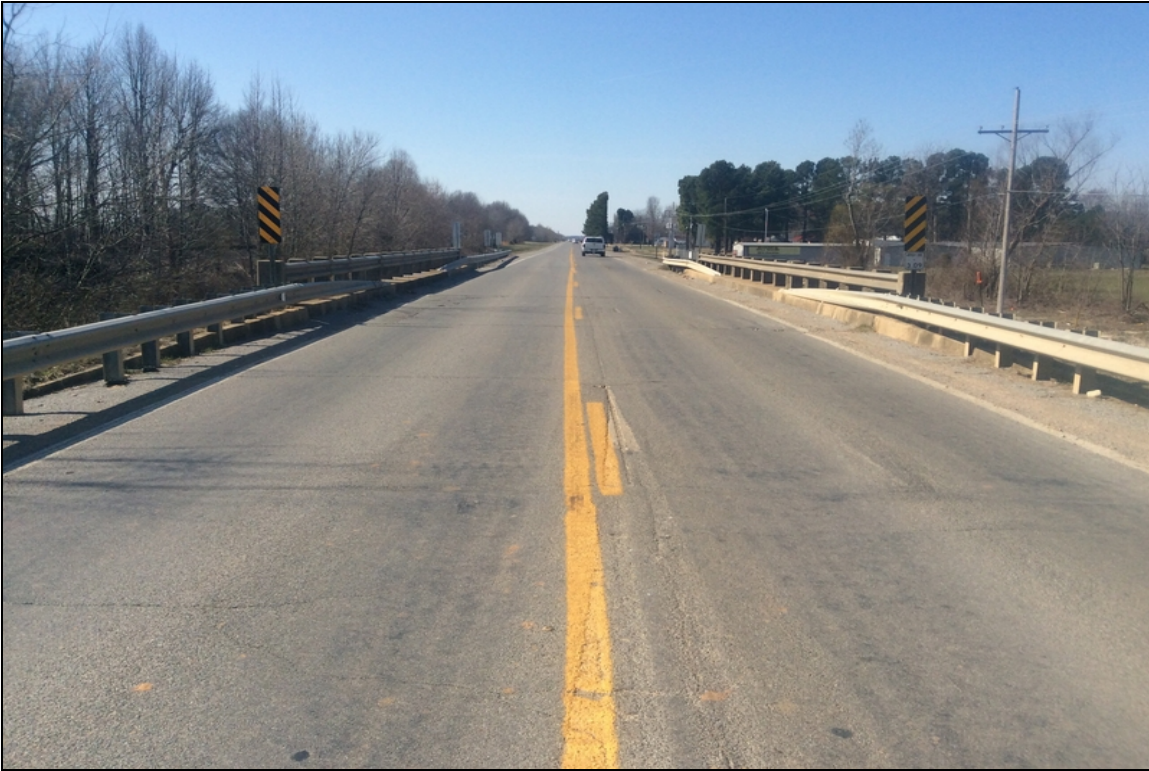
Roadway view

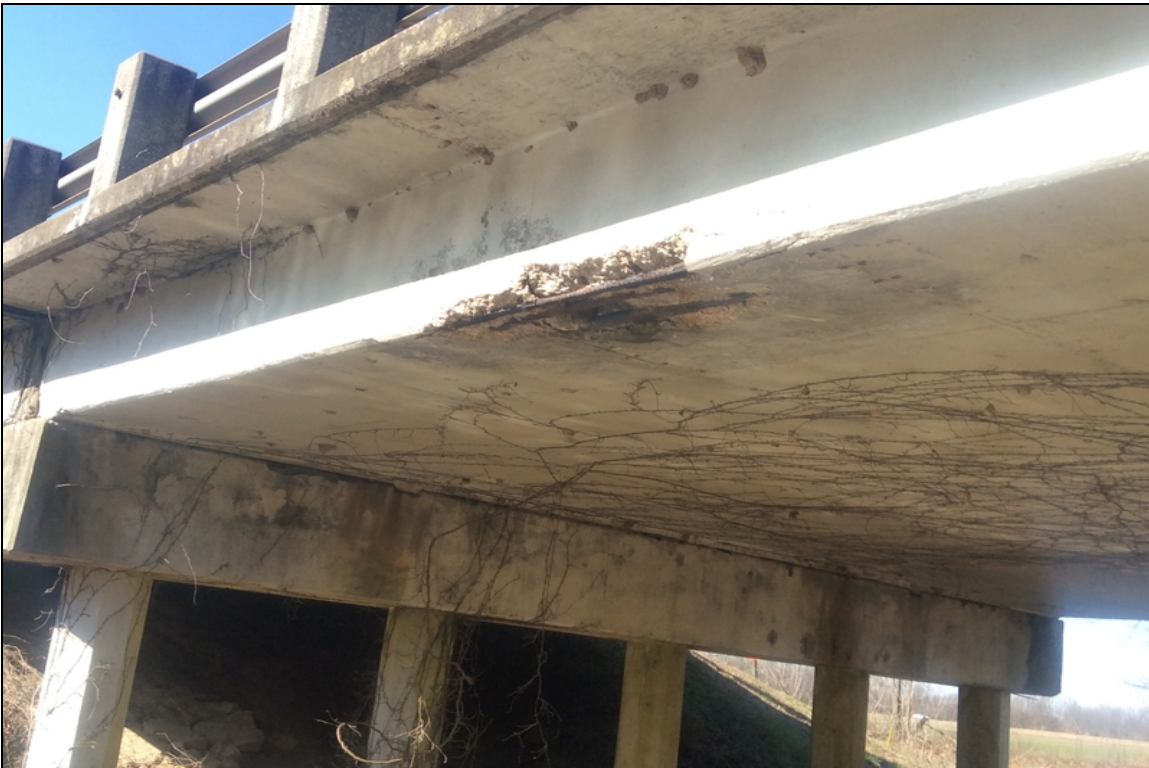
Span 2 shell out area left side to slab

Span 2 soffit has efflorescent cracks, and several small spalls with rebar exposed at drain openings and near beginning of span. Span 3 soffit has a 2' x 1' spall with rebar exposed on Rt edge over bent 3. Two shelled out rebar exposed a 2ft. x 4ft. and 1ft. x 1ft. Lt side around drain openings. Span 2 has 2ft. x 1ft. Rt. drain opening.
