Asset #M0603(Routine)

SH 25-06- LM 1.39 over CANEY CREEK

Location: 1.39 M N INDEPENDENCE COL

Team Lead: Richard Jones Inspection Date: 09/14/2023

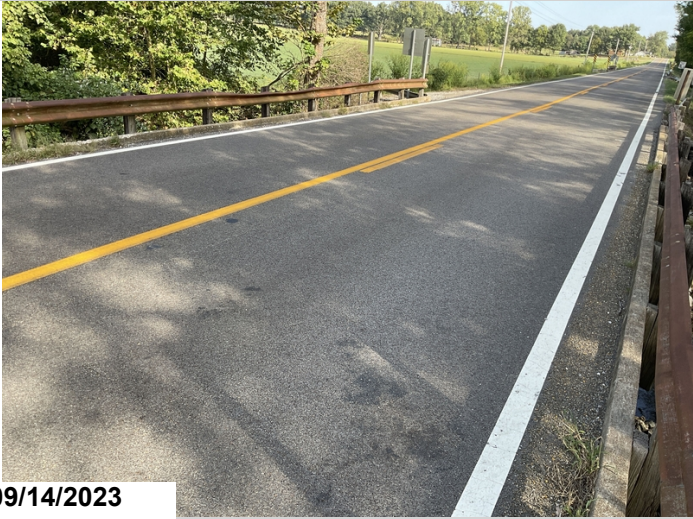
Wearing surface was milled and replaced in 2022 under job 100974.

Wearing surface

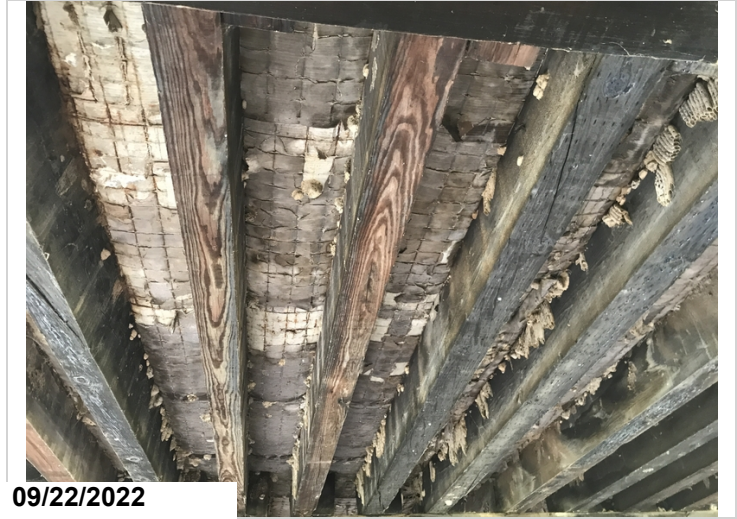
soffit

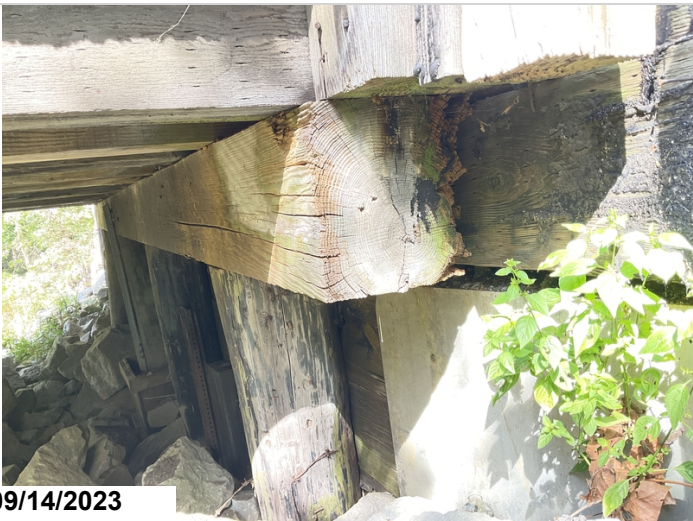
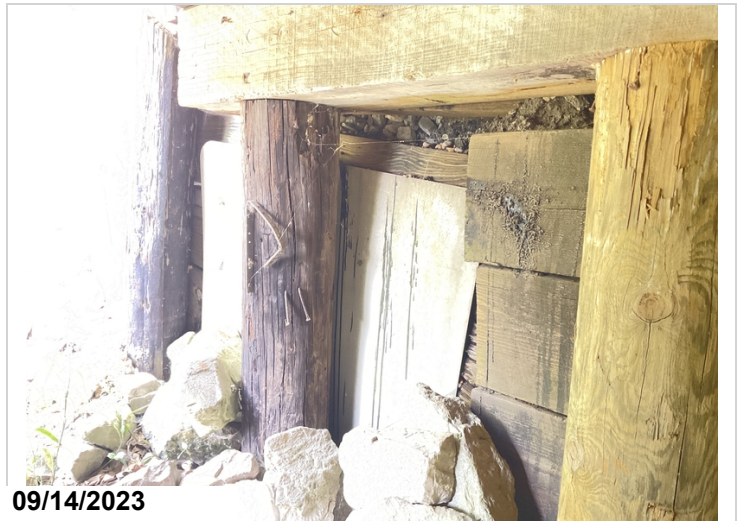
| ELEMENTS | DESCRIPTION | UNITS | TOTAL | CS1 | CS2 | CS3 | CS4 |
|---|---|---|---|---|---|---|---|
| (216) Bent 5 timber backwall between piles 1 - 4 has decay with areas of complete section loss. Some embankment settling through backwall. Lt end of backwall has 4' of section loss and losing embankment. | | | | | | | |

Bent 5 Rt

Bent 5 Lt

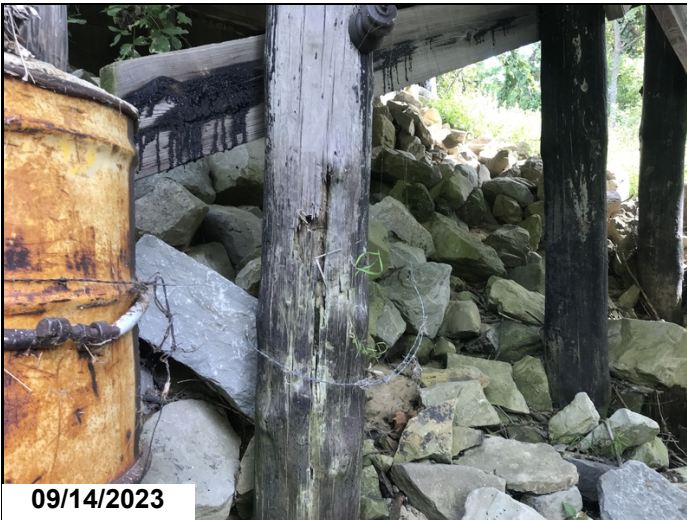
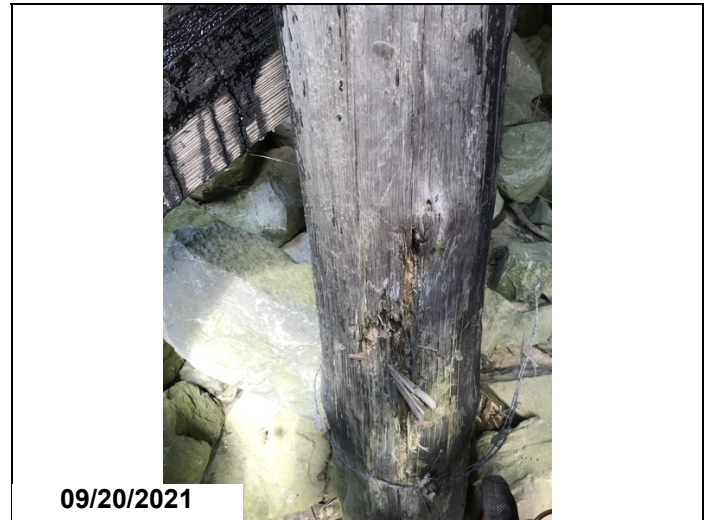
Bent 4 pile 2 has 1.25" of outside decay from ground line to x-brace connection. Pile is decayed and hollow.

2023 - Bent 4 pile 2

2021 Bent 4 pile 2

Type of Work: Piling Repair/Replace

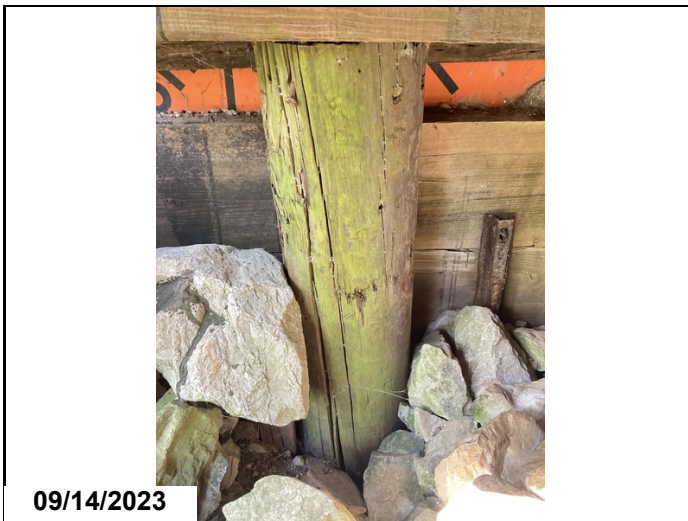
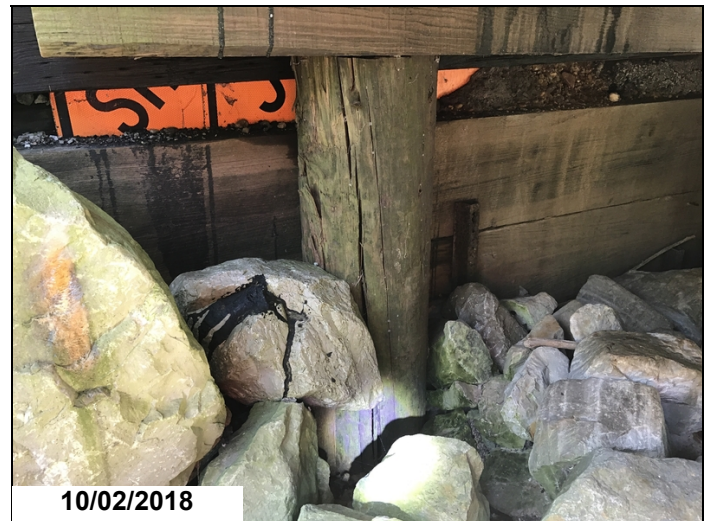
Bent 1 pile 6 is split and hollow with some crushing, (top 3' only of pile visible due to rip rap placement.) Top 3' of pile has open splits up to 1/2" wide. Pile was noted in the past as being decayed and partially hollow at splice, but splice is not visible due to being buried under rip rap.

2023 - Bent 1 pile 6

Bent 1 pile 6 2018

to Dist bridge crew for repair when their priorities will allow. KAW 11-5-18

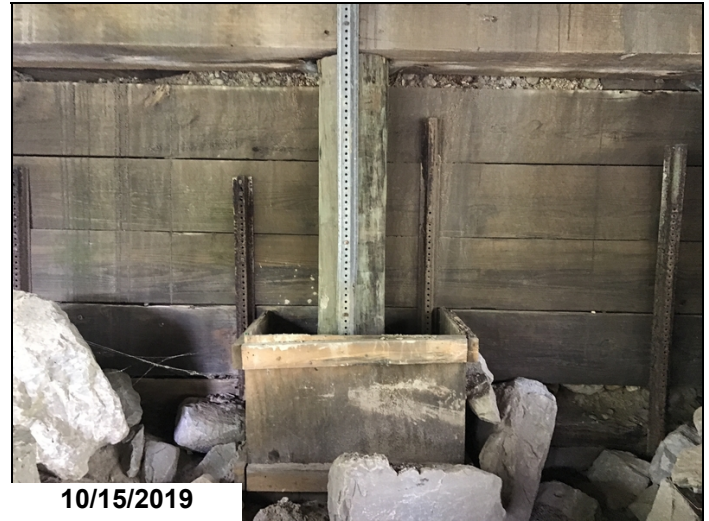
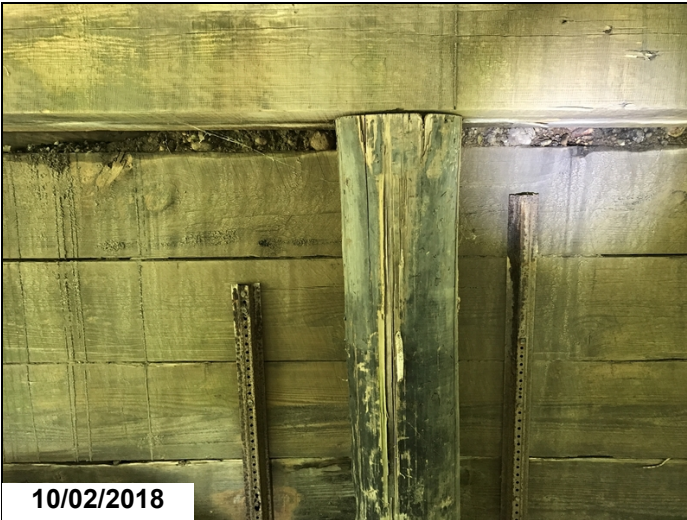
*Bent 5 pile 3 is decayed, hollow, and split with a 1.5" shell remaining.

*Bent 5 pile 3 has been repaired, see 2019 photo. JFA/CWS 10-15-2019

Bent 5 pile 3 replaced 2019

Bent 5 pile 3

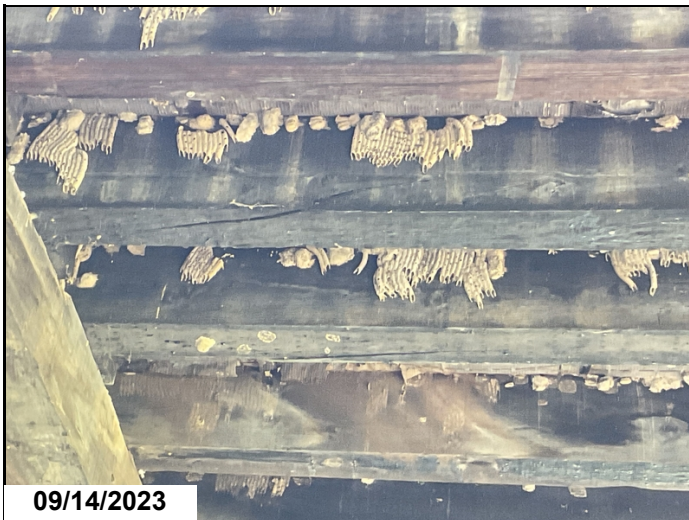
09/14/2023

Span 3 bent 3 girder 9 has a corner split on the bottom that runs halfway into girder.

Span 3 bent 3 girder 10 has corner splits on the bottom near bents 3 and 4.

2023 - Span 3 bent 3 girders 9 and 10

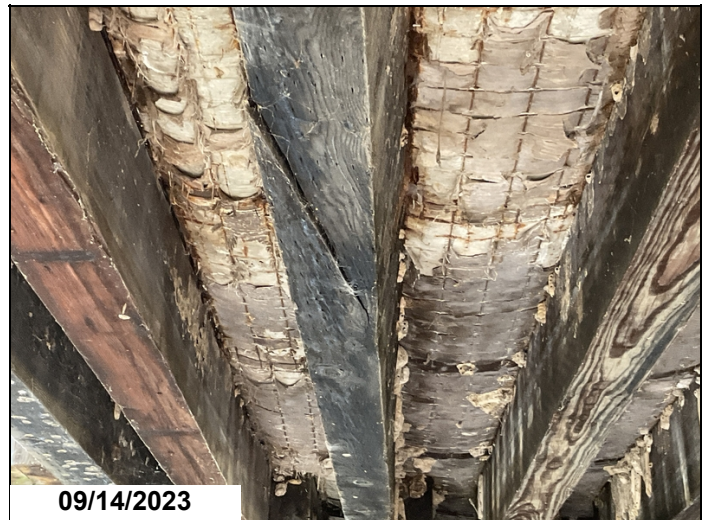
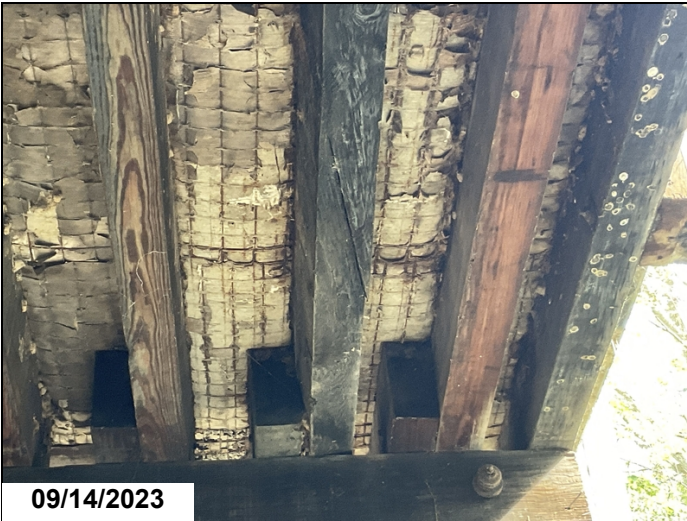
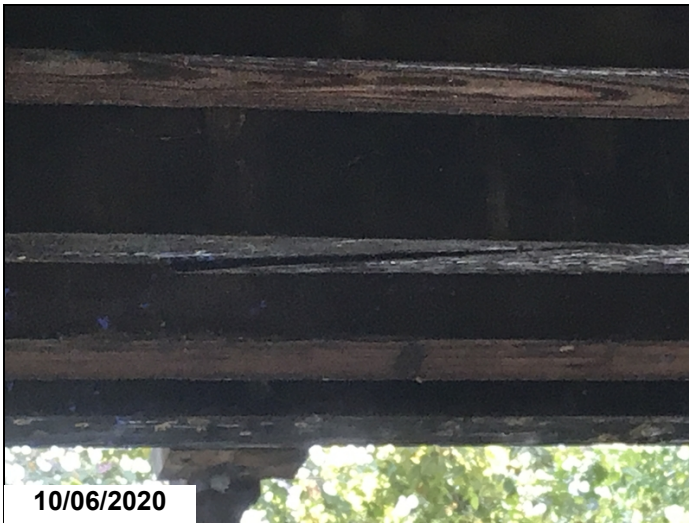
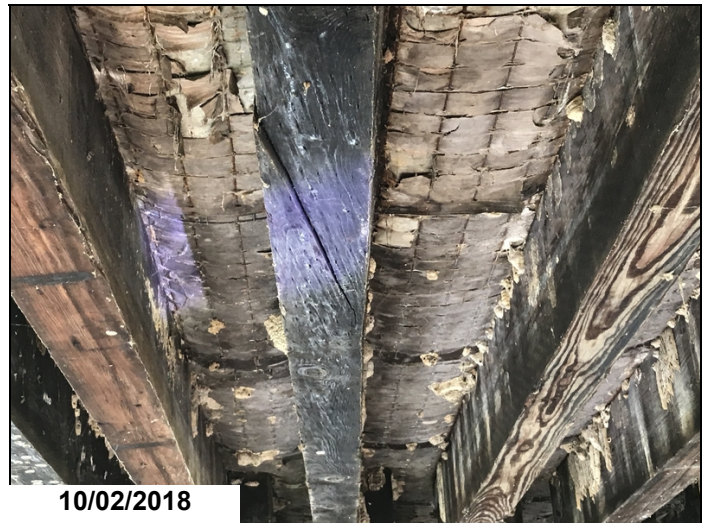
Span 3 girder 13 is broken 6' back from bent 4.

2023 - Span 3 girder 13

2023 - Span 3 bent 4 girder 13

Span 3 girder 13 near bent 4

Span 3 Girder 13 near Bent 4 2018

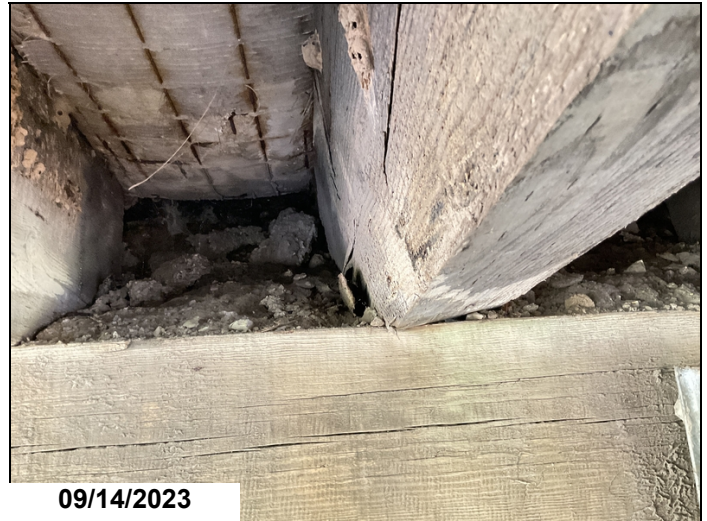
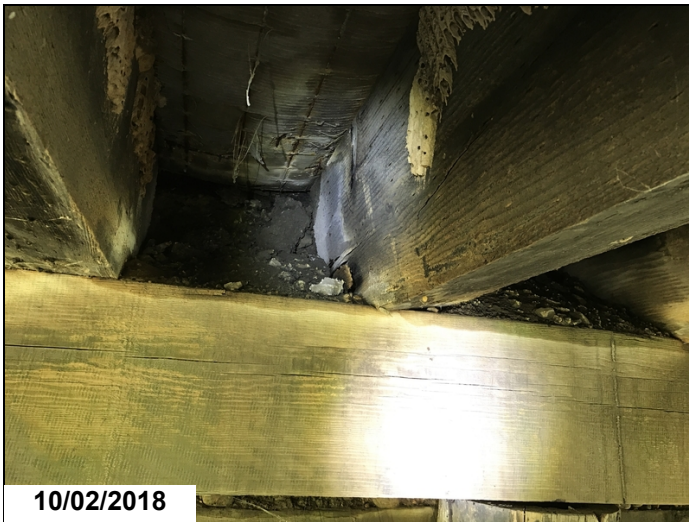
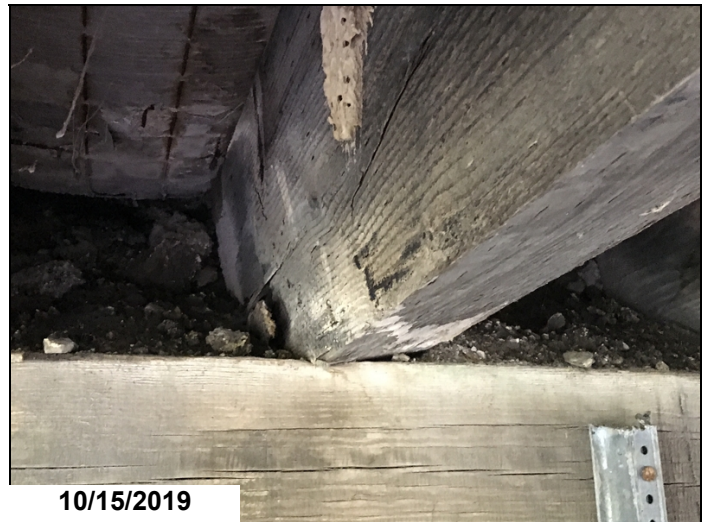
Span 4 bent 5 girder 7 is decayed with some crushing over cap. Girder is leaning to one side over cap.

2023 - Span 4 bent 5 girder 7

Bent 5 Girder 7

Span 4 girder 7 at bent 5 2019

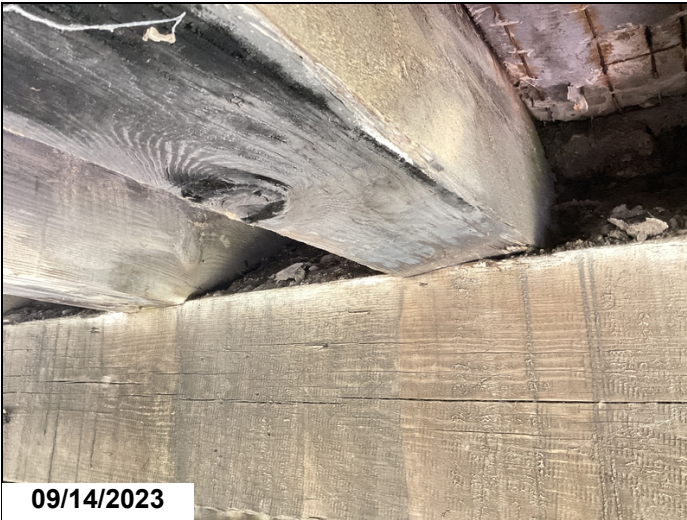
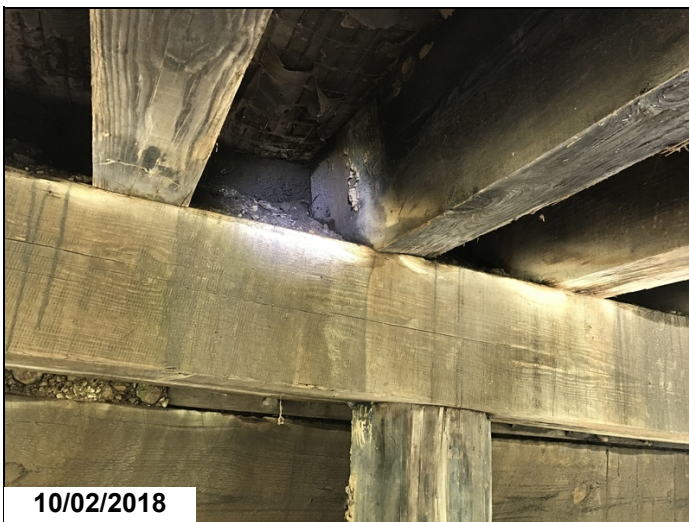
Span 4 bent 5 girder 9 is beginning to crush into cap.

Span 4 bent 5 girder 10 is decayed on the end with some crushing into the cap. Girder is leaning to one side over cap.

2023 - Span 4 bent 5 girders 9 and 10

Bent 5 Girder 10

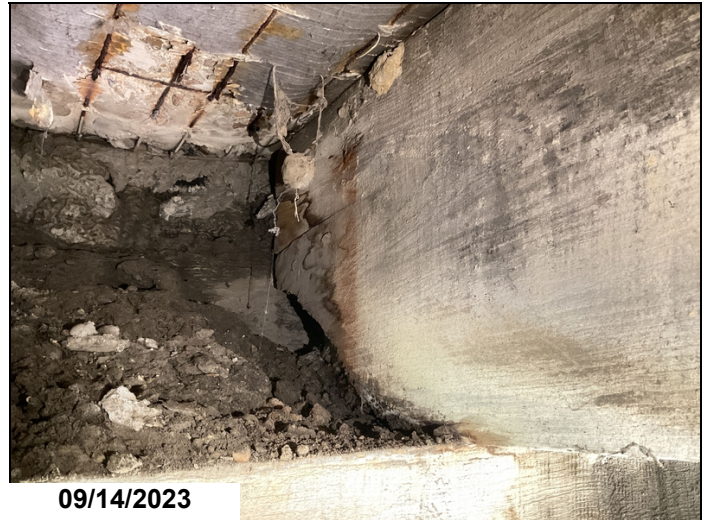
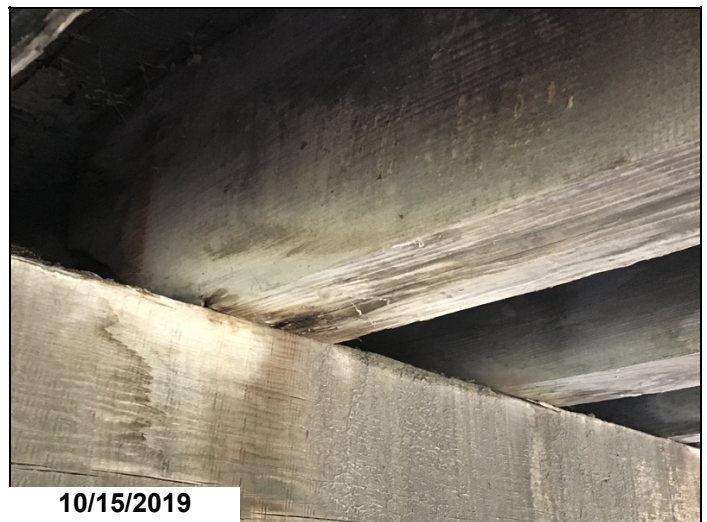
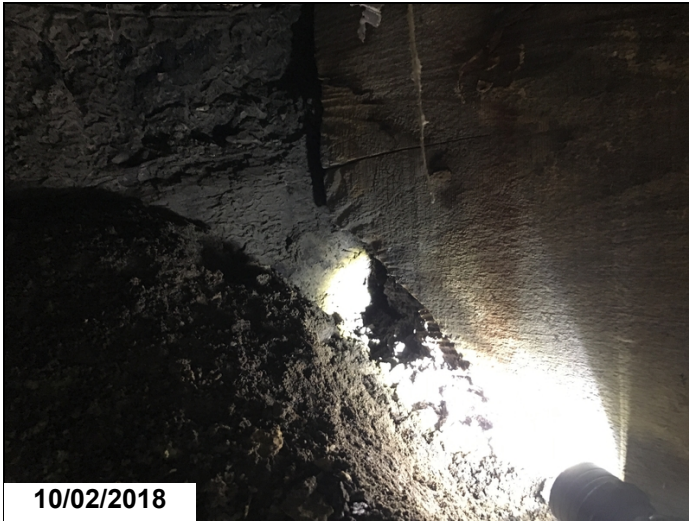
Span 4 bent 5 girder 11 is decayed and hollow at end on bottom of girder.

2023 - Span 4 bent 5 girder 11

Span 4 girder 11 at bent 5 2019

Bent 5 Girder 11

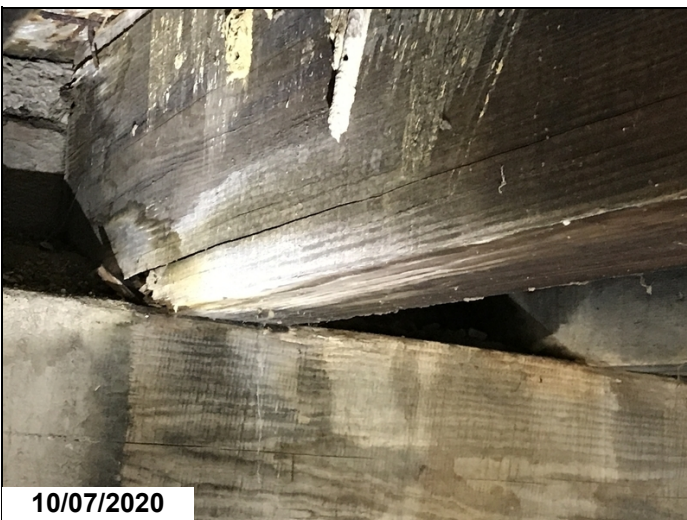
Span 1 bent 1 girder 11 has 4' of decay. Bottom 2" of girder is hollow over cap with some minor crushing.

Span 1 girder 11 bent 1 2020

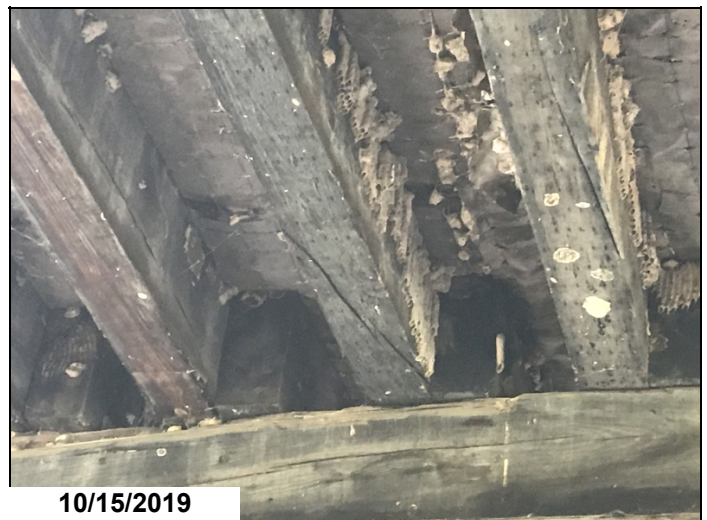
Span 3 girder 10 at bent 3 2019

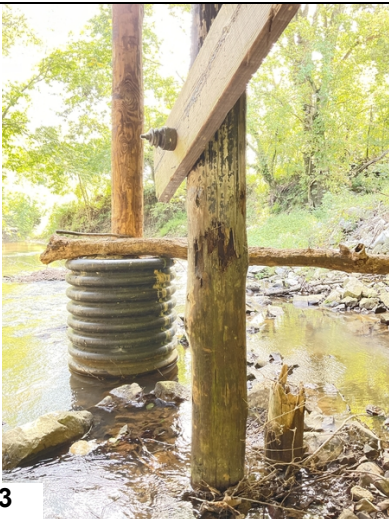
Bent 3 pile 4 has up to 2" of outside decay with some section loss near sway brace.

2023 - Bent 3 pile 4

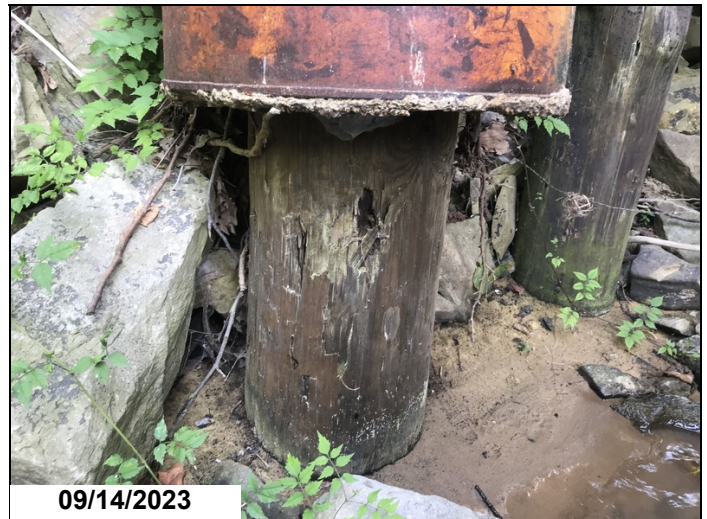
Bent 4 pile 1 was spliced in the past but has some outside decay below the splice.

2023 - Bent 4 pile 1 below splice

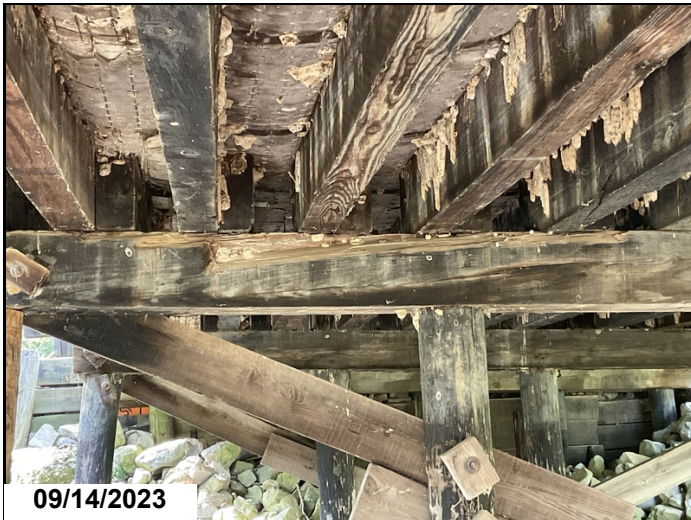
Bent 3 cap top corner on ahead side is split with section loss up to 3" deep from girder 10-14.

2023 - Bent 3 cap ahead

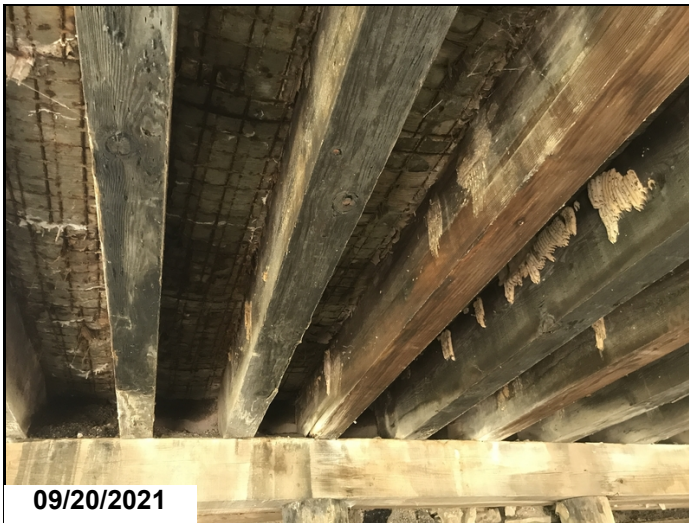
Girder ends over end bents have moderate decay.

2021 - S1 b1 g9-13

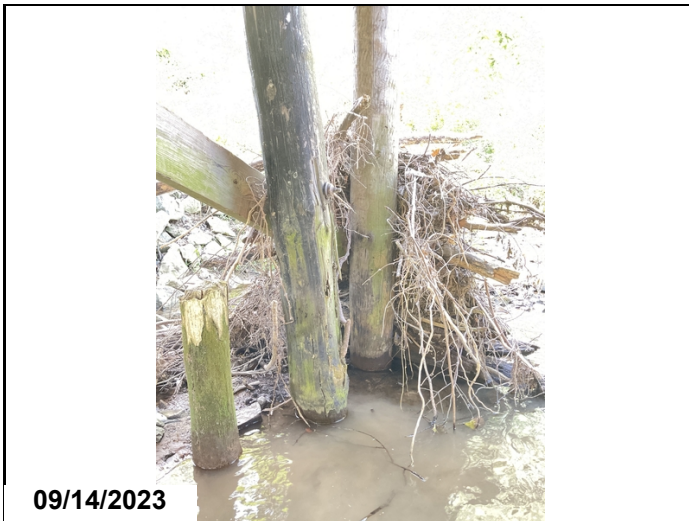
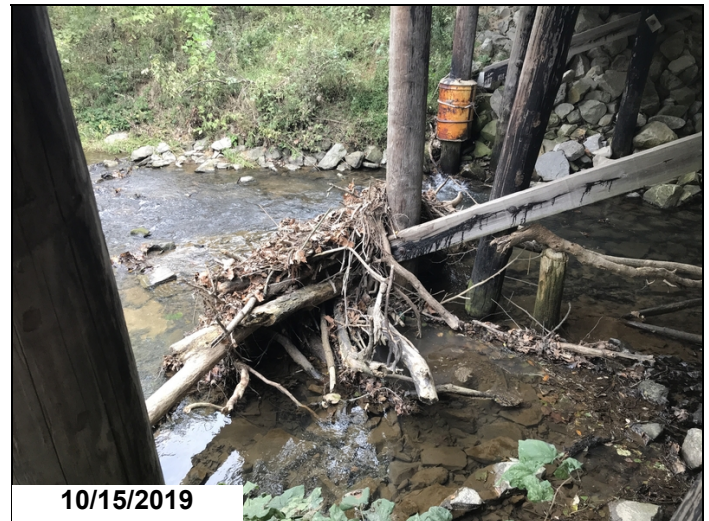
Moderate drift buildup at bent 3.

Bent 3 pile 1 has drift piled up.

2023 - Bent 3 piles 1 and 2

Bent 3 drift LT SIDE 2019

Type of Work: Channel Work/Drift Removal
