Asset #M3317(Routine, Underwater type 2)
SH 25-06- LM 14.30 over LITTLE CYPRESS CREEK
Location: 3.5 MI NE OF LYNN
Team Lead: Richard Jones Inspection Date: 10/03/2023

Asset #M3317(Routine, Underwater type 2)

SH 25-06- LM 14.30 over LITTLE CYPRESS CREEK

Team Lead: Richard Jones Inspection Date: 10/03/2023

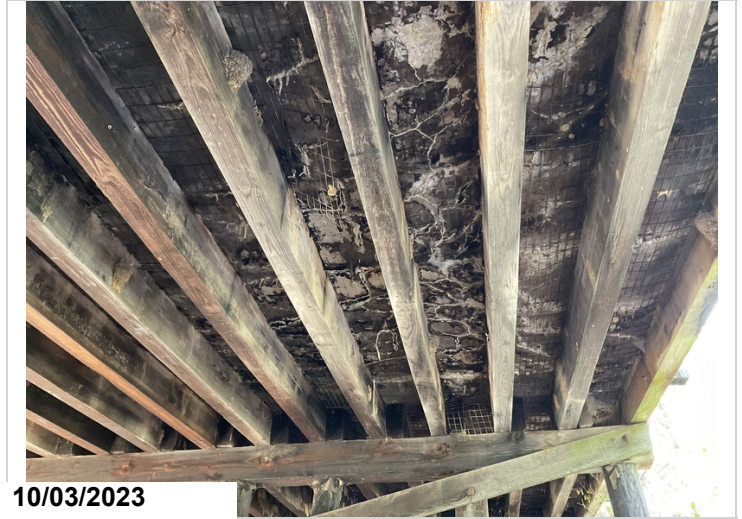
Span 2 soffit

(12) Soffit has numerous map cracks with efflorescence and some rust stains. Lt and Rt edges of deck have concrete disintegration over exterior girders. Deck has a 3' x 1' hole through deck over bent 5 between girders 1 and 2. (510-12) Asphalt wearing surface was milled and replaced under job 100974 in 2021.							
111	Timber Open Girder/Beam	LF	1605	1366	4	21	214
1140	Decay/Section Loss	LF	216	0	0	2	214
1150	Check/Shake	LF	19	0	0	19	0
1170	Split/Delamination (Timber)	LF	4	0	4	0	0

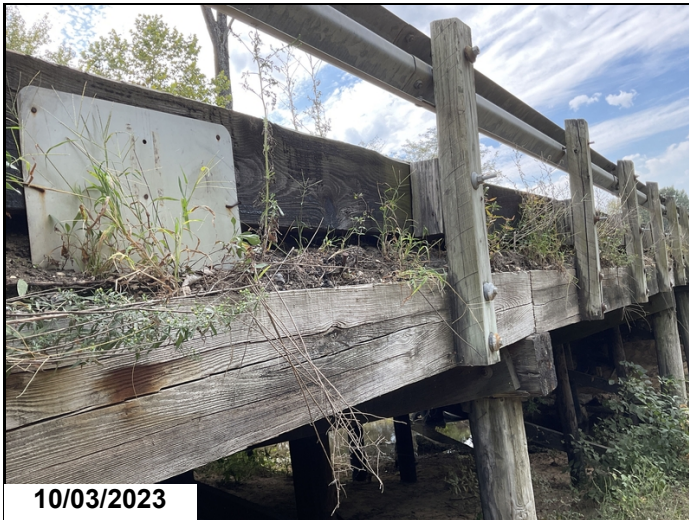
Typ edge of deck

Lt and Rt edges of deck have concrete disintegration over exterior girders. See elements

Lt and Rt edges of deck have concrete disintegration over exterior girders.
Deck has a 3' x 1' hole through deck over bent 5 between girders 1 and 2.

Type of Work: Replace (General)

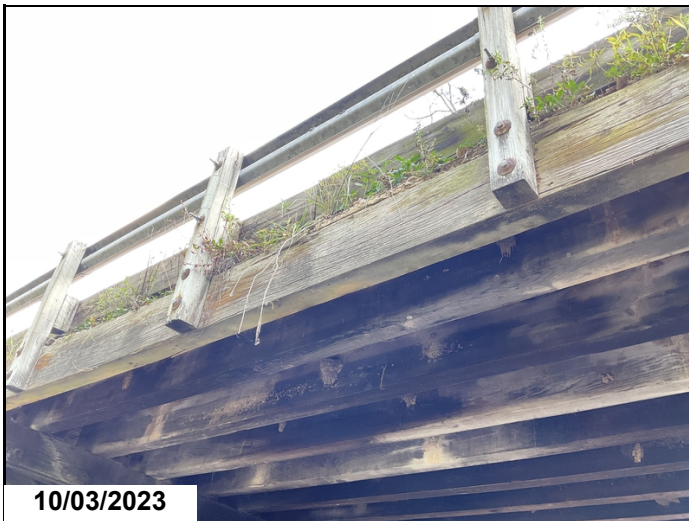
2023 - Span 3 girder 1

Exterior girders (1 and 15) at all spans are decayed and hollow. Vegetation is growing out of tops of girders. See elements

Exterior girders (1 and 15) at all spans are decayed and hollow. Vegetation is growing out of tops of girders. Span 1 bent 1 girder 15 over bent 1 is decayed and hollow at bolted connection to bridge rail post. Span 6 bent 7 girder 6 is decayed and hollow on bottom over cap.

Type of Work: Superstructure Repair

to District Bridge Crew for repair when other priorities allow KAW 10/24/19

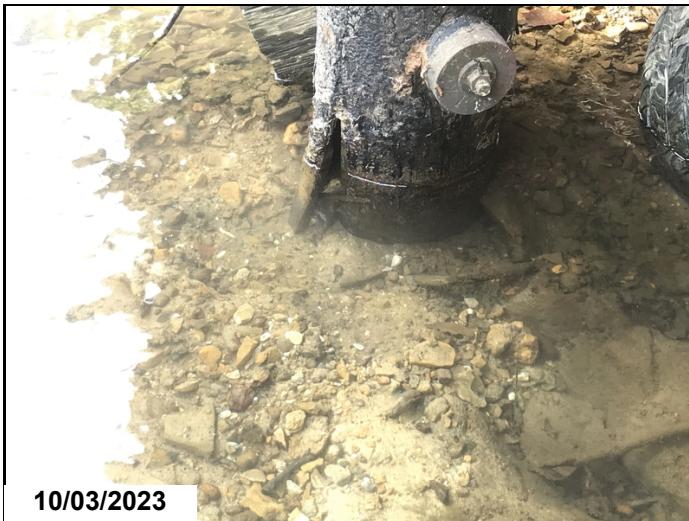
2023 - Bent 3 pile 7

Bent 1 pile 1 is decayed and hollow.
Bent 1 pile 7 is decayed, hollow, and has approximately 40% section loss.
Bent 3 pile 7 has a delaminated area/split near ground line.
Bent 7 piles 2 and 7 are decayed and partially hollow.

Type of Work: Piling Repair/Replace

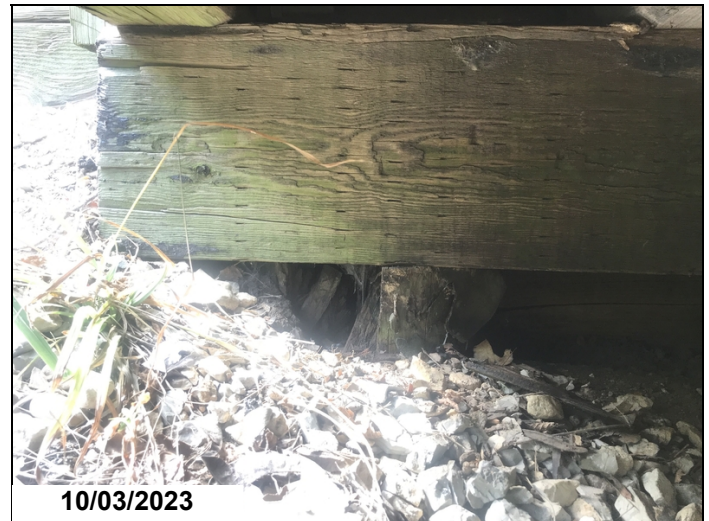
2023 - Bent 1 pile 7

(228) Bent 1 pile 1 is decayed and hollow. Bent 1 pile 7 is decayed, hollow, and has approximately 40% section loss. Bent 1 pile 2 has some core decay and up to 1" of outside decay at ground line. Bent 2 pile 6 has 1" outside decay near ground line on back side. Bent 3 pile 6 was driven out of plumb. Bent 3 pile 7 has a delaminated area/split near ground line. Bent 4 pile 1 is decayed and partially hollow. Bent 4 x brace has a large split at pile 5 on ahead side. Bent 7 piles 2 and 7 are decayed and partially hollow.

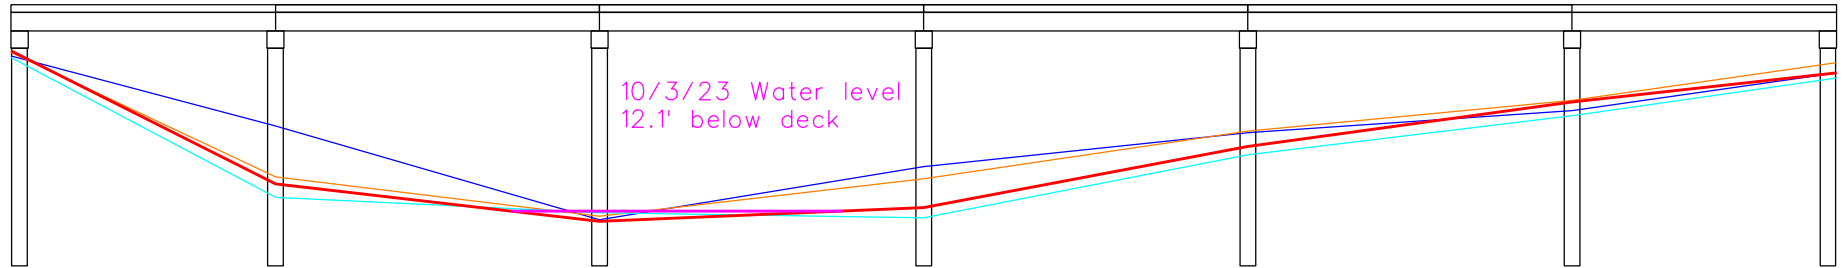
Channel has had some scour since 1972.

Channel soundings taken from top of deck on Rt side (downstream side)
