**Bridge #00431 (Routine)**  
**US 67-20- LM 10.39 over Cypress Creek**  
**Location: West city limits, Corning**

**Team Lead: Richard Jones Inspection Date: February 07, 2017**

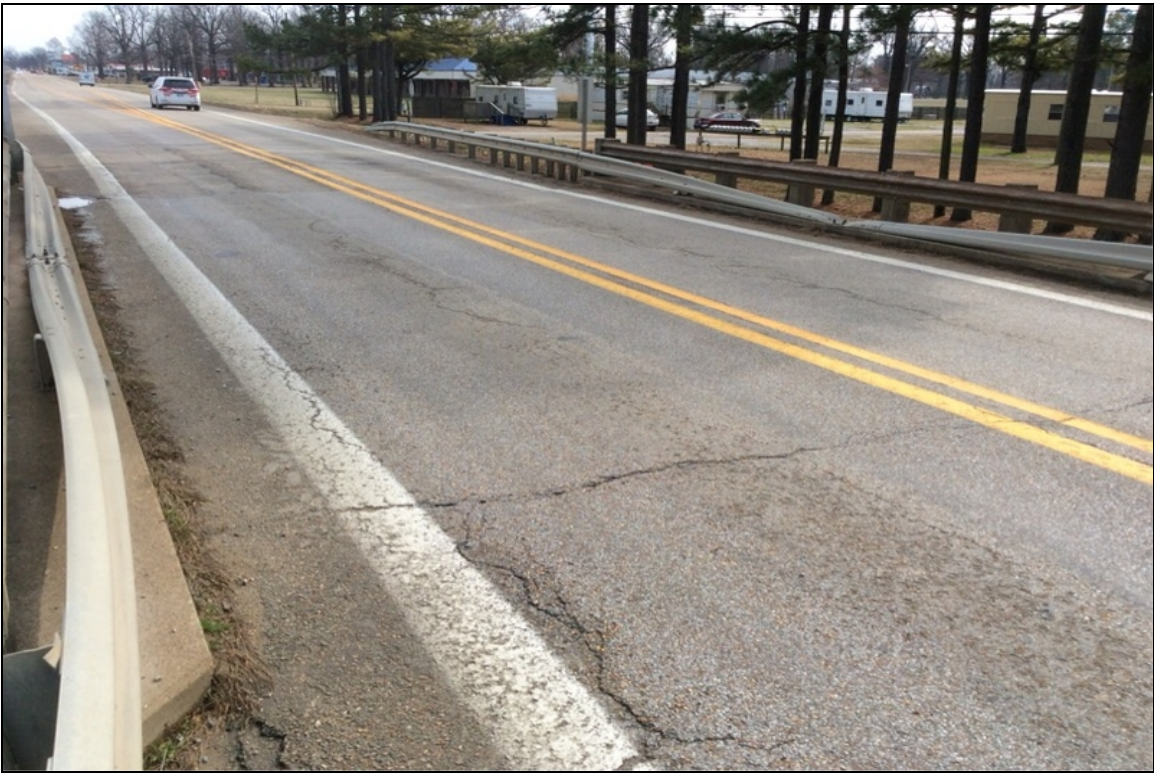
Deck/wearing surface

Deck with asphalt  
overlay has several open unsealed cracks.
