Bridge #00432(Routine)

US 67-20- LM 9.50 over MIDDLE CREEK

Location: 1.5 MI W OF CORNING

Team Lead: Richard Jones Inspection Date: February 07, 2017

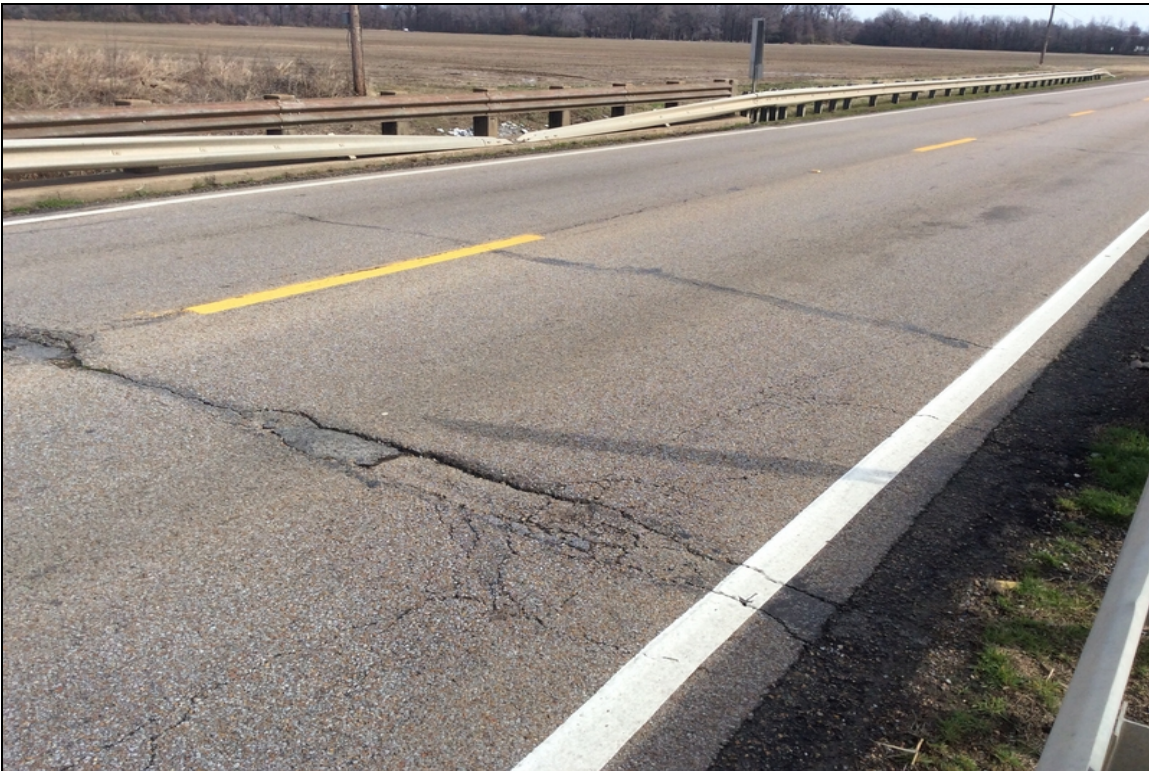
Deck/wearing surface

Deck with asphalt overlay has some sealable cracks.
