Bridge #00496(Routine)

US 67-19- LM 7.31 over CURRENT RELIEF

Team Lead: Richard Jones Inspection Date: January 09, 2020

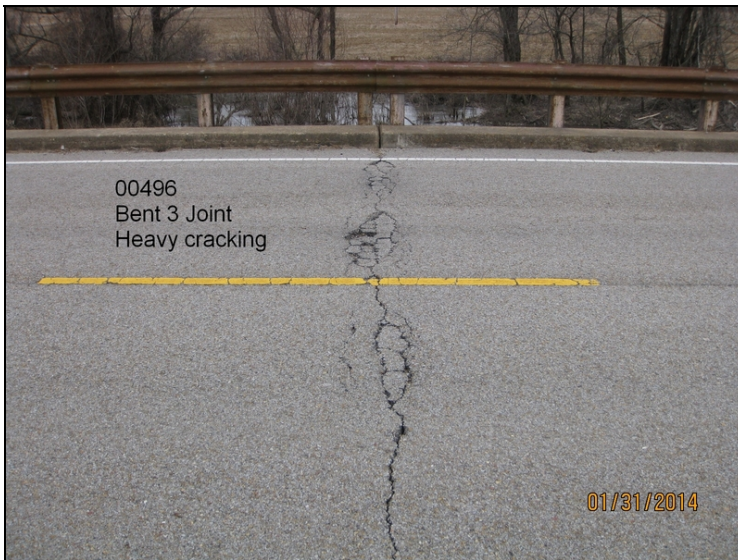
Joint over bent 3

Asphalt overlay has transverse cracks over joints. Asphalt is raveling out in a few places over joints. Asphalt has areas of map cracking/rutting in wheel path.

Asphalt overlay has transverse cracks over joints. Asphalt is raveling out in a few places over joints.
Asphalt has areas of map cracking/rutting in wheel path.
Metal bridge rail and posts have surface rust throughout.
Overhangs have a few minor spalls some with rebar exposed.

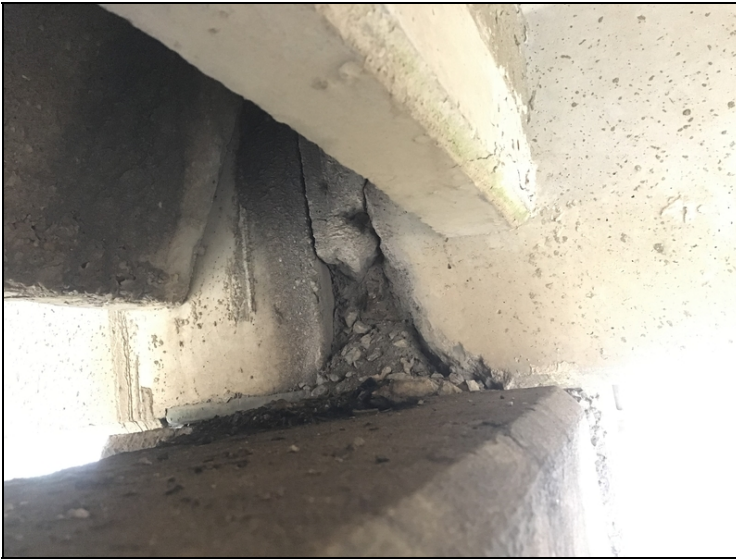
Span 5 bent 5 girder 5

Fixed ends of concrete girders have moderate sized diagonal cracks/spalls over bents. Most have had patches/extensions added to caps under girders in the past. Ends of a few girders have been patched in the past with grout.

Fixed ends of concrete girders have moderate sized diagonal cracks/spalls over bents. Most had patches/extensions added to caps under girders in 2007. Ends of a few girders have been patched in the past with grout.
Concrete diaphragms have several cracks over bents, some with efflorescence.
Span 2 soffit has a spall with rebar exposed between girders 5 and 6.
