Bridge #00497 (Routine)
US 67-19- LM 6.56 over SALLEE SLOUGH

Team Lead: Tim Myrick Inspection Date: May 14, 2018

Bridge #00497 (Routine)

Inspection Comments

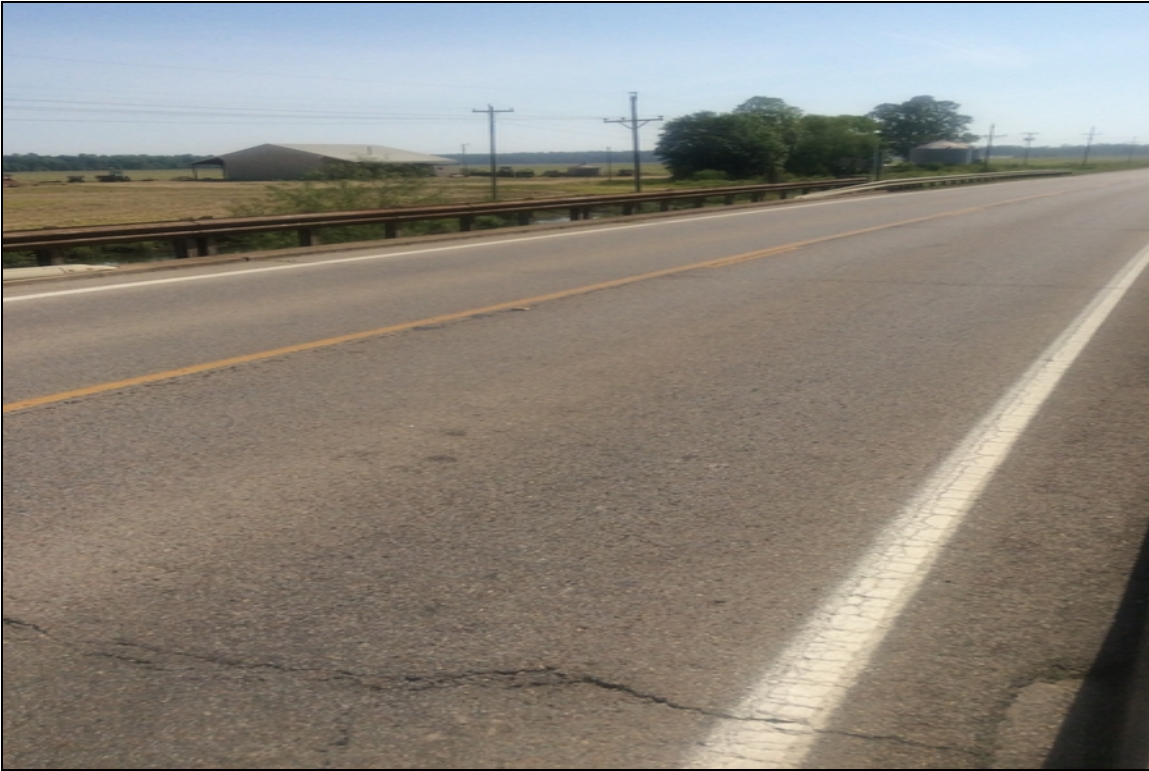
Deck view

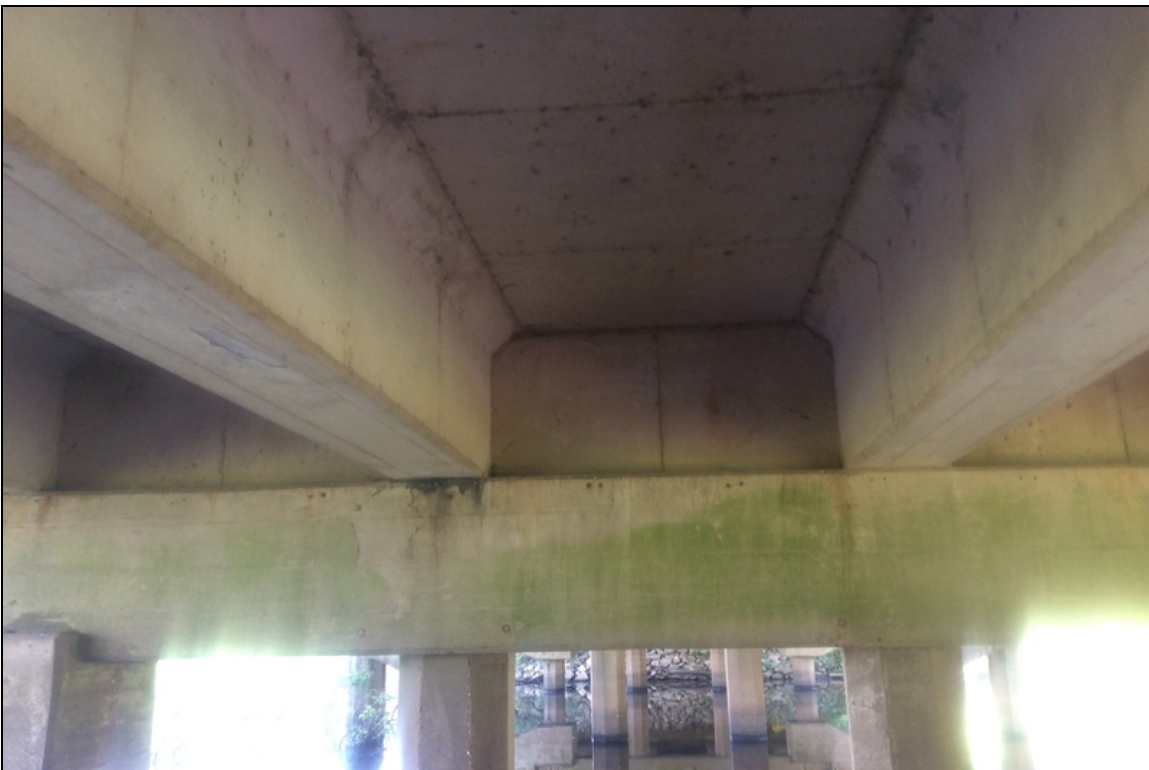
Underneath deck view

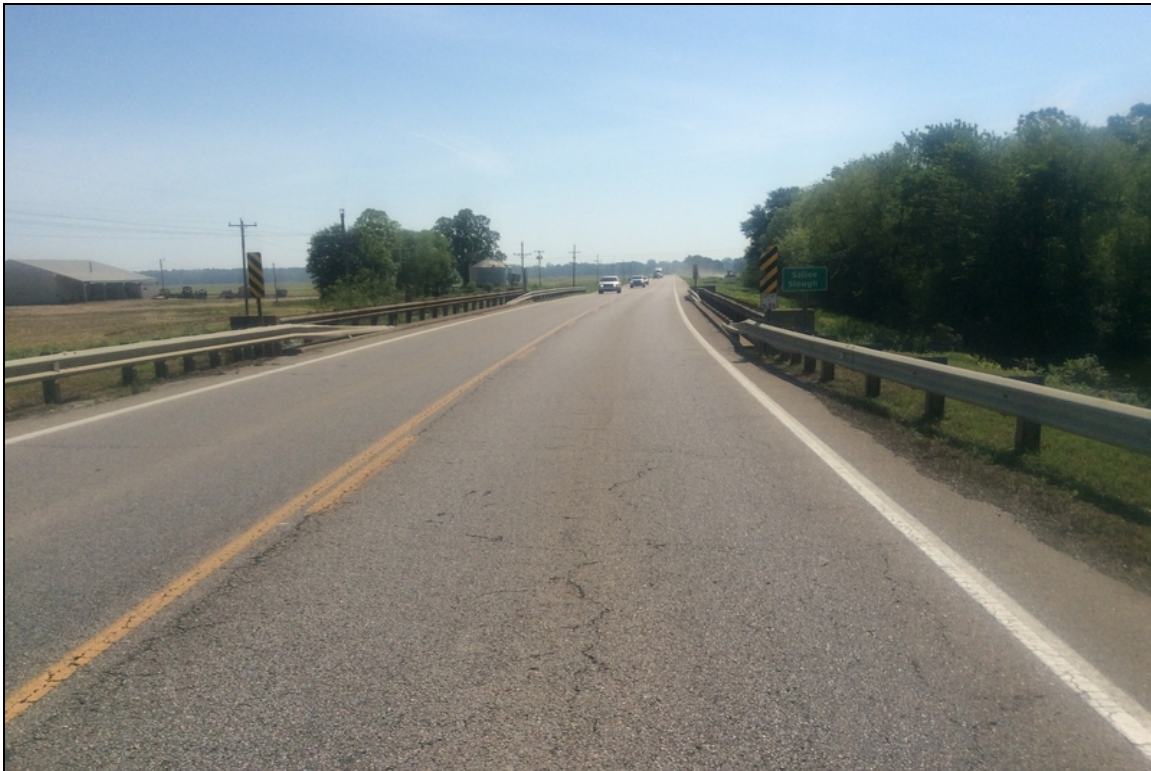
Roadway view
