Bridge #00498(Routine)

US 67-19- LM 6.48 over LEIBHABER SLOUGH

Team Lead: Tim Myrick Inspection Date: May 14, 2018

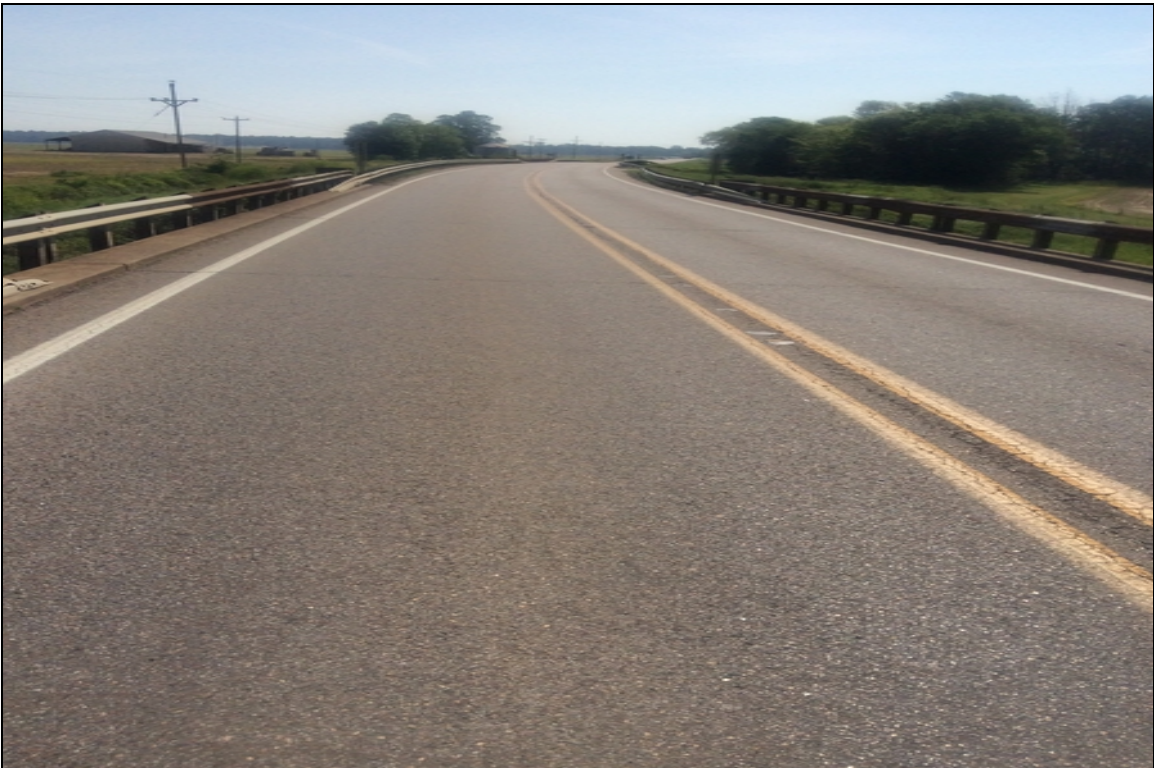
Deck view

Routine inspection 2018 Concrete deck with asphalt overlay has a few moderate size cracks in asphalt overlay, mainly over joints and centerline. Concrete soffit, Span 4, Bay 2 near Bt. 4 has a 2 ft. x 6 in. spall with exposed rebar. Concrete soffit has a few insignificant cracks with efflorescence. Bridge rail are 50% rust covered with pitting.
