Bridge #00499(Routine)
US 67-19- LM 6.14 over Pheffer Bottom
Location: 6.08 MI NE JCT US 62 & 67

Team Lead: Tim Myrick Inspection Date: May 14, 2018

IDENTIFICATION	
(1) State Names	Arkansas
(8) Structure Number	00499
(5) Inventory Route	67
(2) Highway Agency District	10
(3) County Code	121-Randolph County, Arkansas

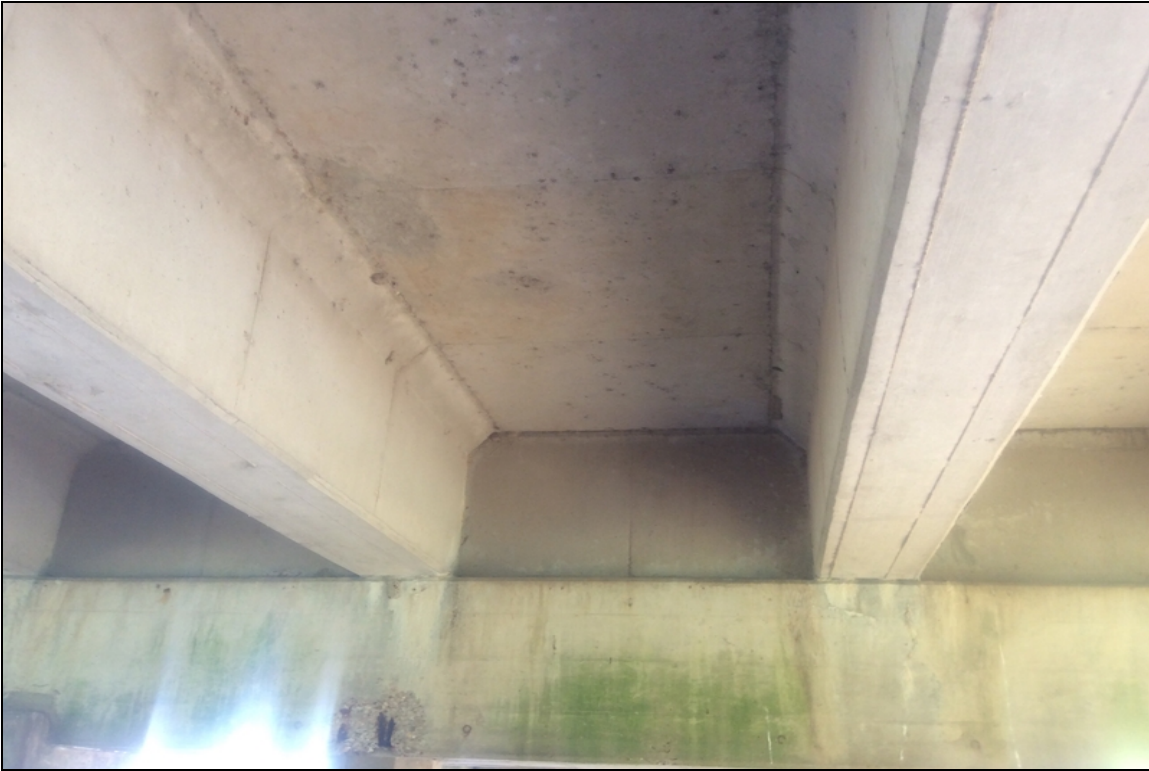
Underneath deck view

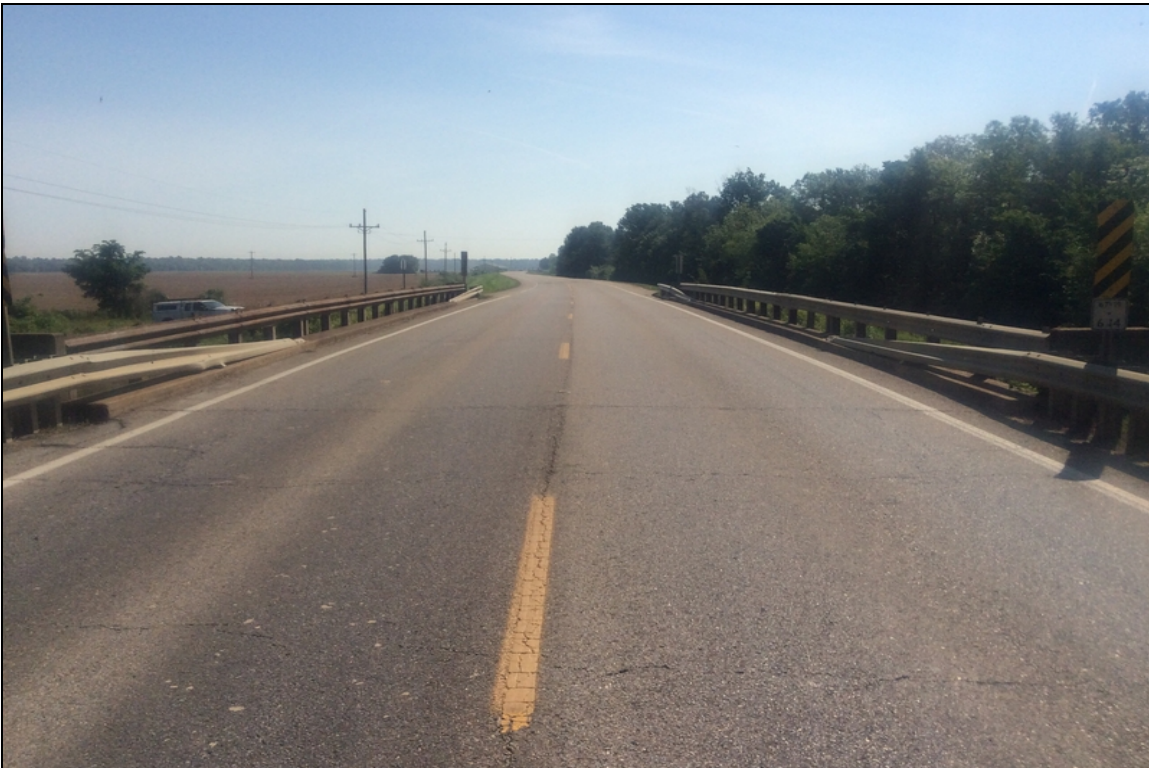
Roadway view

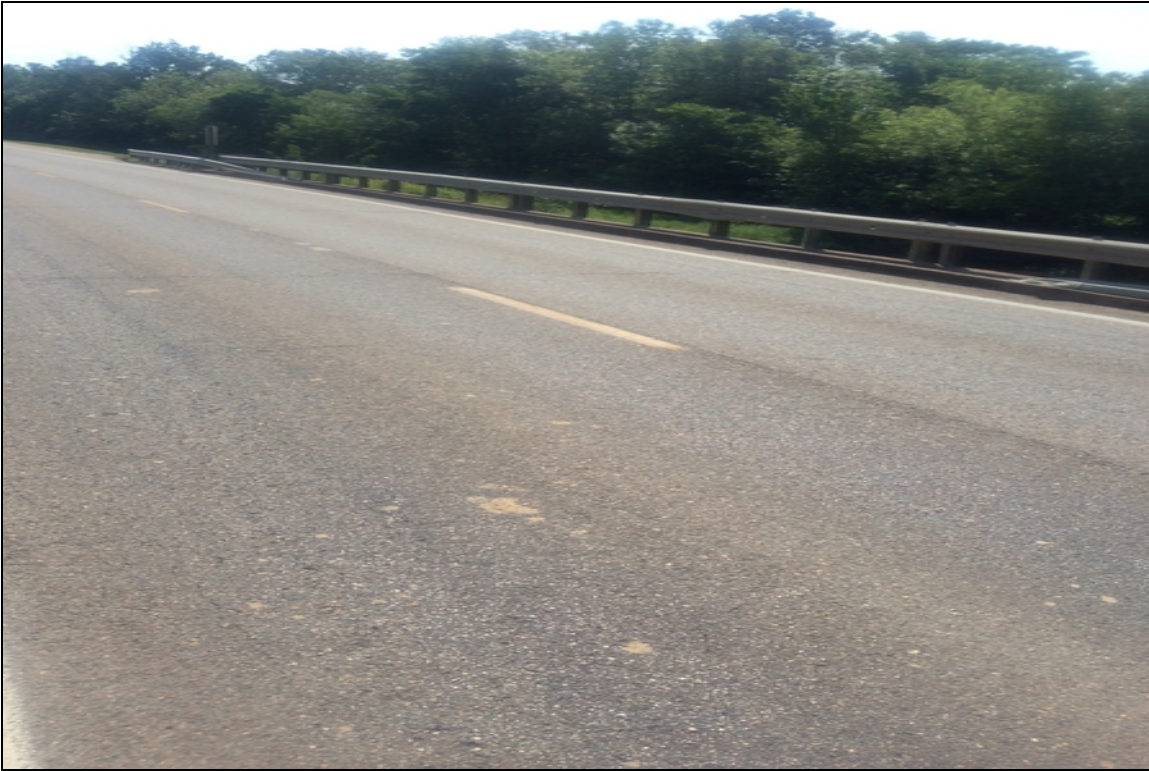
Deck view
