Bridge #00500(Routine)

US 67-19- LM 5.63 over BEAVER DITCH

Team Lead: Richard Jones Inspection Date: January 09, 2020

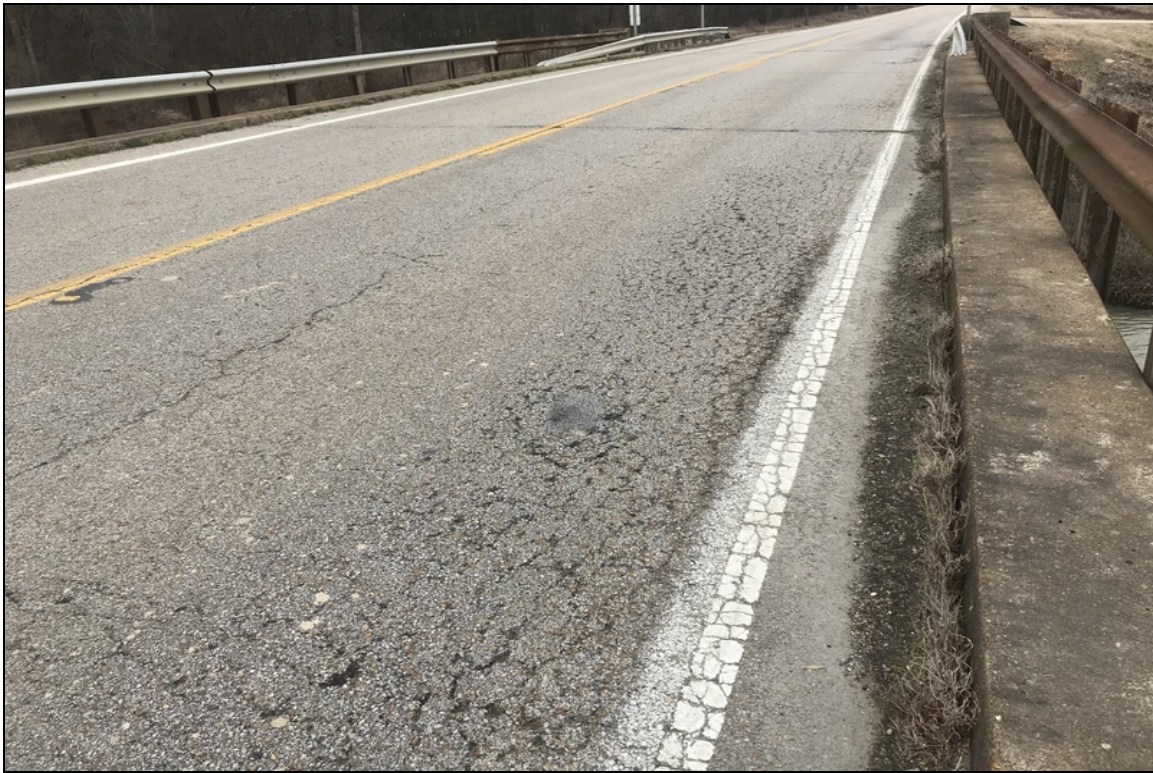
Map crack / rutting

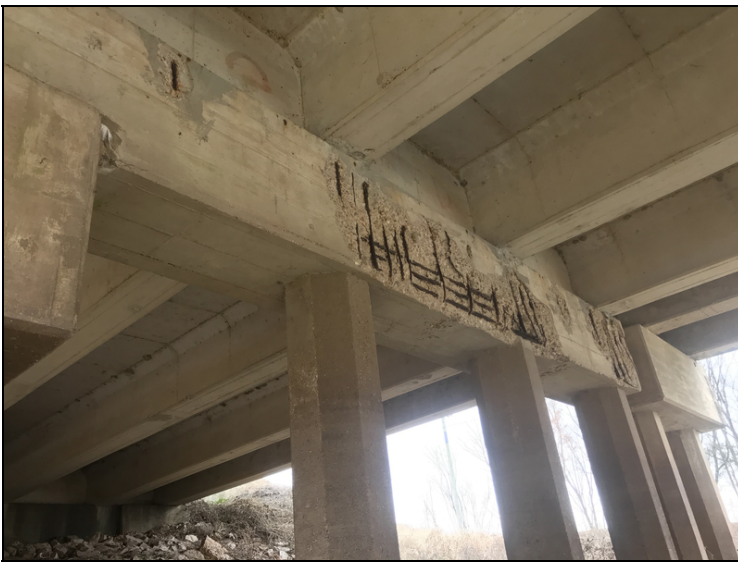
Bents 2, 3, and 4 concrete caps have a few spalls and delaminated areas.

Bent 4 cap has 14' of rebar exposed on back face. Stirrup bars have heavy section loss. These areas have been patched in the past, but patches have spalled out.

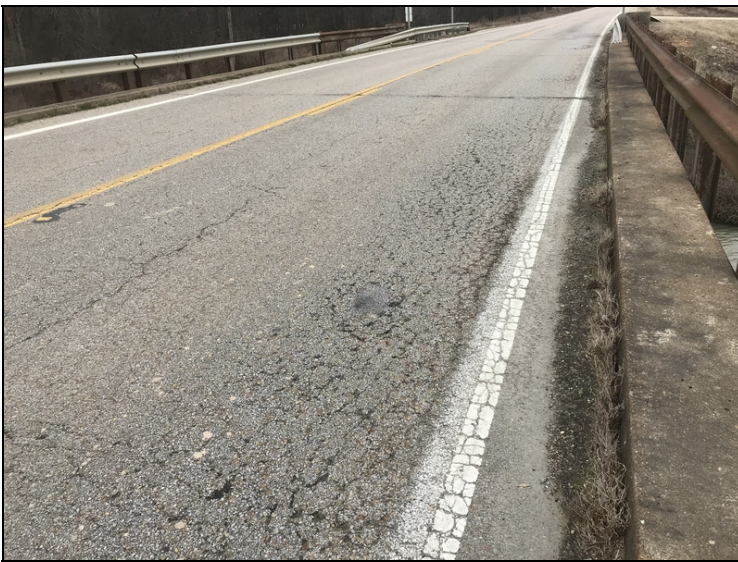
Asphalt wearing surface has several longitudinal and transverse cracks. Asphalt has map cracking and rutting in wheel paths with a few patched areas.

Map crack / rutting
