Bridge #00501(Routine)

US 67-19- LM 4.85 over MULE DITCH

Team Lead: Tim Myrick Inspection Date: May 11, 2017

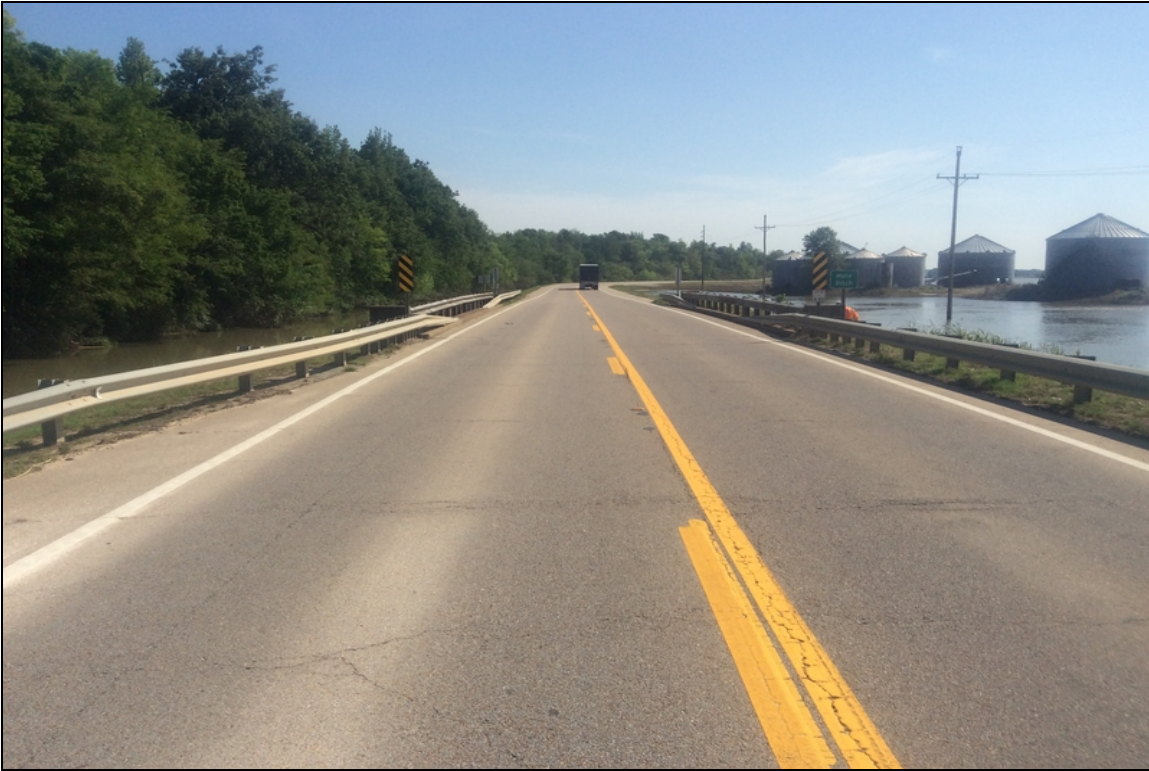
Wearing surface asphalt overlay has minor – moderate sized cracks over joints and in wheel path. Metal rail has minor surface corrosion.

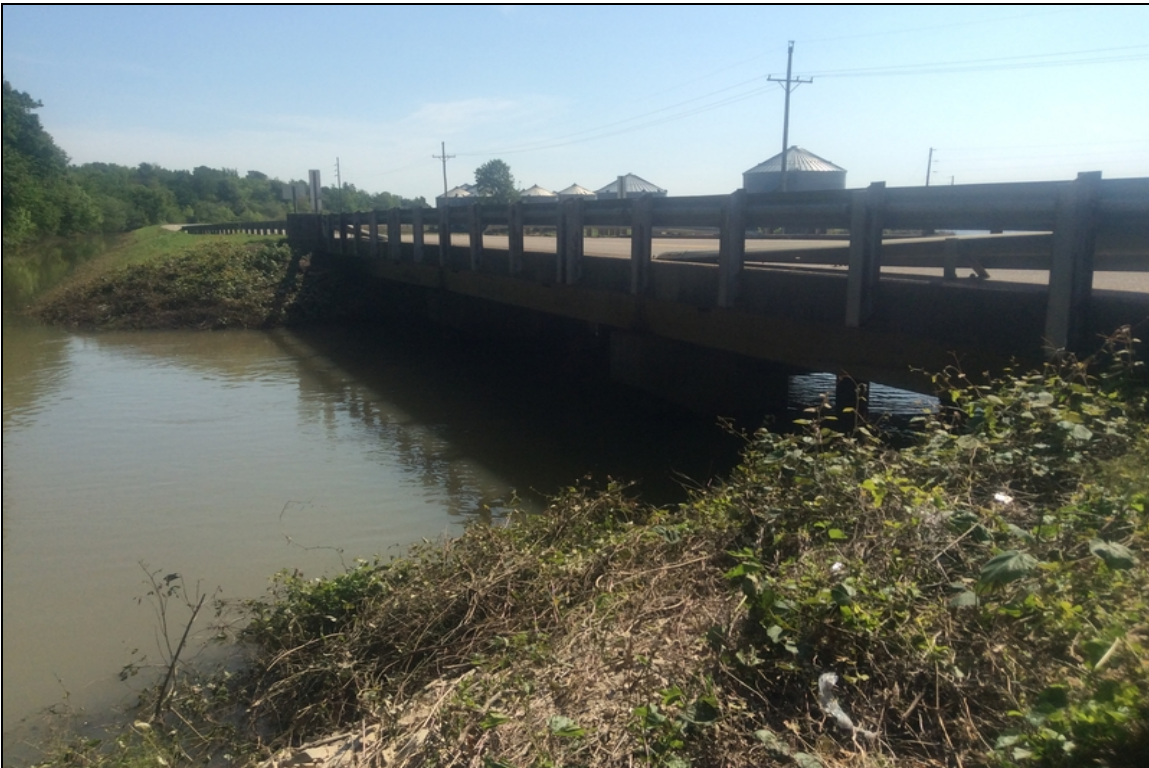
Lt. side of Bent 1 abutment Void under Roadway 1 ft. deep X 3 ft. back under at white line width is unknown, See photo 2017. Bent 2 cap has 3 small delaminated areas under girders 3, 4, and 5 on back side, and 1 foot of rebar exposed on ahead side near pile 3. Span 2 bent 3 girders 1 and 6 each have 1 foot cracked at end. Bent 3 cap has a few small spalls with exposed rebar. (3 feet) Rt end of cap has 2 feet delaminated. Span 3 bent 3 girders 1 and 3 have cracks on end. Span 3 bent 3 girder 6 has 1 foot of exposed rebar on end.
