Bridge #00508(Routine)

US 67-19- LM 3.40 over FOURCHE

Location: 3.34 MI NE JCT US 62

Team Lead: Richard Jones Inspection Date: April 15, 2019

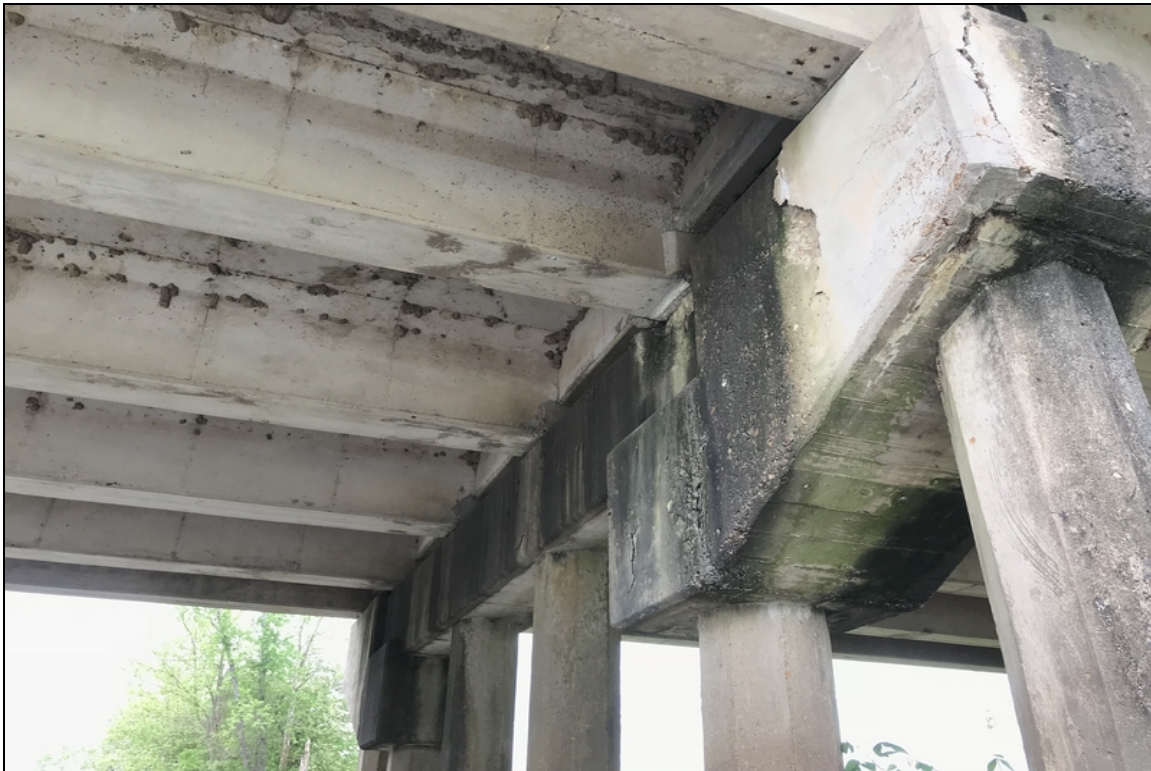
span 5 bent 5 girders 1 - 6

Bent 5 cap has a large delaminated area on ahead side under girder 1. Cap is spalled under girder 2 with up to 3" loss of bearing area. Bent 6 and 7 caps have depressions at old truss bearing locations.

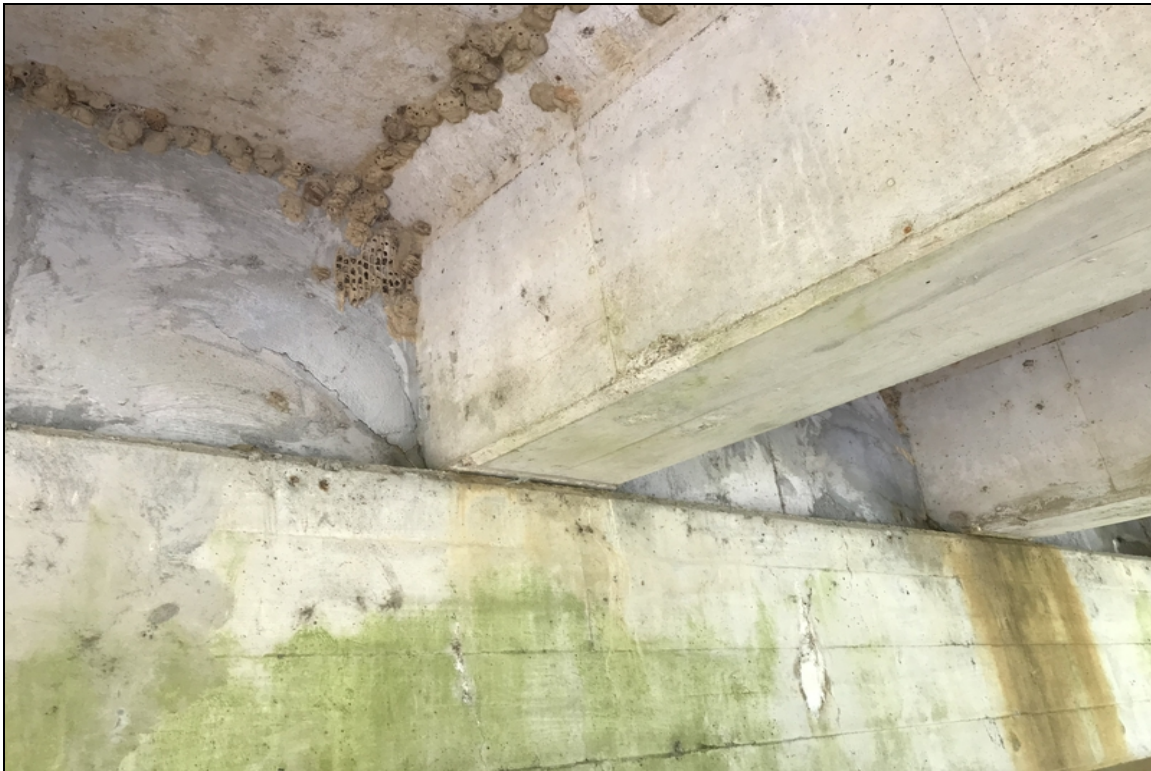
typical fixed end

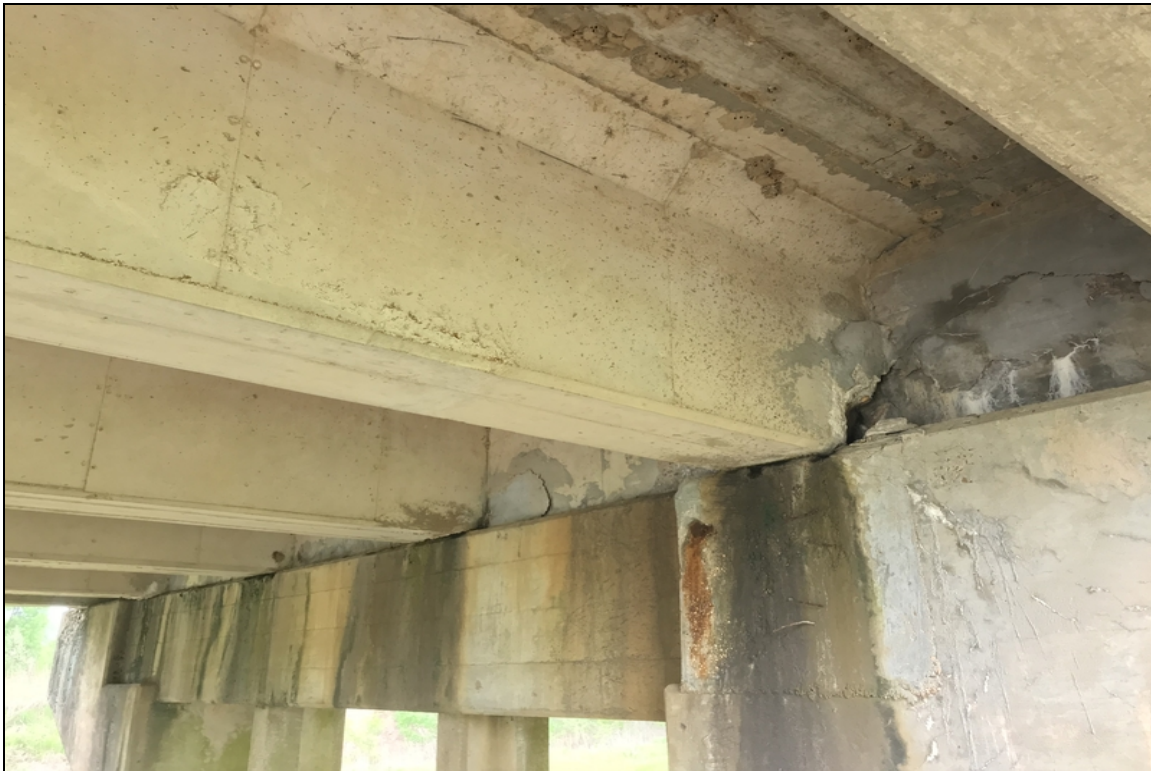
span 4 bent 4 girder 2

Span 4 bent 4 girder 2 patched area has spalled out at end of girder.

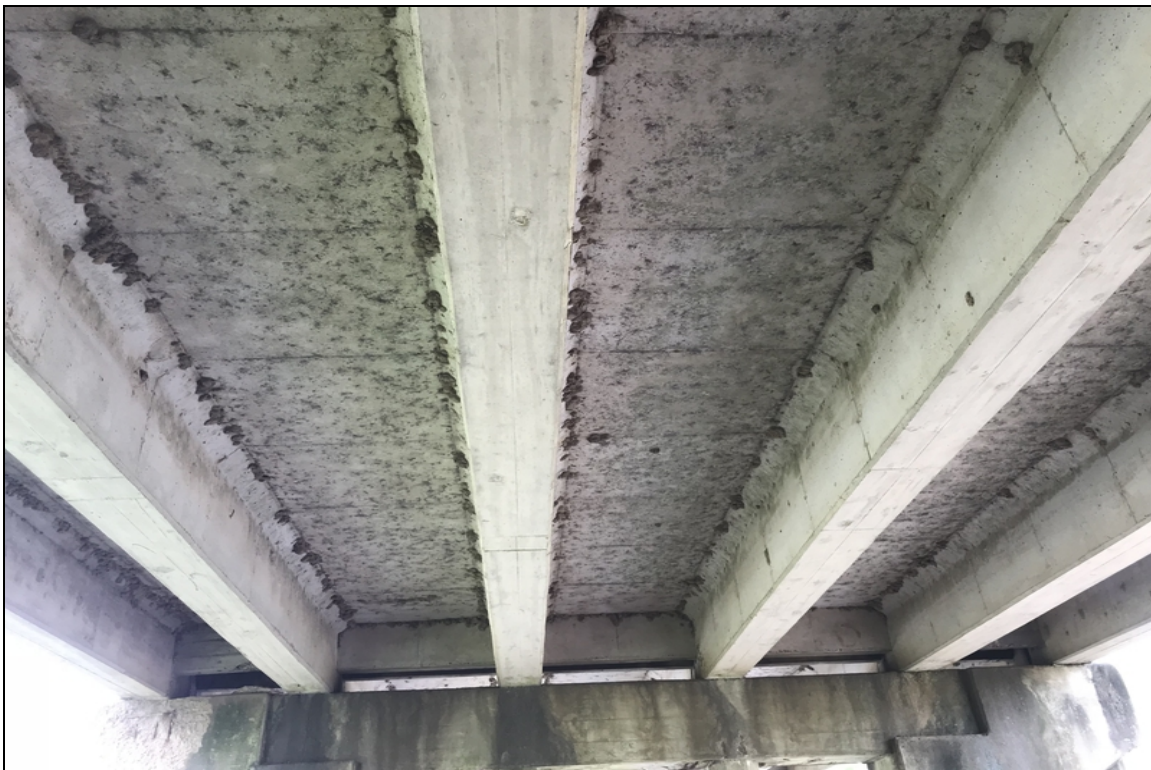
typical soffit
