Bridge #00730(Routine)

US 67-19- LM 5.44 over CURRENT RELIEF

Team Lead: Tim Myrick Inspection Date: May 14, 2018

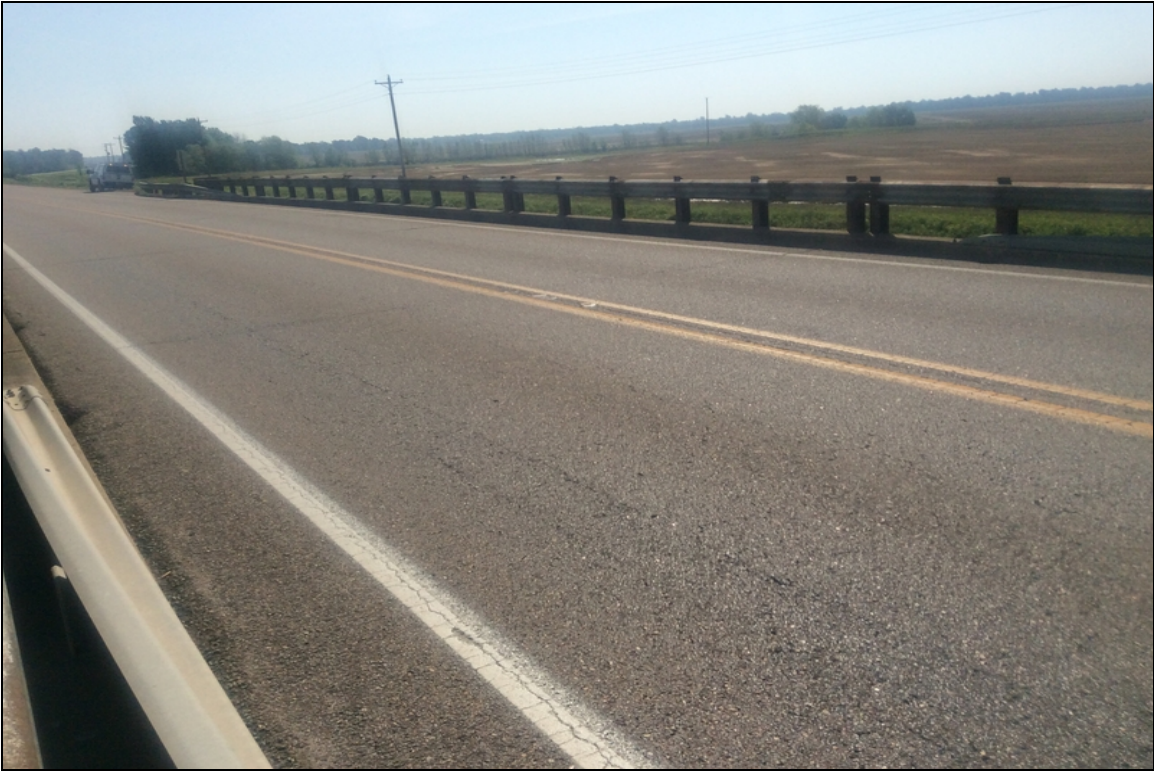
Deck view

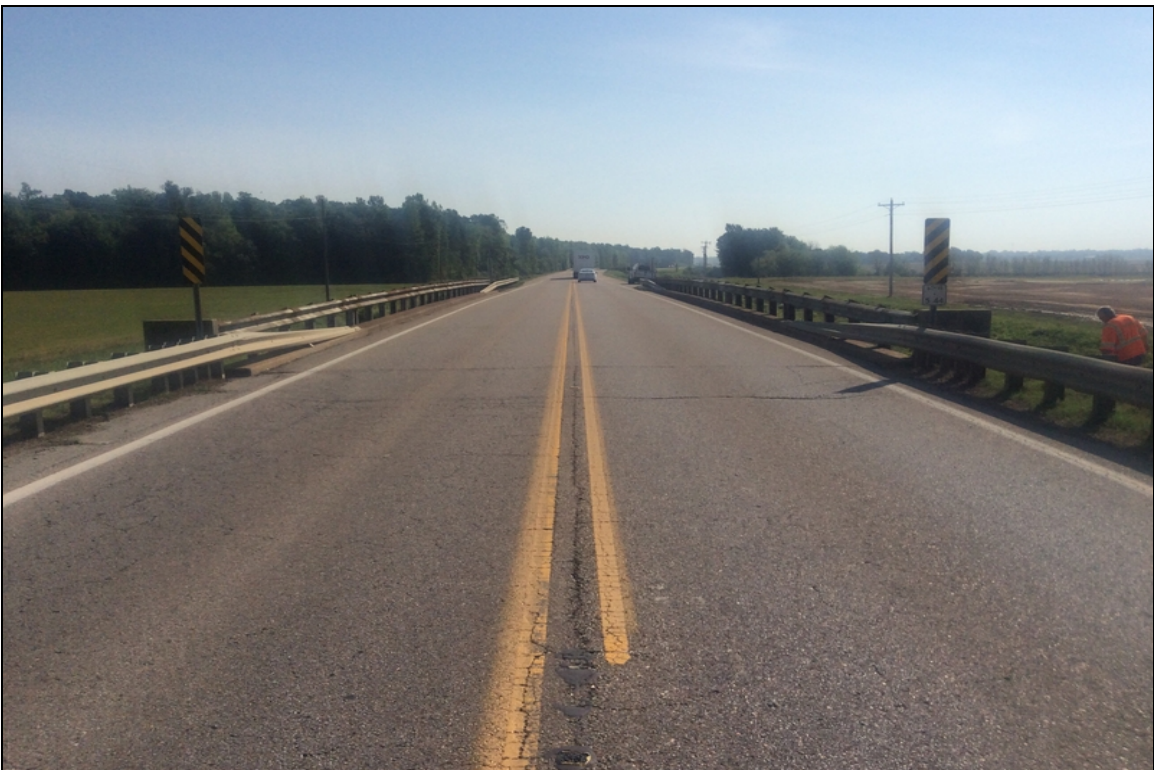
Roadway view

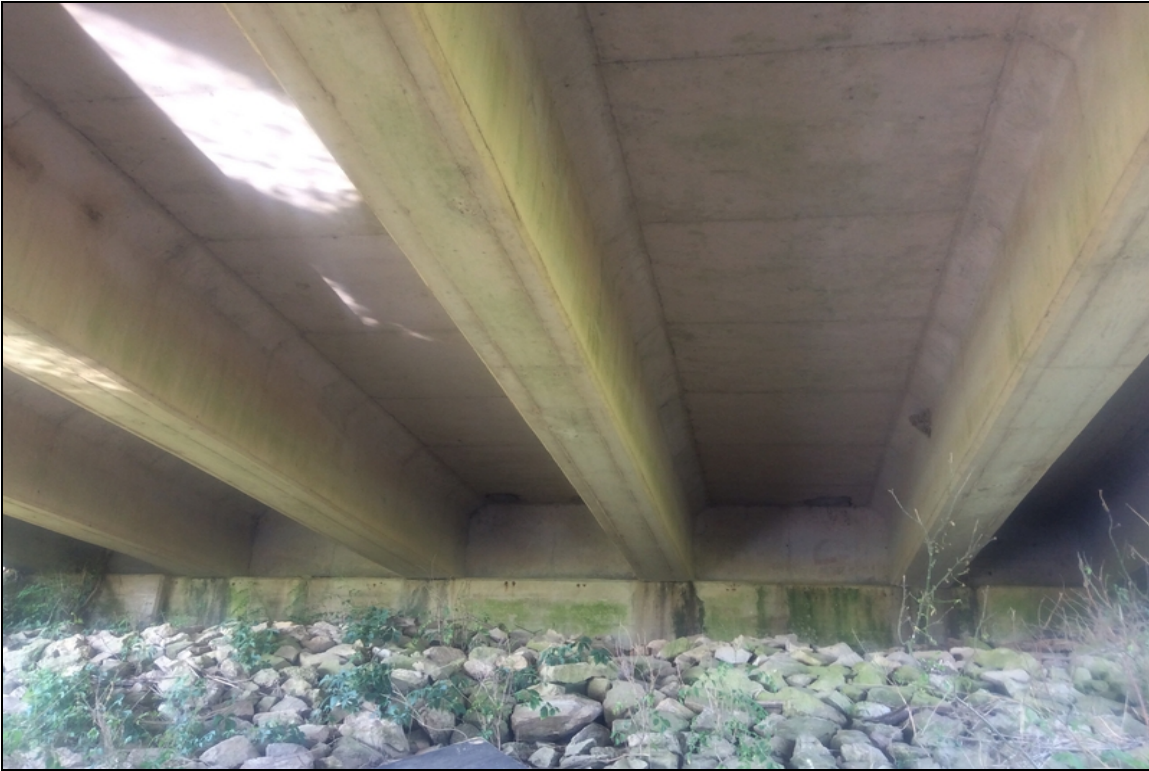
Underneath deck view
