Route:226 Section:03 Log:5.34

Bridge #06581 (Routine)
SH 226 SEC 3 over US 63 & W. Parker Rd.
Location: JCT US 63&SH 226

Team Lead: Richard Jones Inspection Date: August 18, 2020

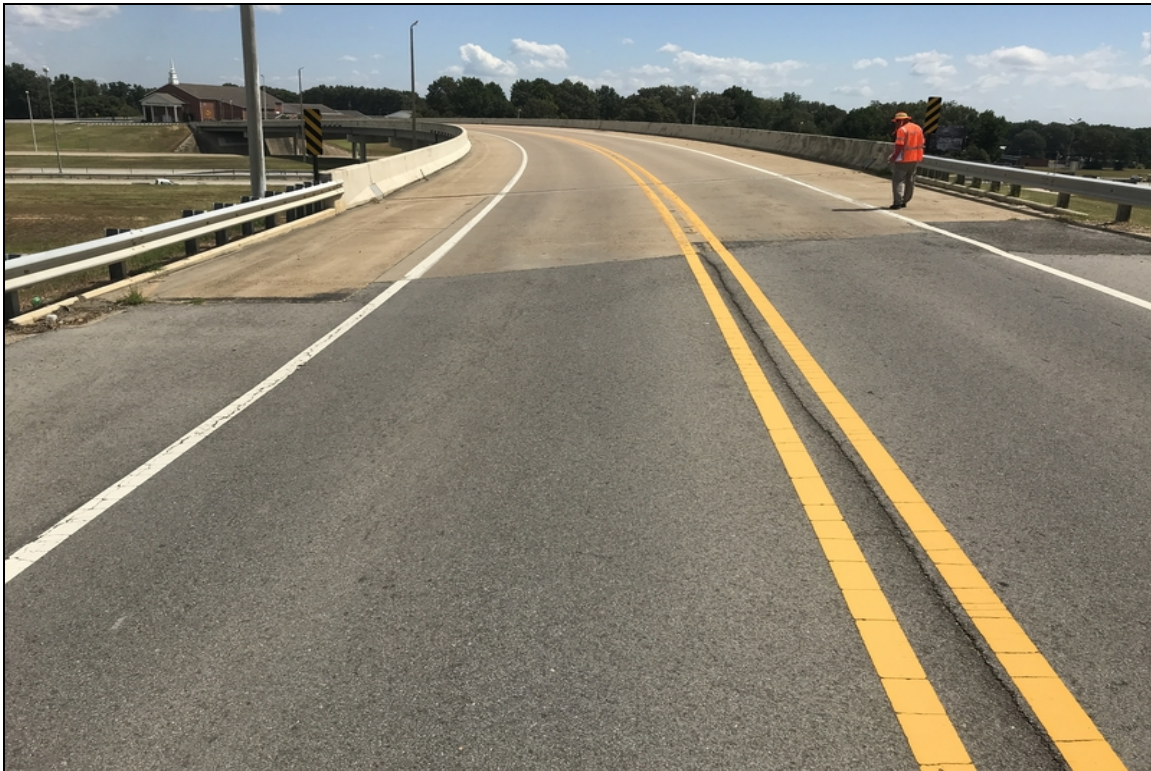
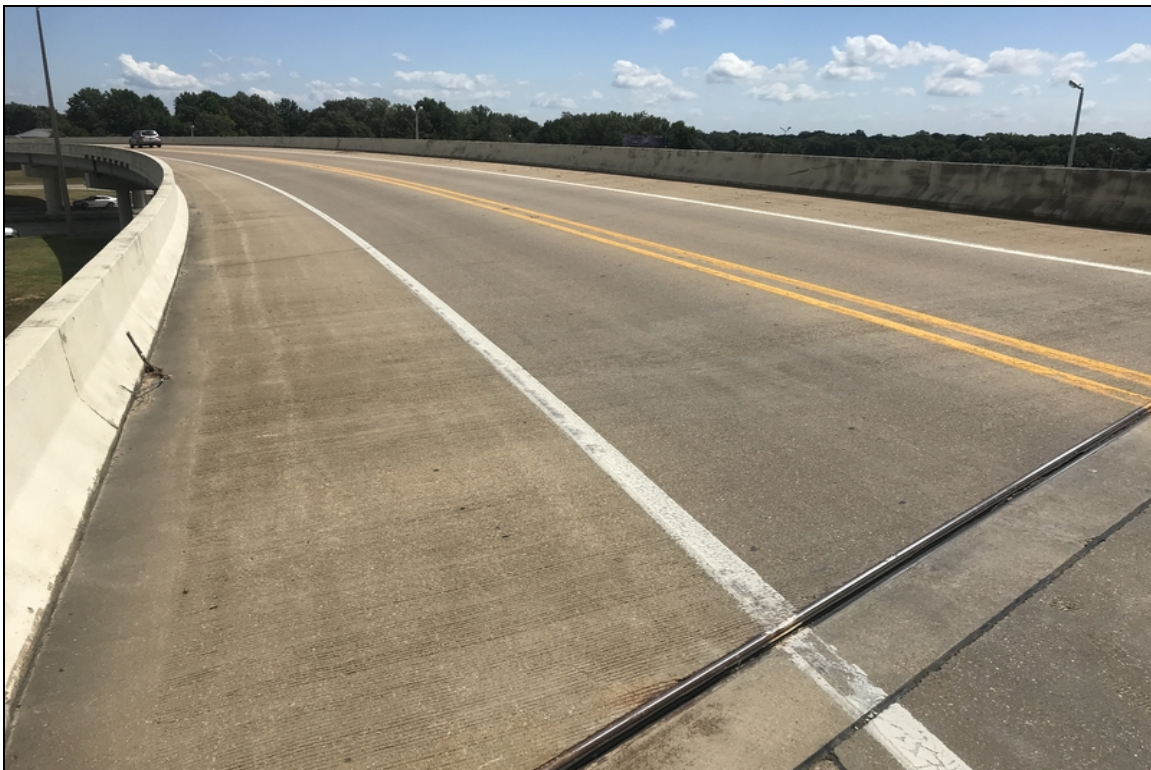
Overall

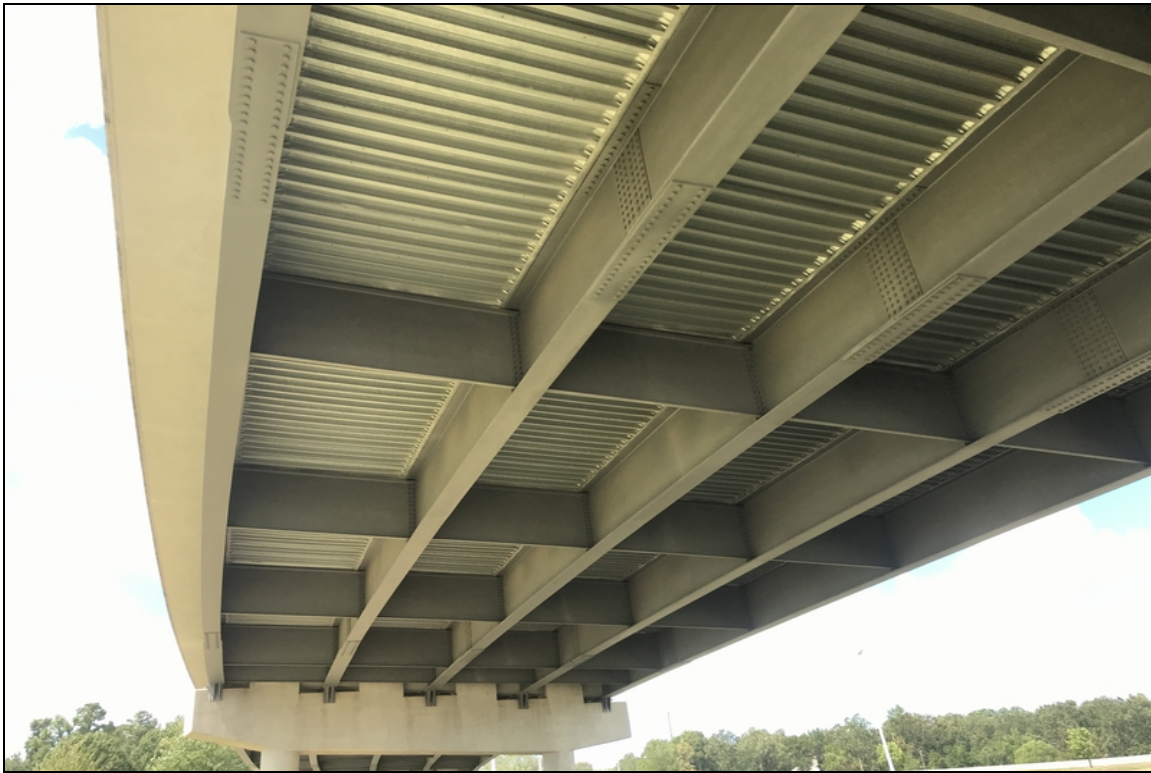
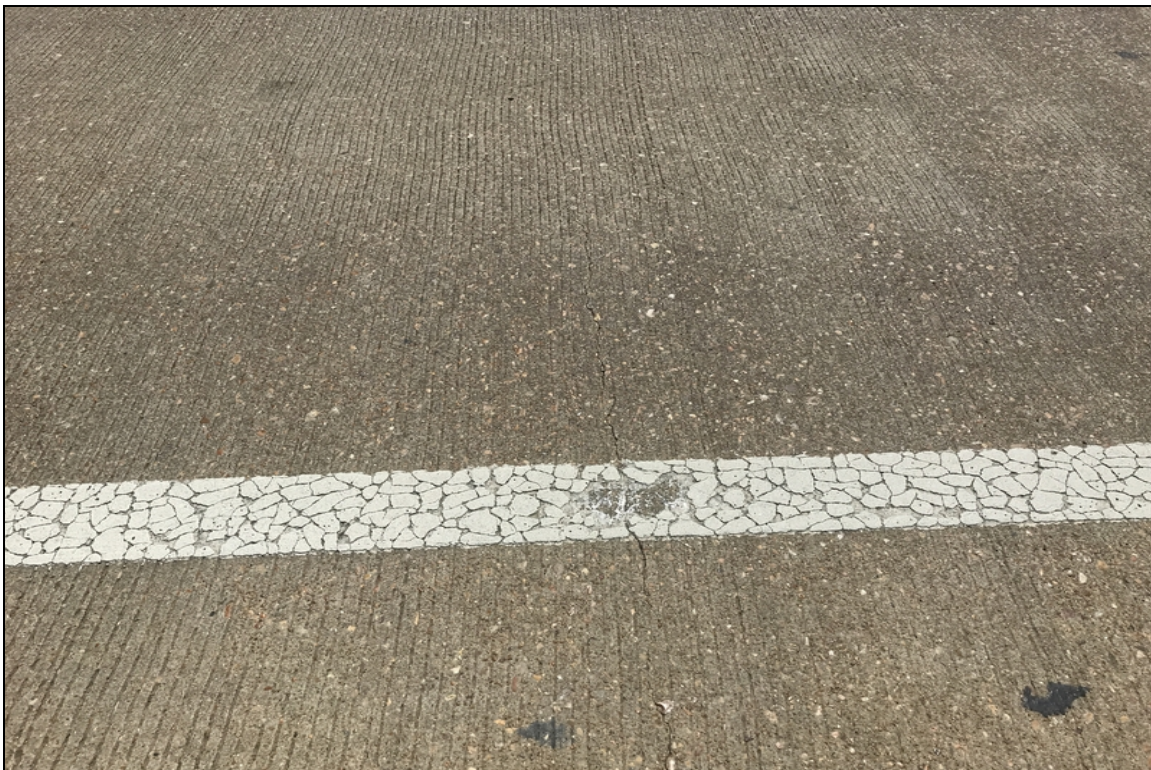
Deck transverse cracks

Approach slabs have several wide unsealed cracks.
Concrete bridge rails have several minor cracks. Some have efflorescence.
Deck has a few unsealed transverse and longitudinal cracks.
Strip seals have some debris impaction in gutters.
Poured joint material over saw cut joints has a few areas of missing seals.
Overhangs have a few transverse cracks with efflorescence. Some have rust stains near drain openings.
Span 6 bay 4 stay in place form has a 3 ft. x 1' area rusted with heavy section loss.

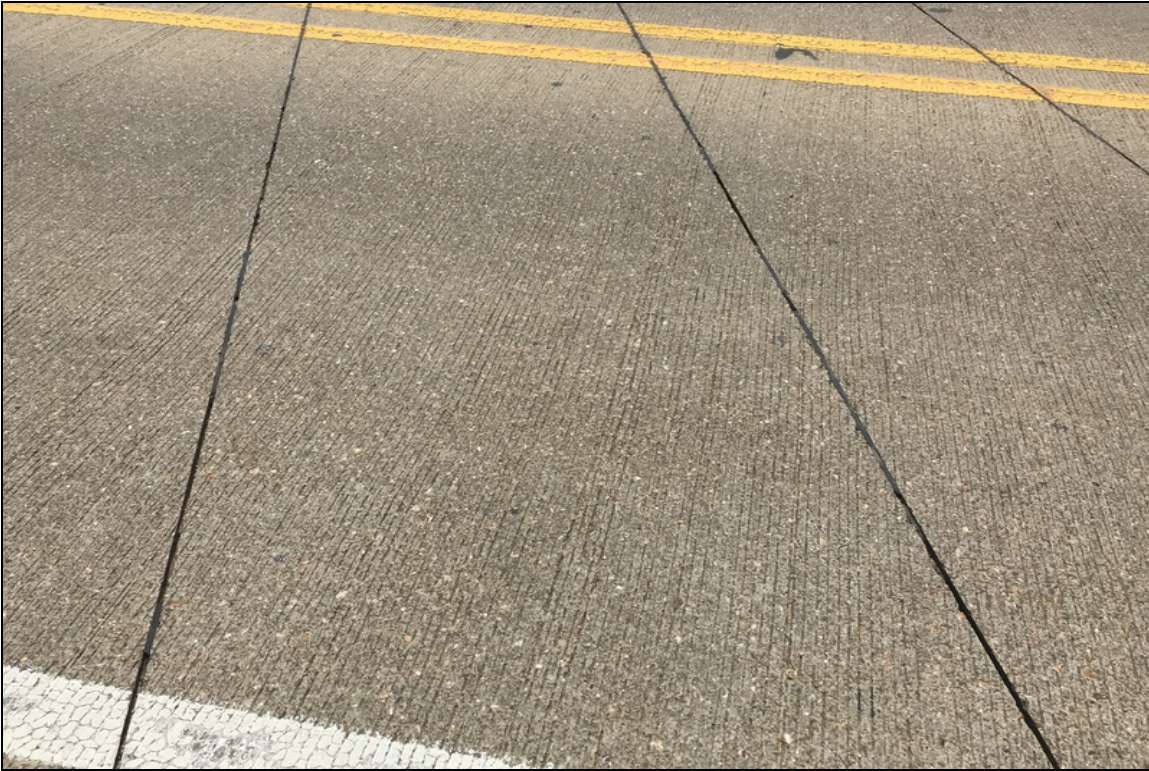
Saw cut joints

Poured joint material over saw cut joints has a few areas of missing seals.

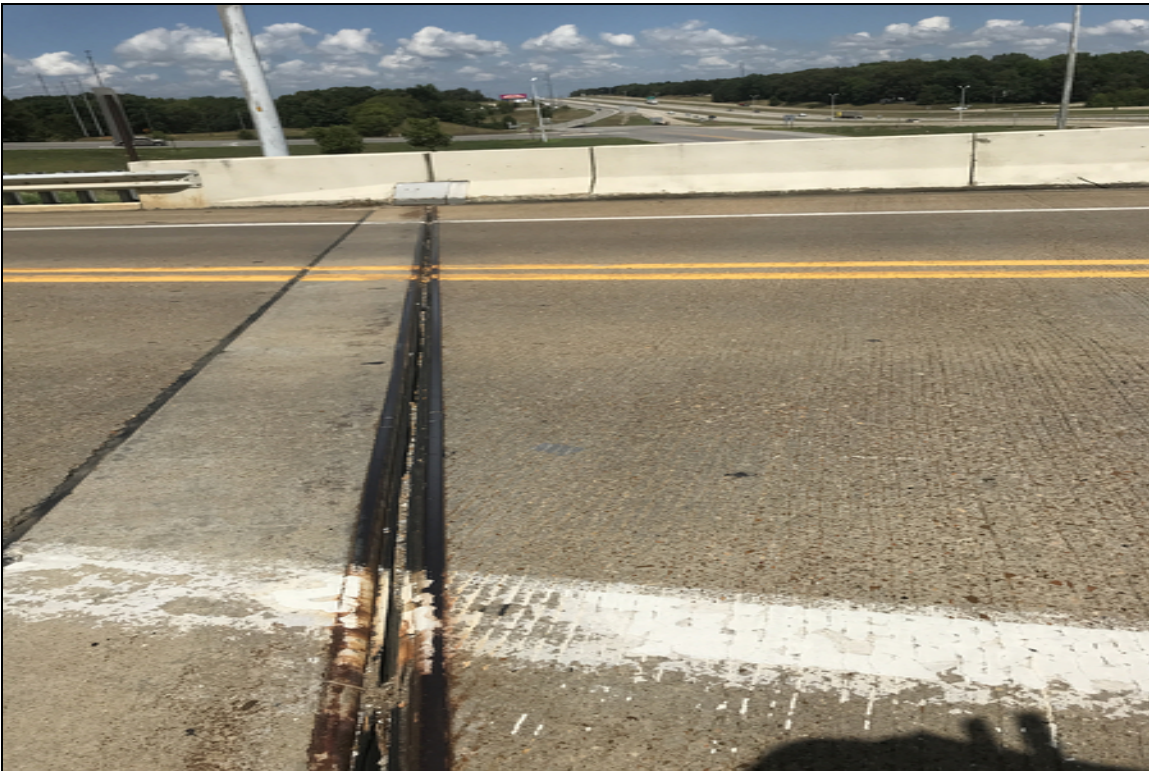
strip seal

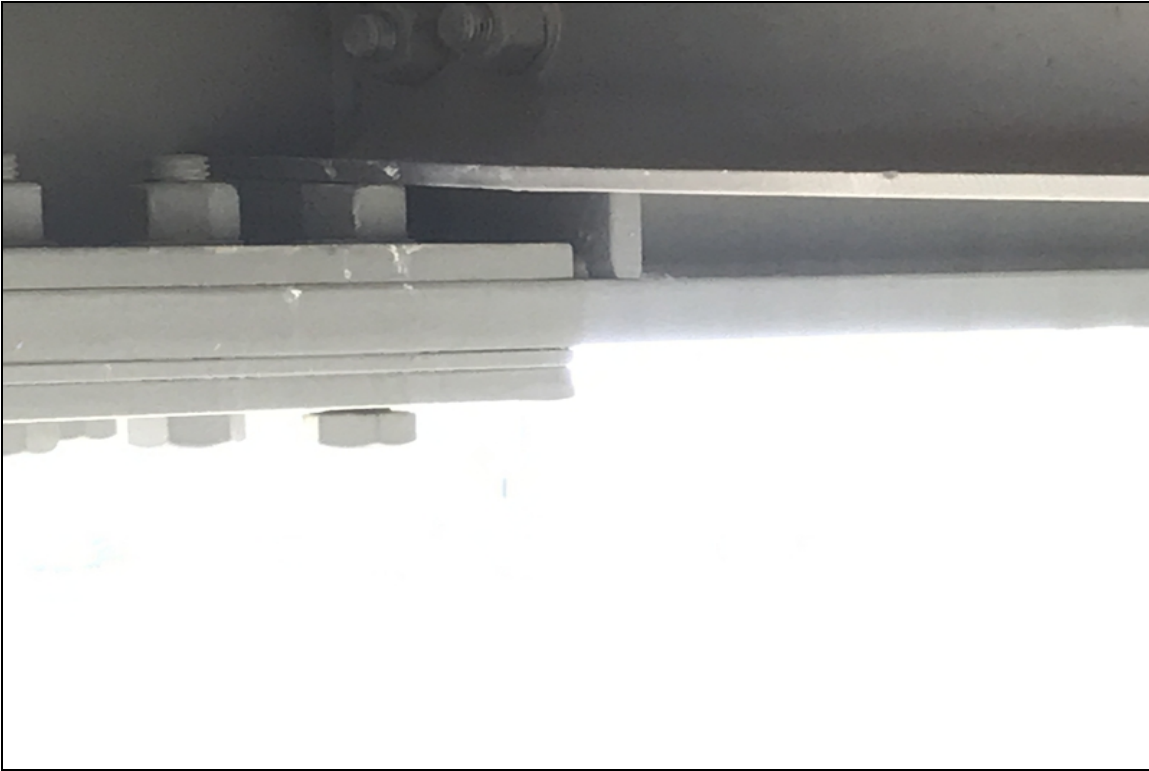
Span 6 splice 2 girder 5

Bottom flange of girders have a few areas of freckled rust near bearings.
Bearing welds between steel plate and bottom flange of girder have several undercuts.
Span1 bent 1 bearings all have pack rust between plates above and below the elastomeric pad.
Bent 2 bearing 1 is not welded to bottom flange of girder on Lt side.
Span 4 bay 1 diaphragm 5 has 1 diaphragm bolt missing at connection to girder 1.
Span 5 bent 5 girder 4 earthquake restraint has one nut and washer pulling through bracket.
Span 6 splice 2 girder 5 has 1 loose bolt on bottom flange. Diaphragm is blocking bolt.

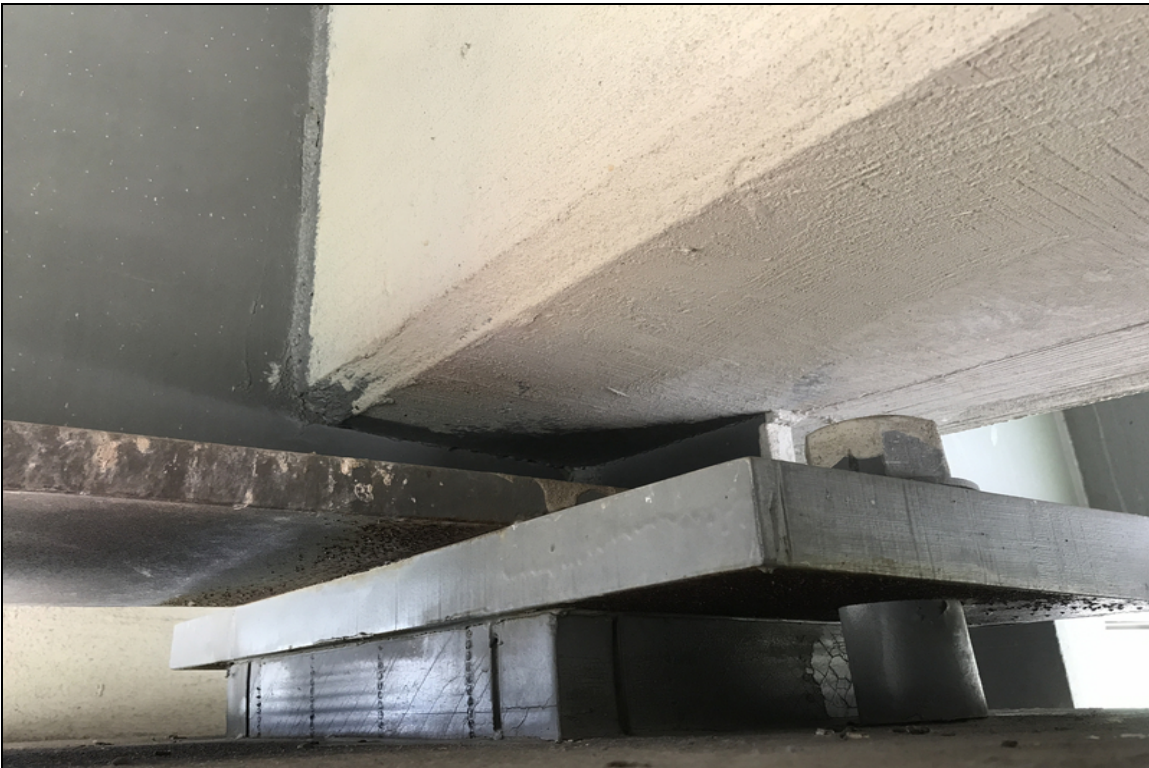
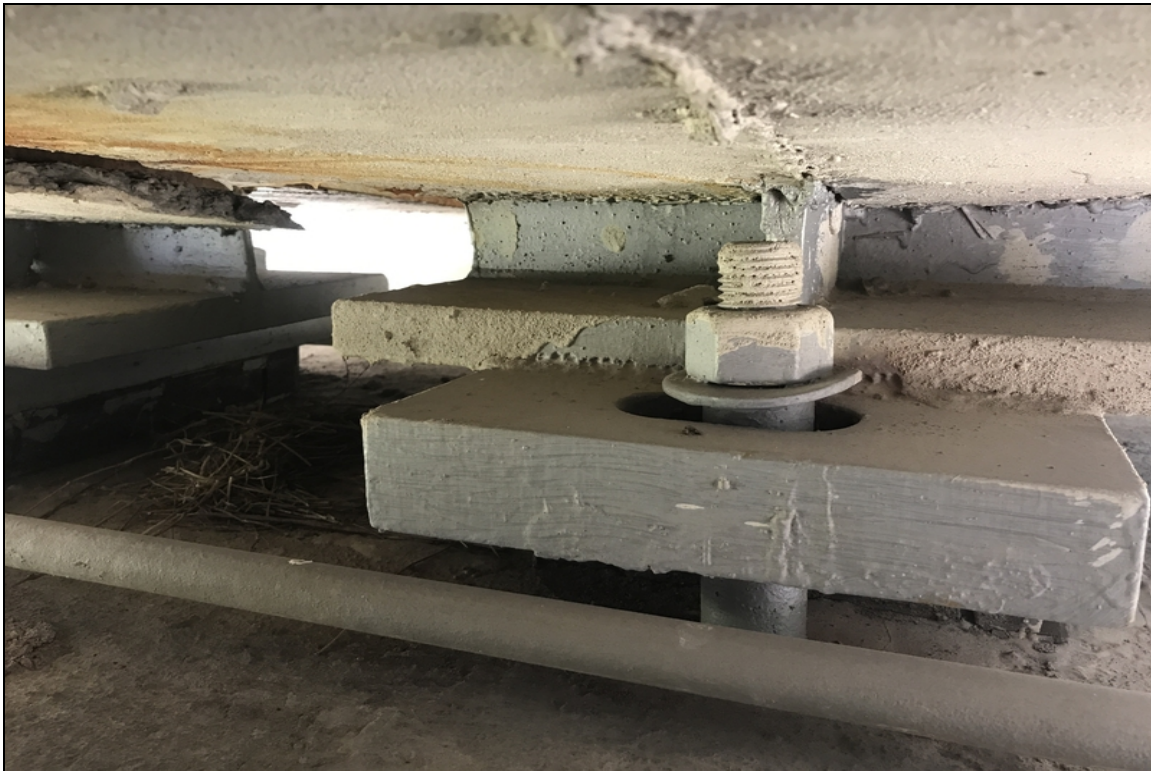
typ undercuts

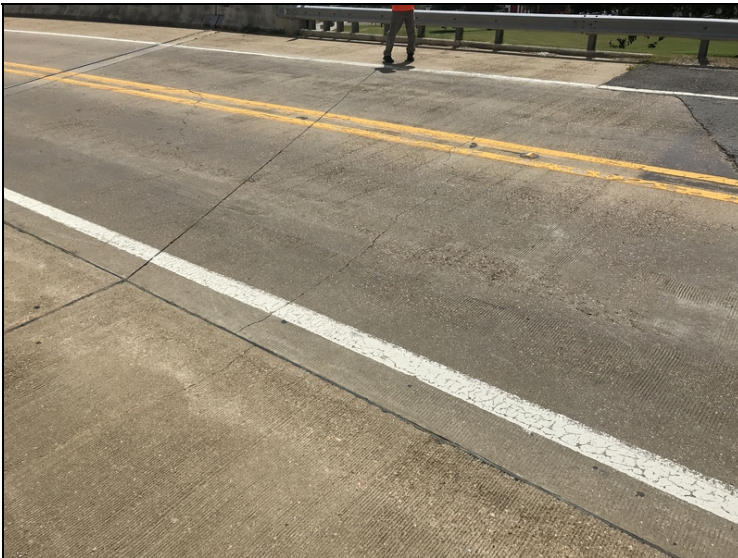
Approach slabs have several wide unsealed cracks.

Beginning approach slab

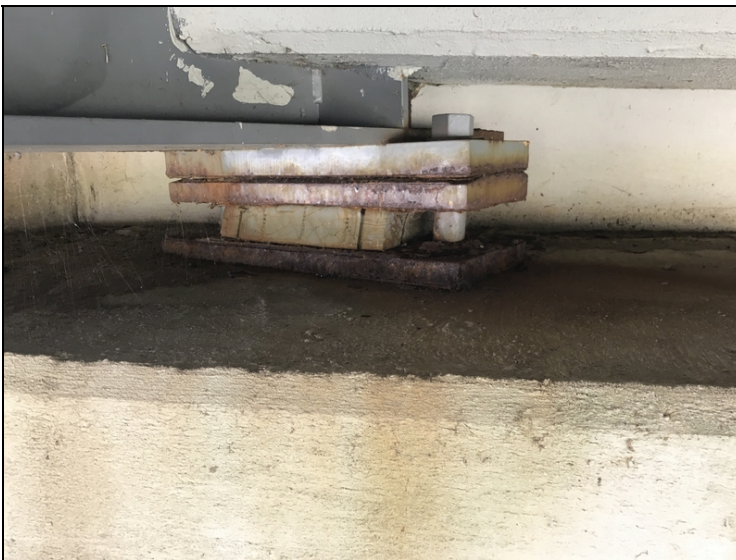
Bottom flange of girders have a few areas of freckled rust near bearings.
Bent 1 bearings all have pack rust between plates above and below the elastomeric pad.

Span 1 bent 1 girder 2 pack rust on all bearings
and all elastomeric pads are expanded at least 1".

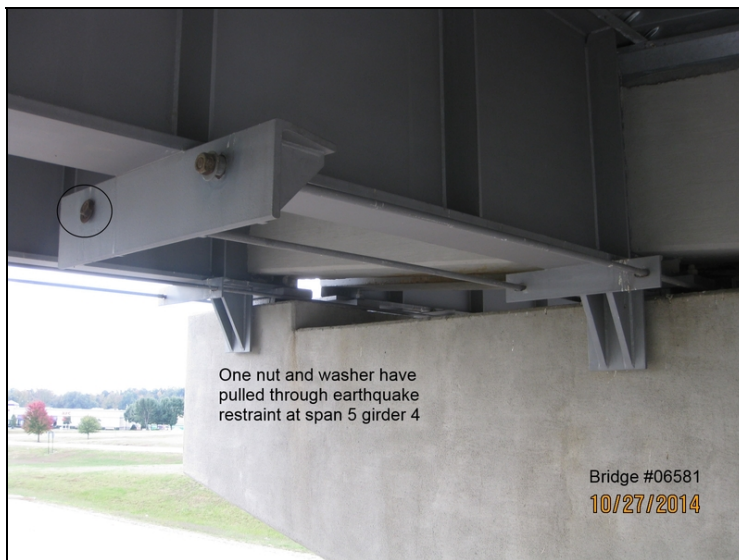
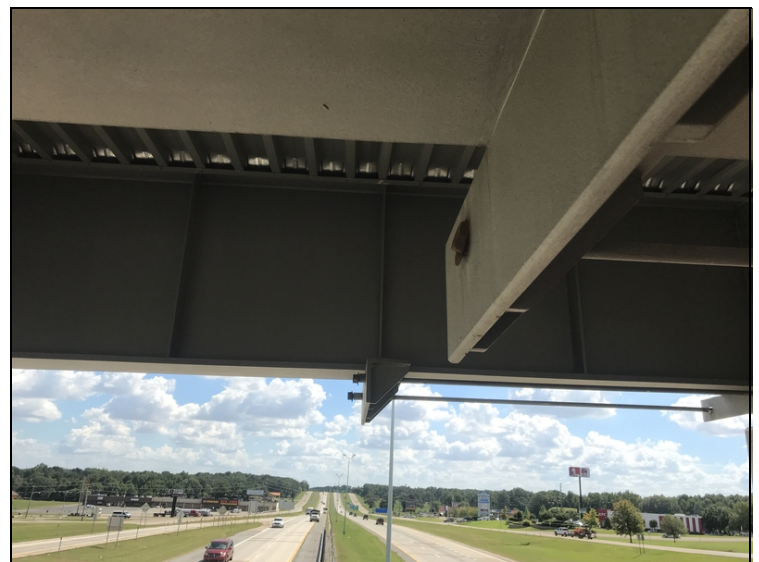
Span 5 bent 5 girder 4 earthquake restraint has one nut and washer pulling through bracket.

Span 5 girder 4 bay 4 earthquake restraint bolt head pulled through bracket.

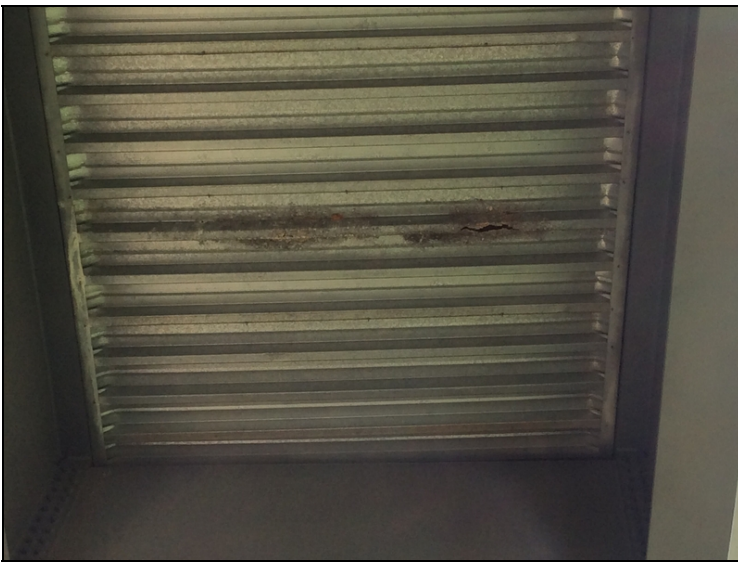
Span 6 bay 4 stay in place form has a 3' x 1' area of rust and section loss.

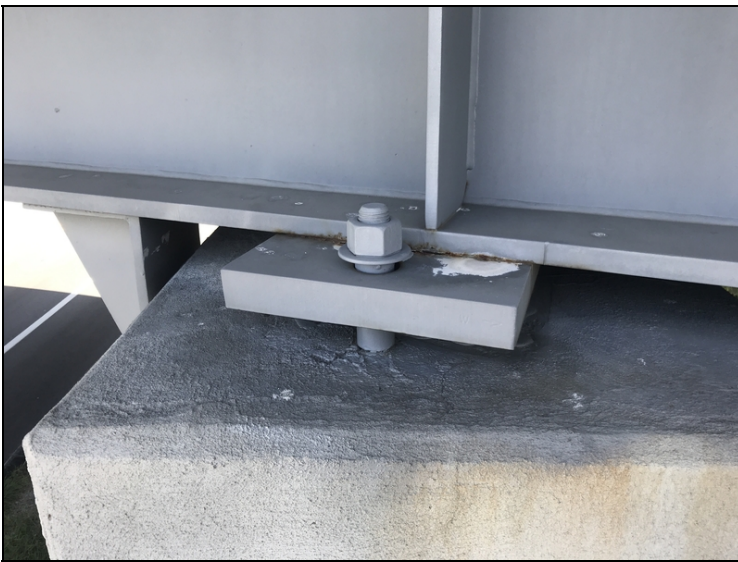
Bent 2 bearing 1 is not welded to bottom flange of girder on Lt side.

Bent 2 left side no weld.
