Bridge #07028(Routine)

Washington Ave. over US Hwy 63-06

Team Lead: Richard Jones Inspection Date: August 18, 2020

IDENTIFICATION	
(1) State Names	Arkansas
(8) Structure Number	07028
(5) Inventory Route	60840
(2) Highway Agency District	10
(3) County Code	31-Craighead County, Arkansas

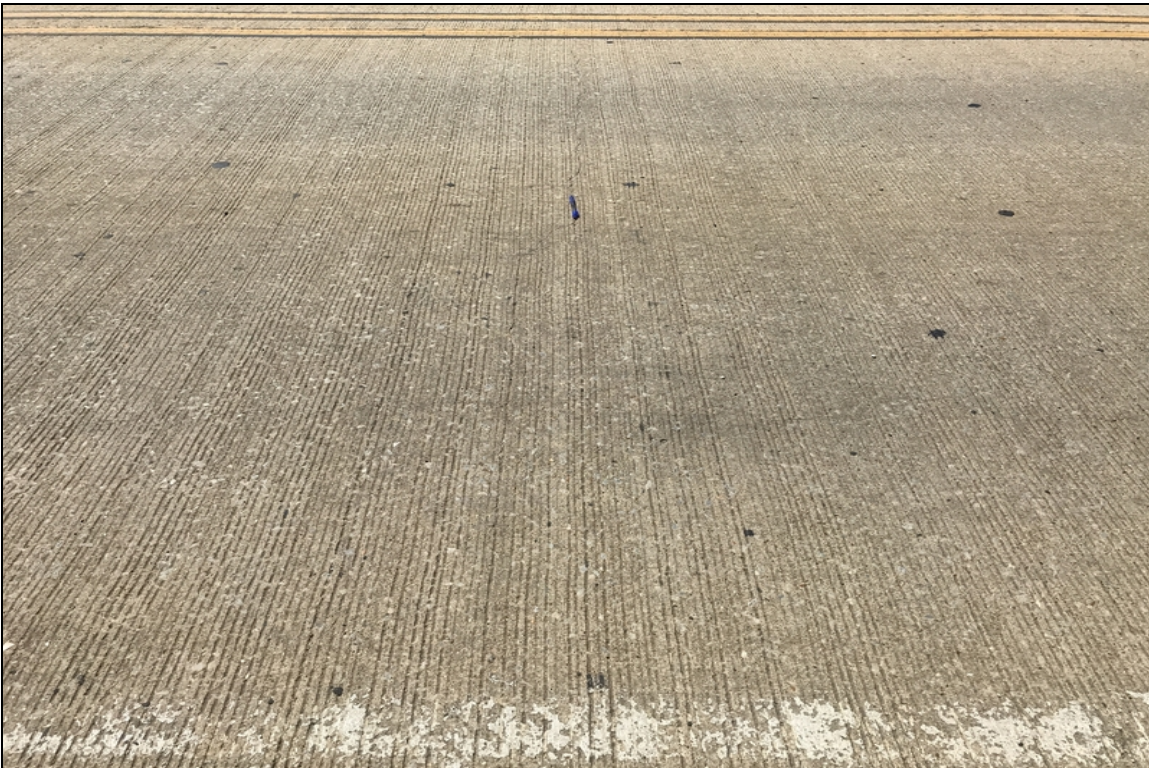
Transverse and longitudinal cracks

Approach slabs at bents 1 and 5 have some settlement. Approach slabs have several unsealed cracks.  
Approach slab at bent 1 end has an asphalt overlay.  
Approach roadway asphalt at end of bent 5 approach slab has settlement.  
Deck has a few unsealed longitudinal and transverse cracks.  
Concrete rails have several cracks with efflorescence.  
Overhangs have transverse cracks with efflorescence.  
Poured joint material in saw cut joints has a few areas missing.

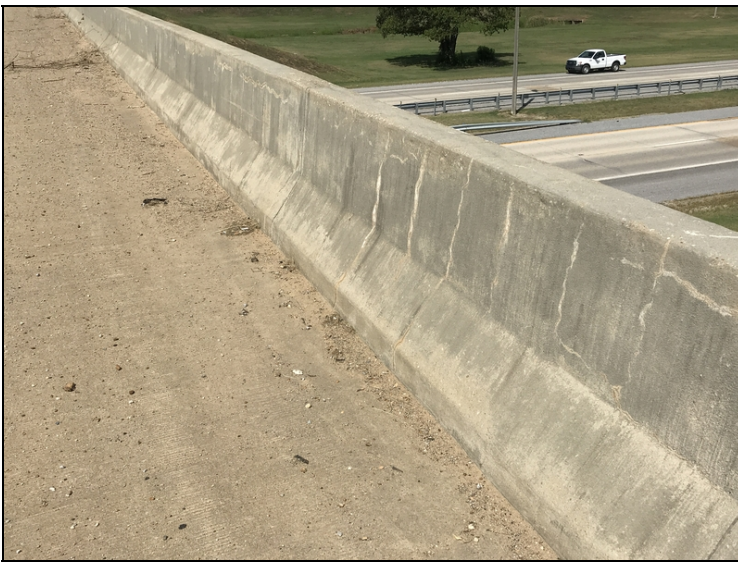
Typ rail

Concrete rails have several cracks with efflorescence.

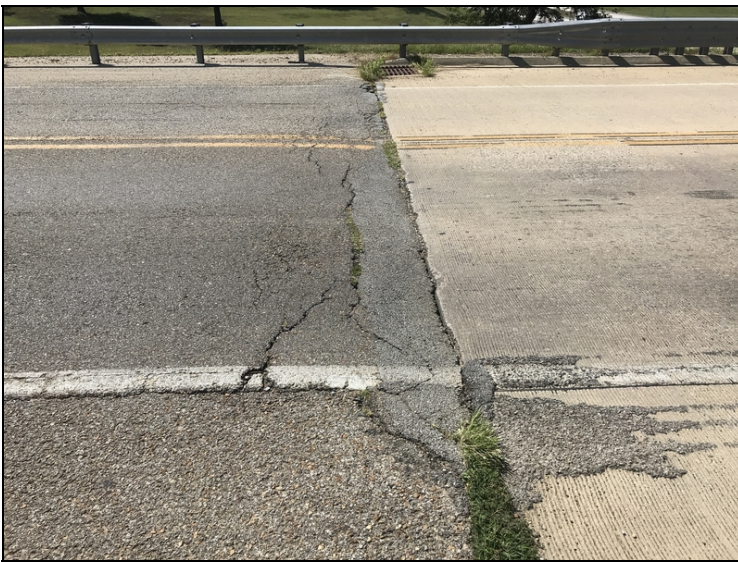
Bent 5 approach roadway

Approach slabs at bents 1 and 5 have some settlement.

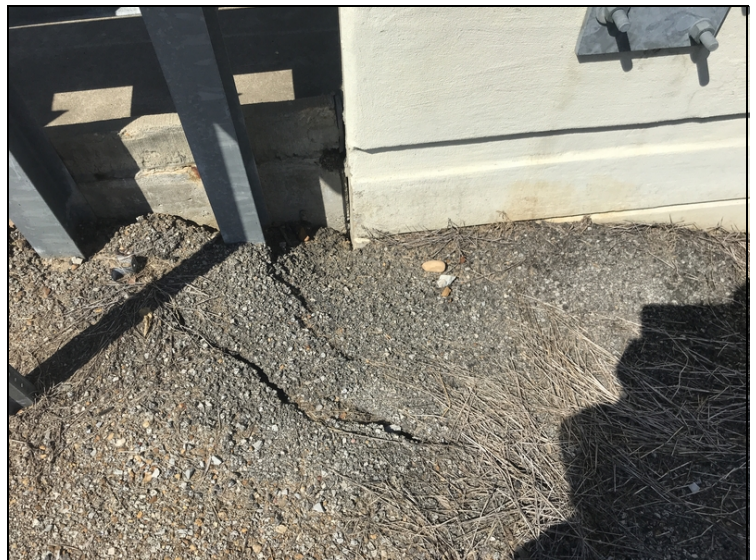
Concrete slope paving has settled up to 5" at end bents.

End bent 1 settling right side typical.

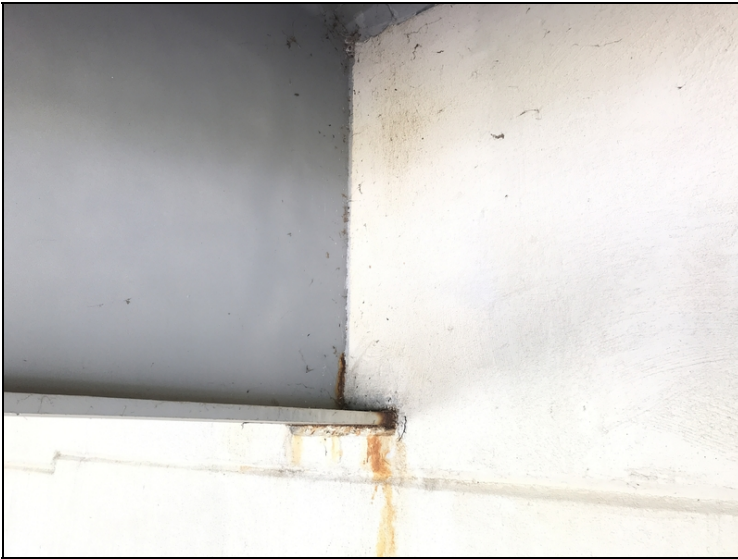
Span 4 bent 5 girder 3

Girders at bents 1 and 5 abutments have pack rust at bottom of web and bottom flange at connection to concrete diaphragm.

**Date Reported:** 08/31/2020  
**Priority:** D- Routine  
**Type of Work:** Clean  
**Status:** Open  
**Component:** Superstructure
