Bridge #A5204(Routine)
I-555 over SLSW RR; Mahon St.
Location: 4.14 MI NW OF SH 18

Team Lead: Richard Jones Inspection Date: April 21, 2020

IDENTIFICATION	
(1) State Names	Arkansas
(8) Structure Number	A5204
(5) Inventory Route	63
(2) Highway Agency District	10
(3) County Code	31-Craighead County, Arkansas

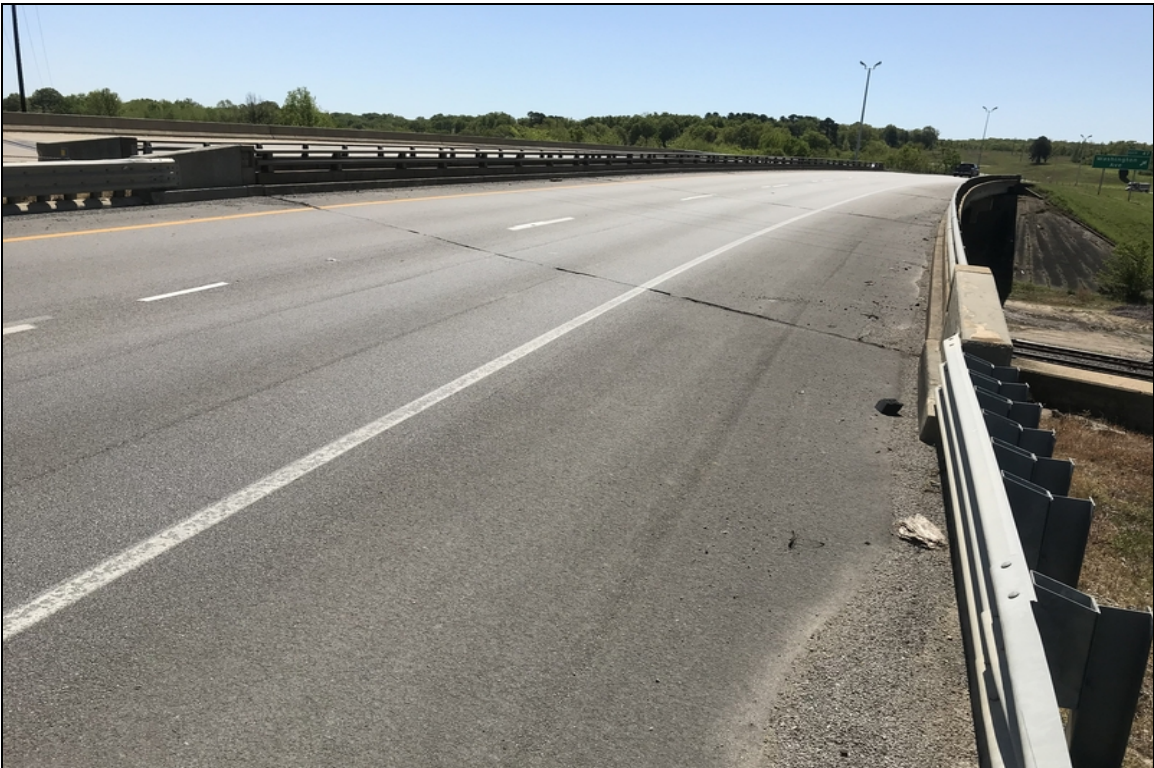
wearing surface

Deck has been noted in the past as having several unsealed transverse cracks, delaminated areas and spalls with rebar exposed. Deck has been covered with asphalt overlay.

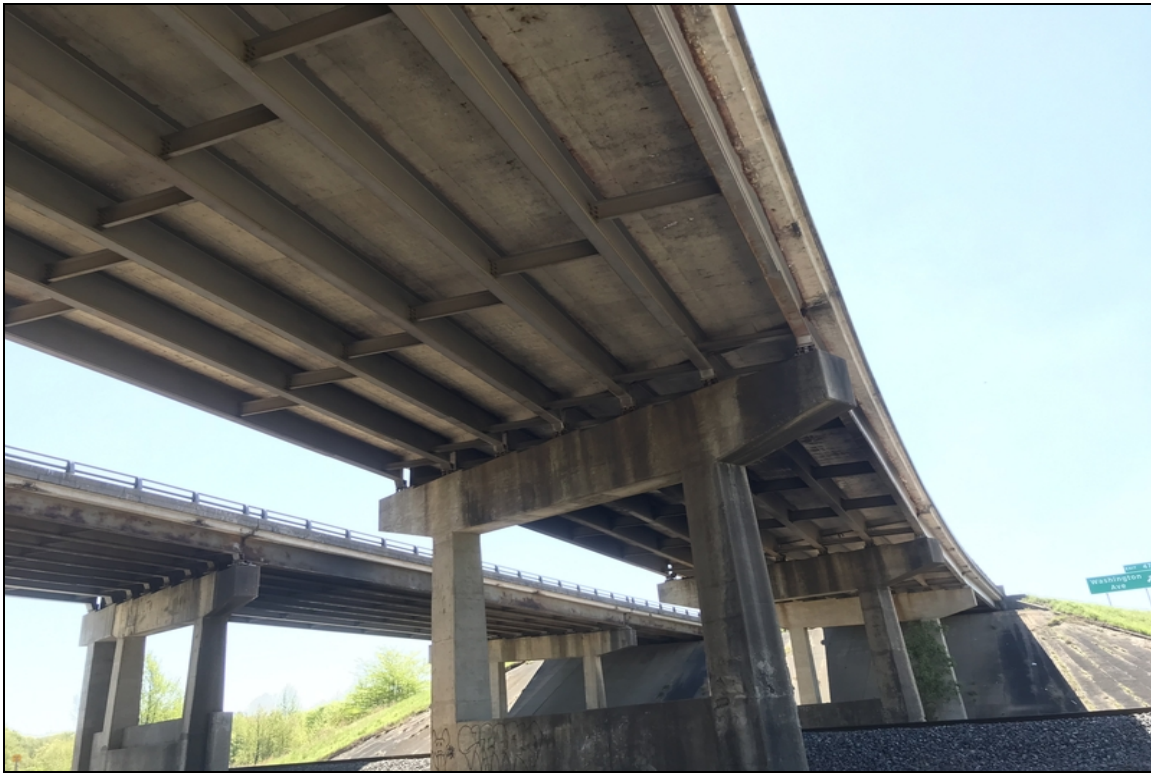
Soffit and overhangs have a few minor efflorescent cracks.

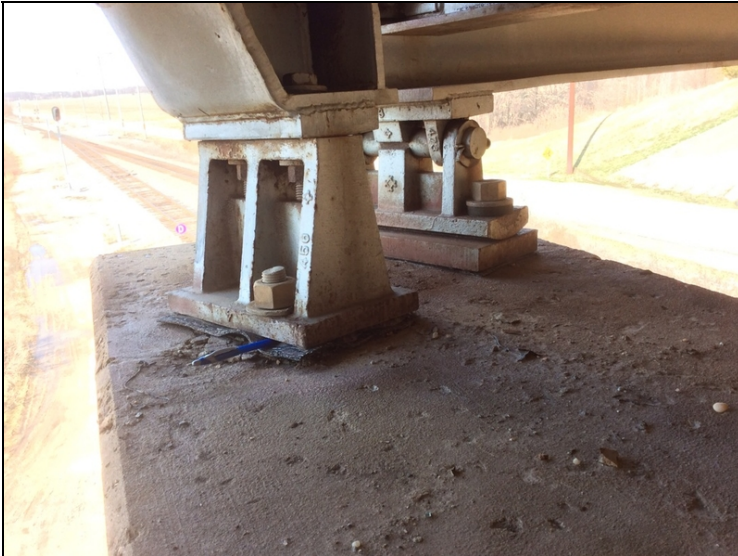
Span 4 bent 4 fixed bearings 1 – 7 are rotated back and twisted. Front edge of bearing has separated from cap up to 1/2" (bearing 7 has 1" gap). Bearings have several loose bolts at connection to bottom flange of girder. Several are missing anchor bolts.

Bent 4 Bearing 7 tilted and twisted, typical for bearings on Bt. 4.

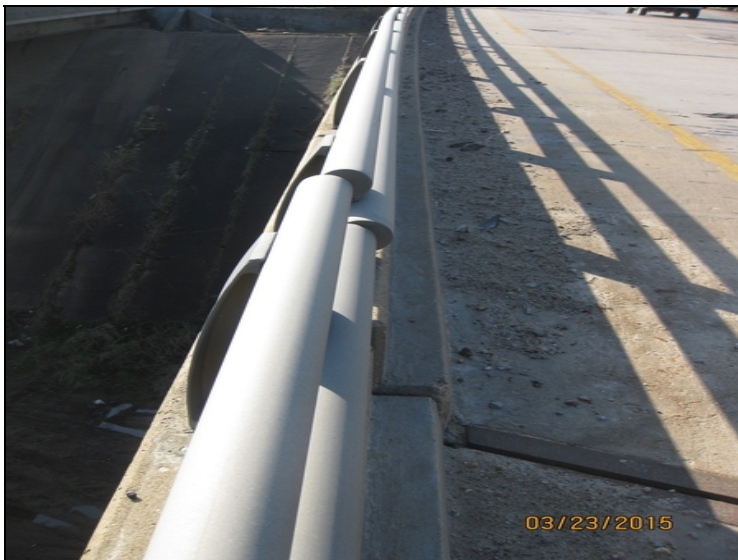
Deck at bent 4 has a one inch lateral shift. Bent 4 girder 1 at spans 3 and 4 are butted together.

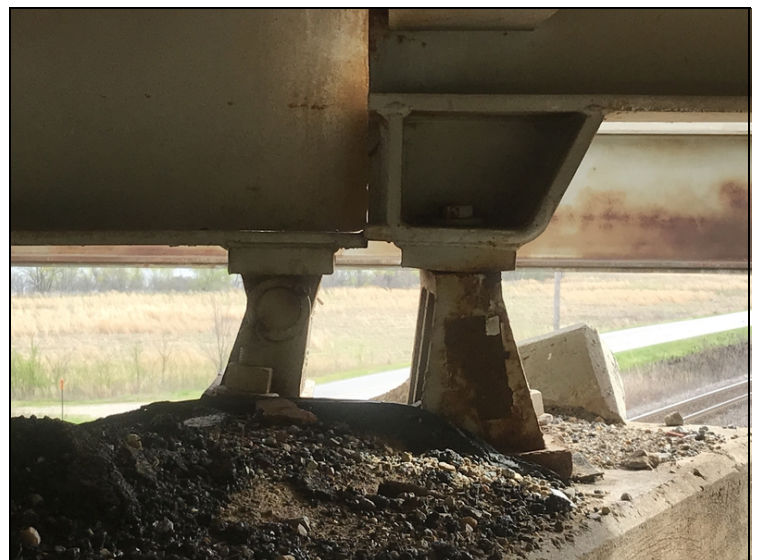
Span 3 and 4 bearing 1

Bent 4 girder 1 at spans 3 and 4 are butted together.

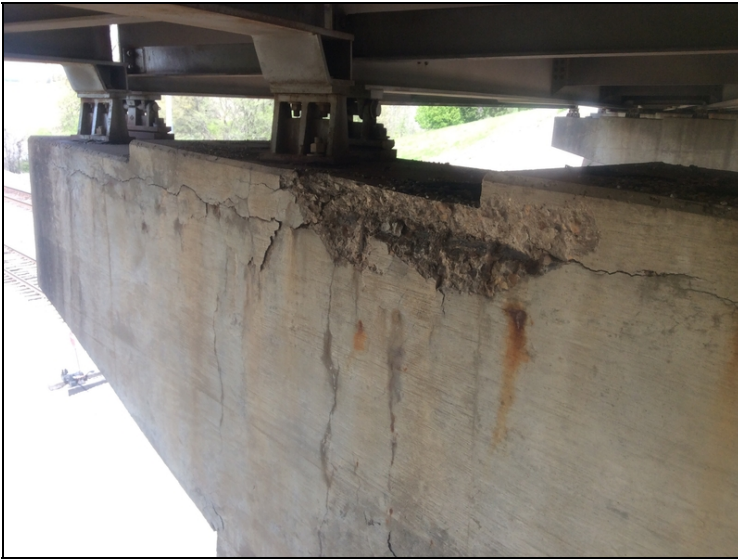
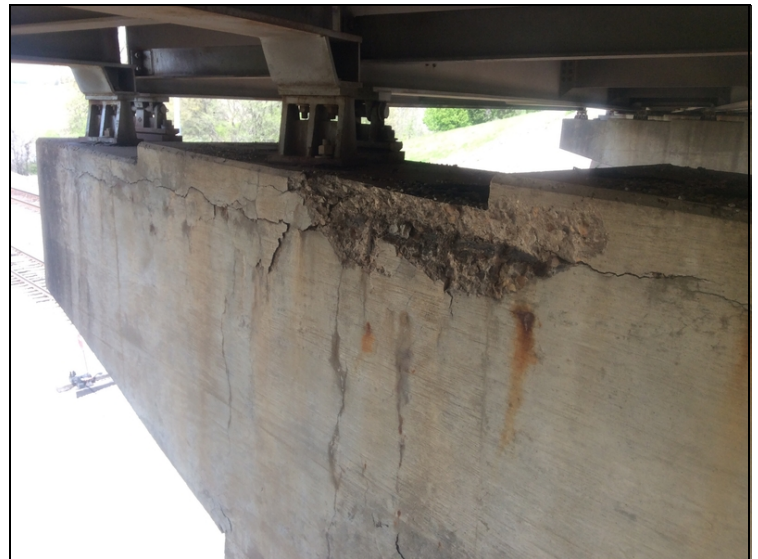
Bent 4 cap has 25' on ahead side with horizontal cracks/delaminated and spalled with 3' of rebar exposed. Crack runs along face of cap 6" - 8" down from top of cap. Back side of cap has a 3' horizontal crack between girders 6 & 7.

Bent 4 cap has 25' on ahead side with horizontal cracks/delaminated areas. Cap has a spall with 3' of rebar exposed between bearings 3 and 4.

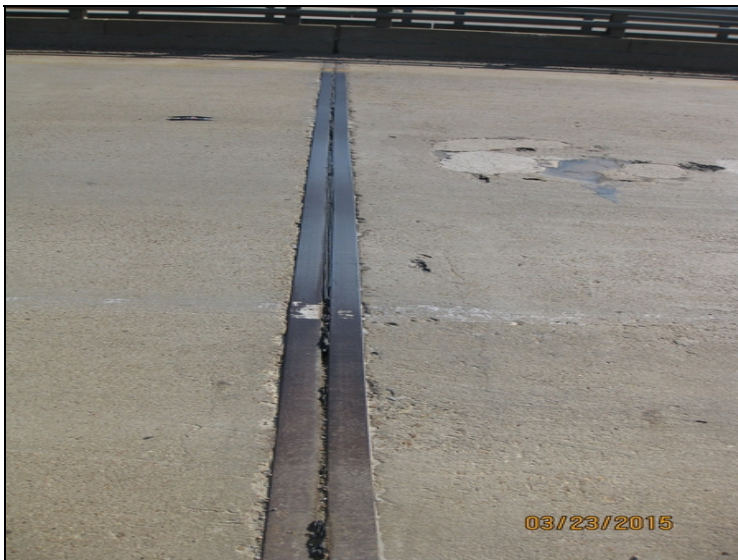
Joints at bents 2 - 5 are closed. Concrete haunches underneath have cracks and/or spalls.

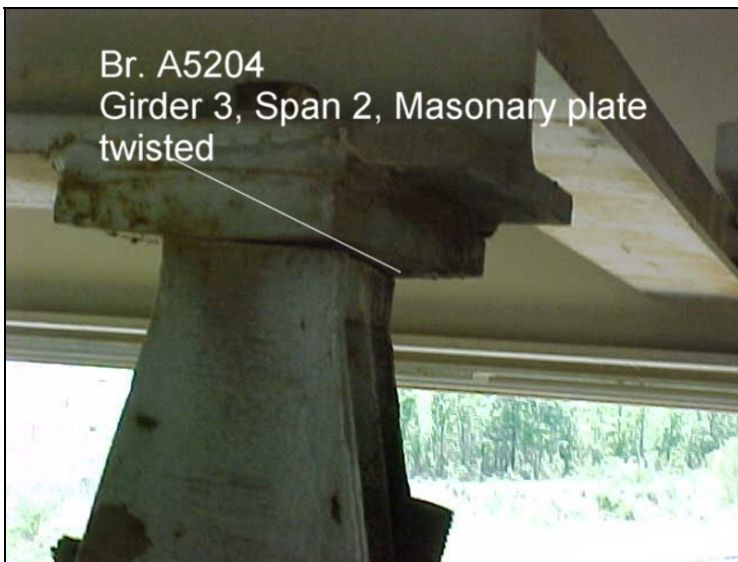
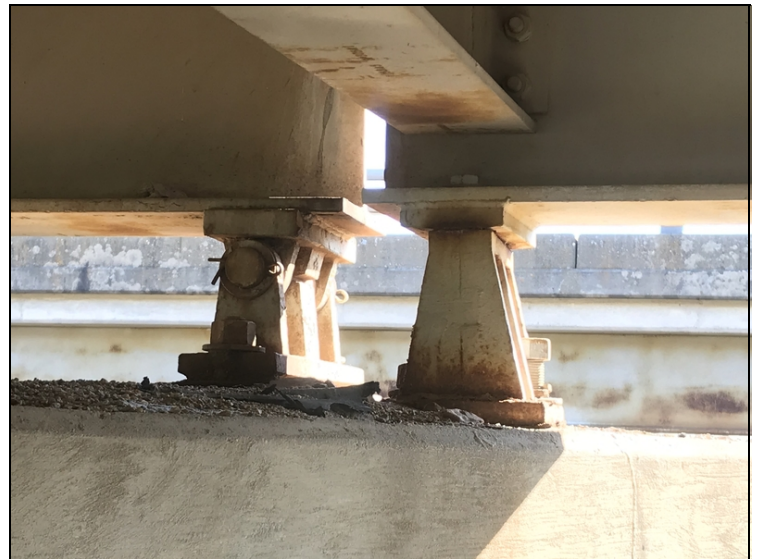
Span 2 bent 2 bearing 1

Span 2 bent 2 fixed bearings have several loose bolts between bottom flange of girder and top plate of bearing. Several bearings are twisted.

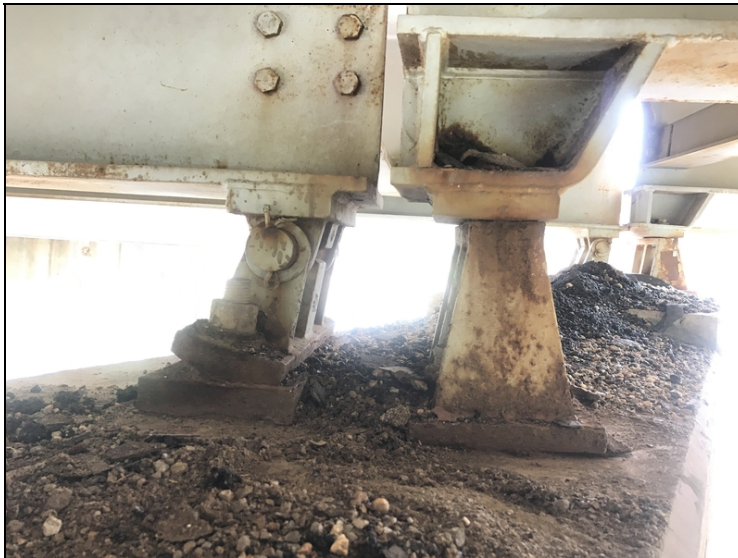
Span 3 and 4 Bent 4 bearing 2

Spans have shifted laterally in the past. Several bearings have missing anchor bolts. Several have loose bolts at bearing and girder connection.
Several rocker bearings are at max rotation.
Several fixed bearings have shifted/twisted. Several fixed bearings are rocked back with a gap between front side of bearing and cap.

Span 3 bent 4 bearings 1 and 2 are rotated ahead and at max rotation.

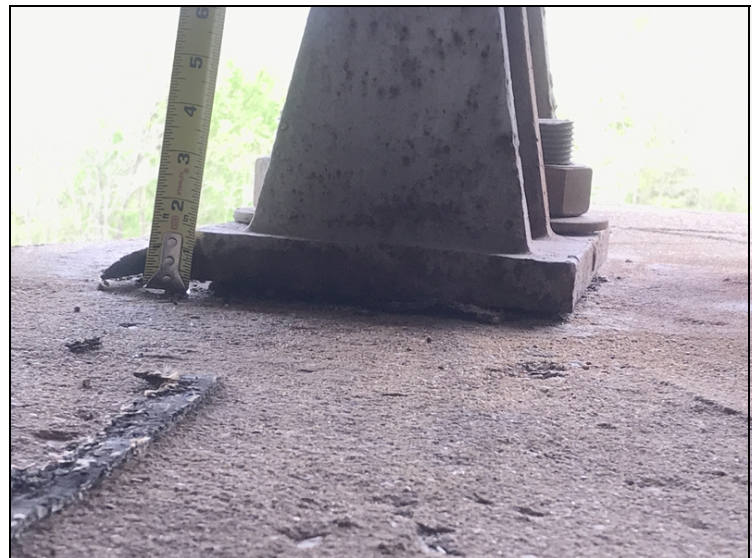
Span 3 Bent 3 bearing 7

Span 3 bent 3 fixed bearing 7 is rotated back. Bearing has a 1/2" gap between front side of bearing and cap.

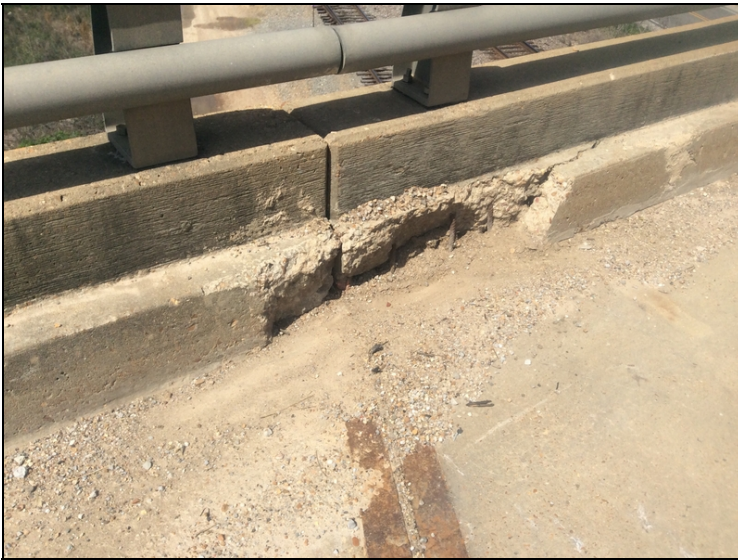
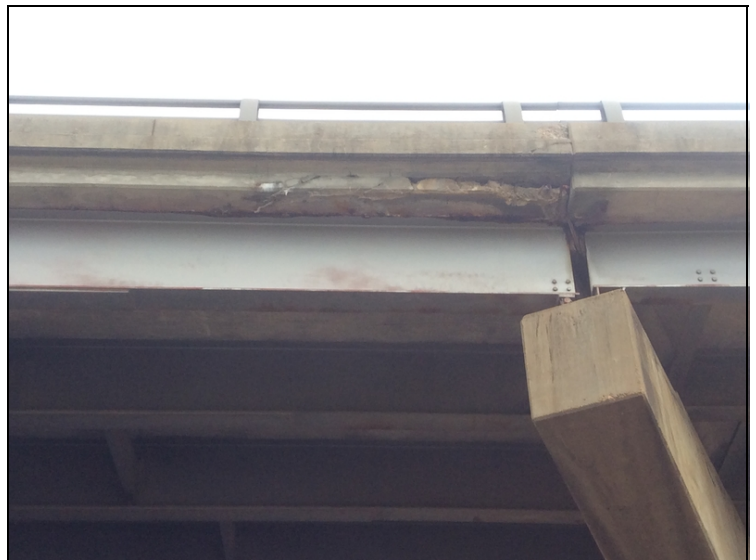
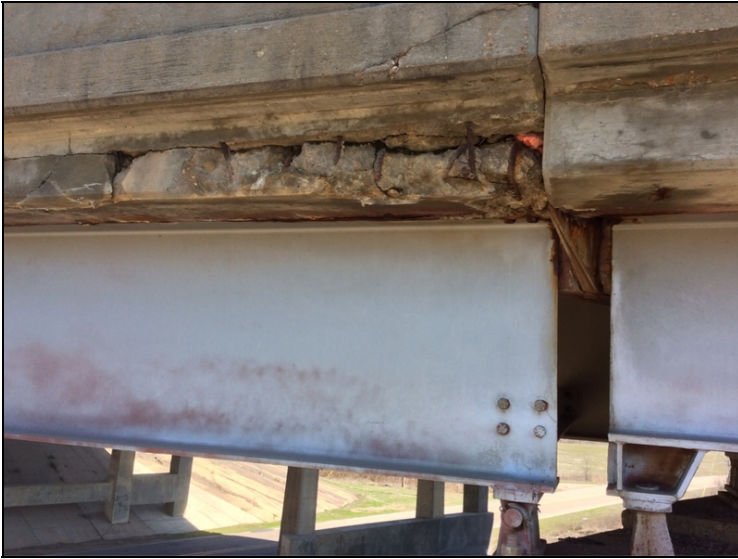
Bent 4 joint is closed. Rt rail and overhang over bent 4 is spalled with 4' of rebar exposed.

Bent 4 Joint has closed, causing damage to Rt. side curb and overhang.

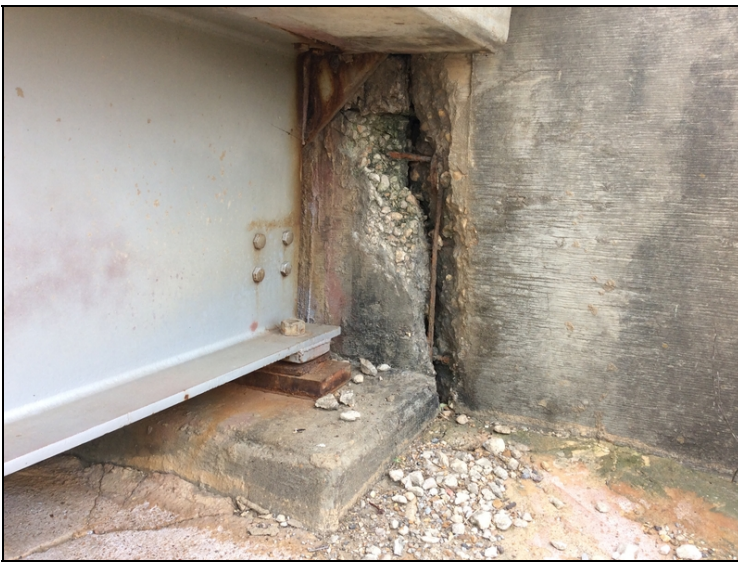
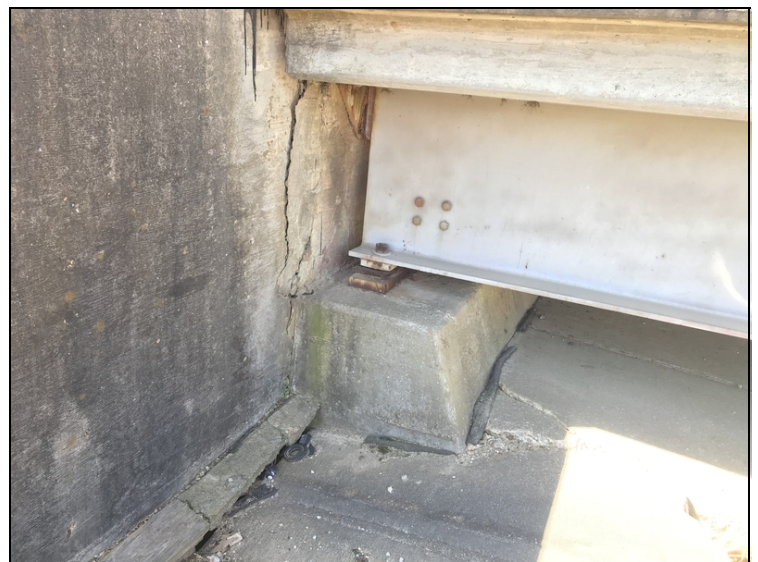
Bent 6 Lt

Bent 6 backwall is cracked/spalled with rebar exposed. Backwall has rotated back towards girders $\frac{3}{4}$ ".

Bent 6 backwall is cracked/spalled with rebar exposed. Backwall has rotated back towards girders $\frac{3}{4}$ ". Cap has wide vertical cracks under bearing 2.

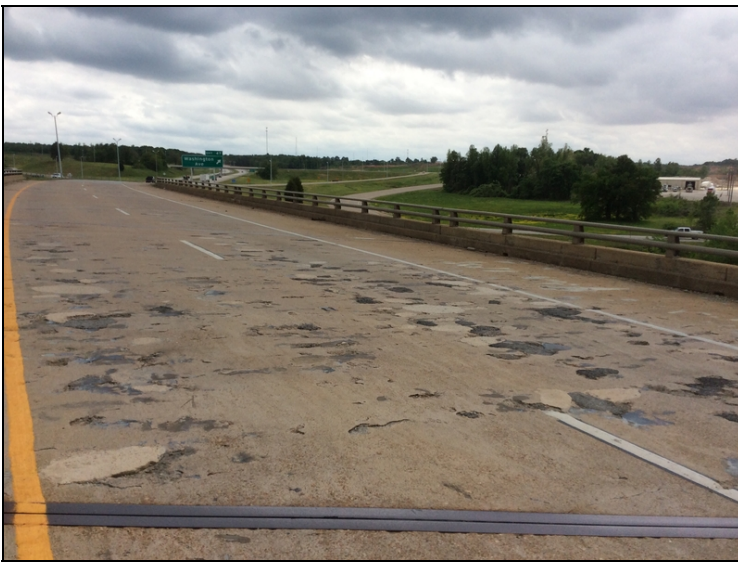
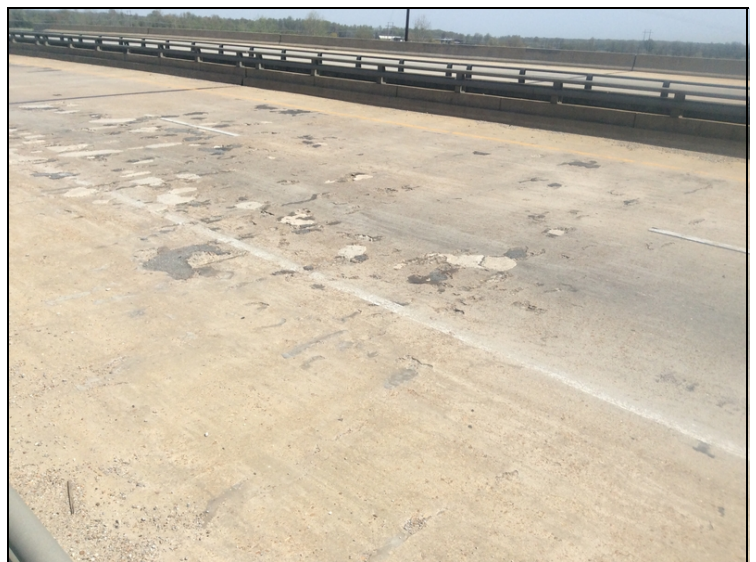
Deck has several spalls, delaminated areas, and unsound patches.
