Bridge #B5204(Routine)

I-555 over SLSW RR; Mahon St.

Location: 4.14 MI NW OF SH 1B

Team Lead: Richard Jones Inspection Date: April 21, 2020

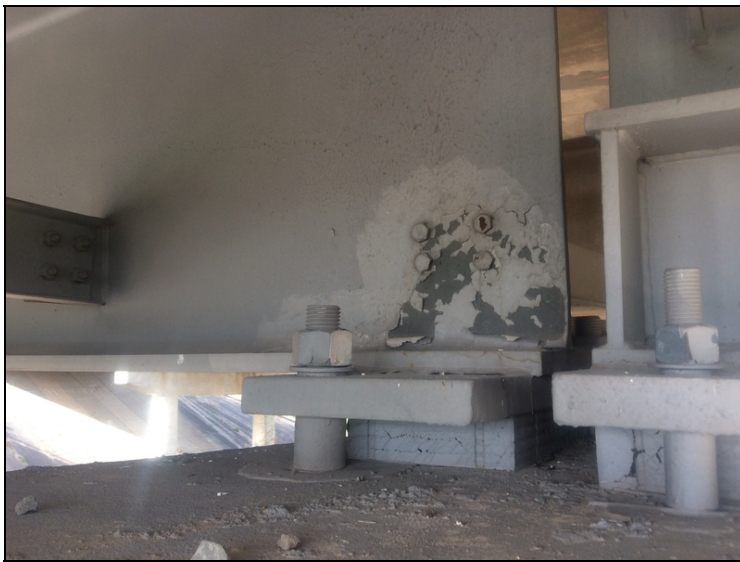
Original steel girders and diaphragms have scattered surface rust throughout.
New girders (1 and 2) have several areas of peeling paint.

Typical paint peeling to Girder 2 of all spans

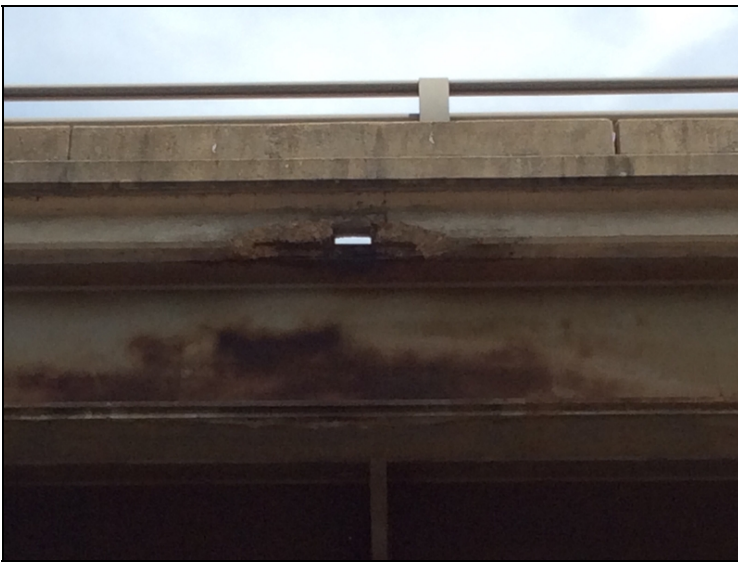
Overhangs have several spalls with rebar exposed at drain openings.
