Bridge #A5205(Routine)

I-555 over LOST CREEK

Location: 4.43 MI NW OF SH 1B

Team Lead: Richard Jones Inspection Date: April 14, 2020

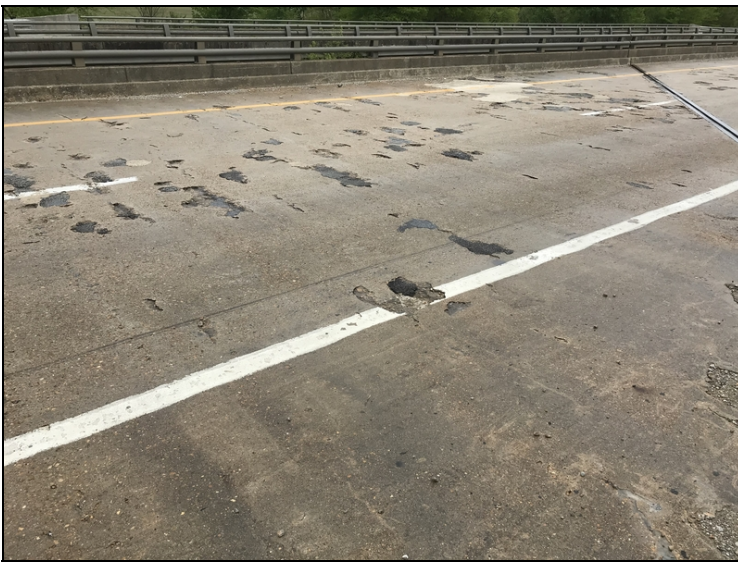
Span 2

Concrete deck has several transverse cracks. Deck has several spalled and delaminated areas along transverse cracks and along joints at ends of spans. Several spalls have rebar exposed.

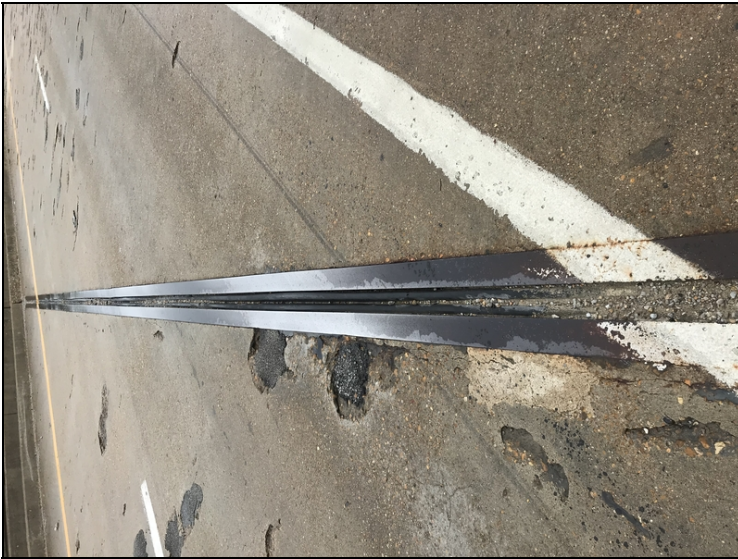
Bent 2 joint

Compression seals have several tears and several areas losing adhesion. Bent 3 joint seal has 15' near Lt gutter that has dropped out of joint armor.

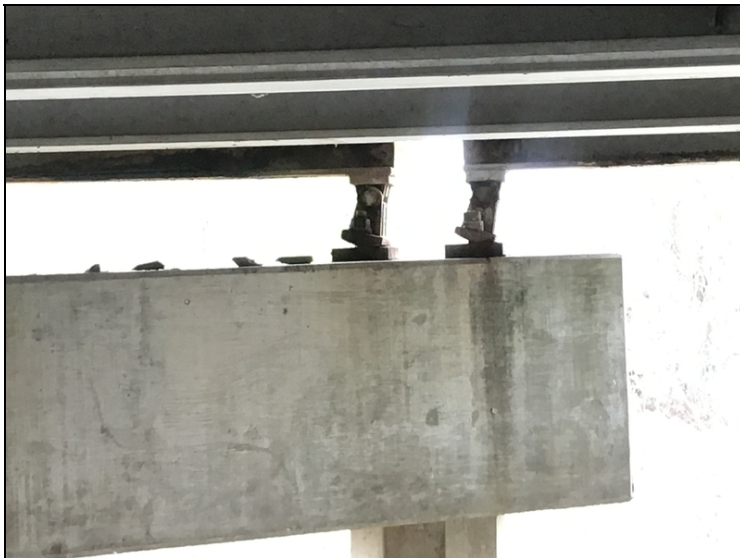
Bent 2 bearing 7

Steel bearings have surface rust throughout. Rocker bearings have some pack rust.  
Expansion bearings at bents 2 and 3 are tilted up to 15 degrees. A few bearings are at or near max rotation.  
Span 2 bent 3 fixed bearing 7 has one anchor bolt sheared off.

Steel bearings have surface rust throughout. Rocker bearings have some pack rust.

Expansion bearings at bents 2 and 3 are tilted up to 15 degrees. A few bearings are at or near max rotation.

Span 2 bent 3 fixed bearing 7 has one anchor bolt sheared off.

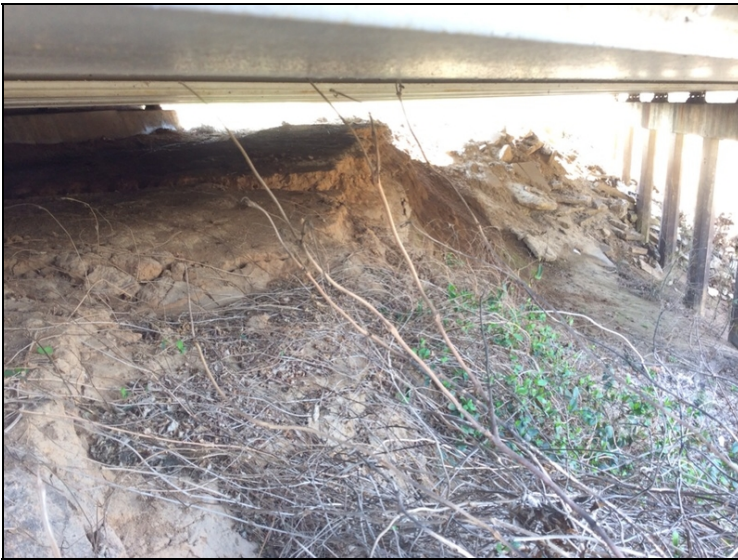
Slope under span 3

Embankment erosion is progressing under and adjacent to span 3.

Embankment erosion is continuing under and adjacent to span 3.

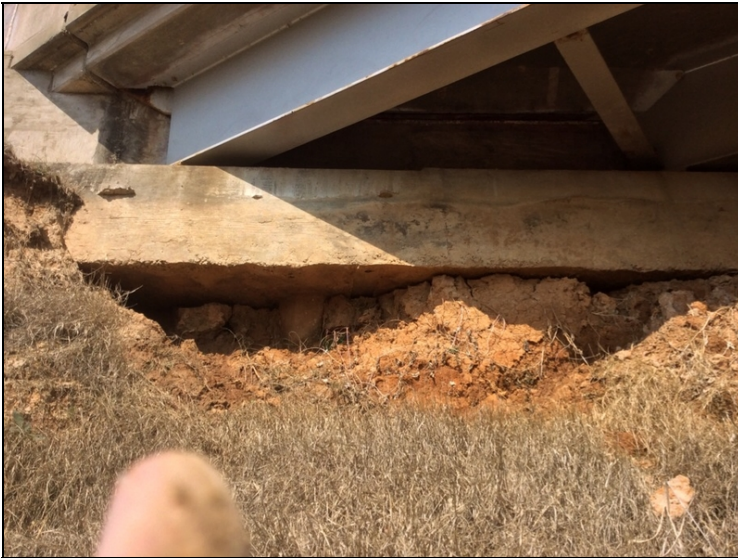
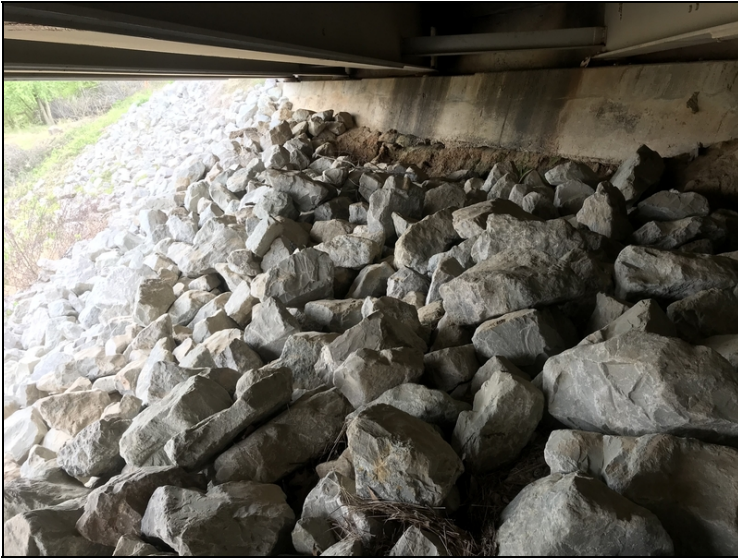
Bent 1 Rt

Rt end of bent 1 abutment is undermined for 12 feet with 1 pile exposed.

Slopes have been lined with stone rip rap.

Embankment under span 1 was lined with rip rap in 2017. Undermined cap at bent 1 was repaired with hand placed rip rap.
