Bridge #B5205(Routine)

I-555 over LOST CR.

Location: 4.43 MI NW OF SH 1B

Team Lead: Richard Jones Inspection Date: April 14, 2020

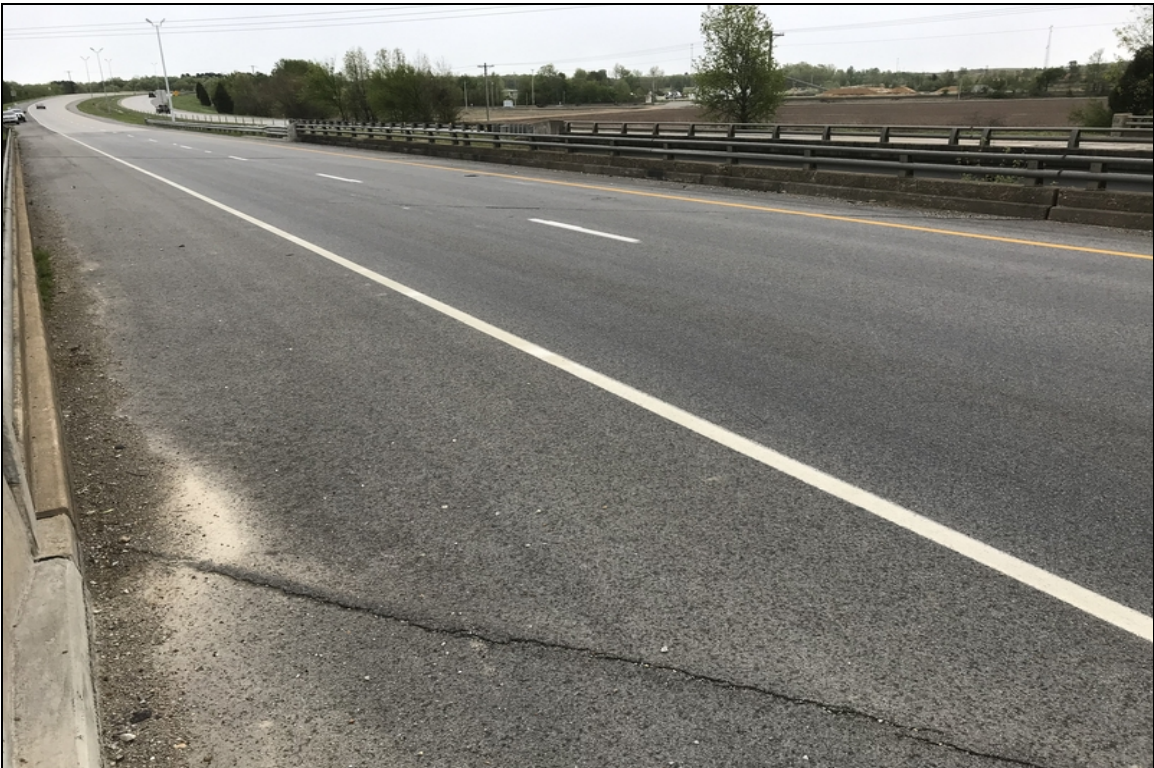
Wearing surface

Asphalt wearing surface has a few potholes in Rt lane at span 2. Exposed deck has some rebar exposed.

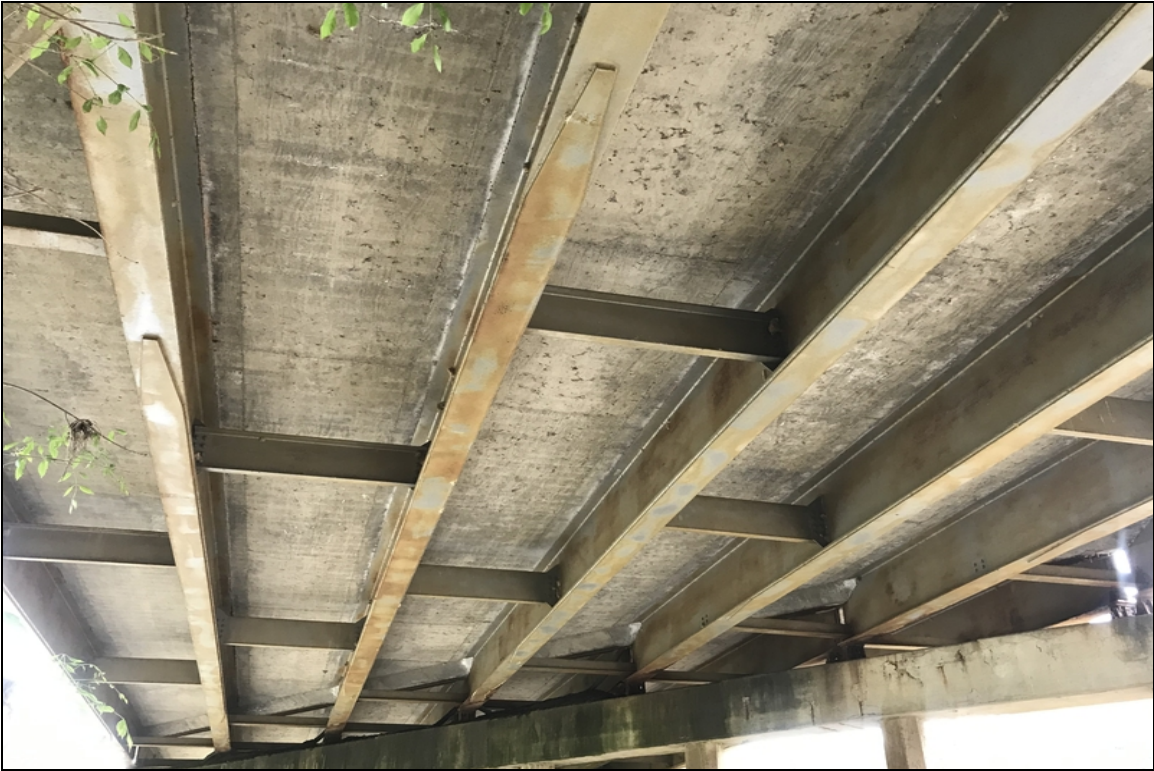
Soffit

Concrete deck has been noted in past inspections as having several cracks, delaminated and patched areas, and spalls with some rebar exposed.

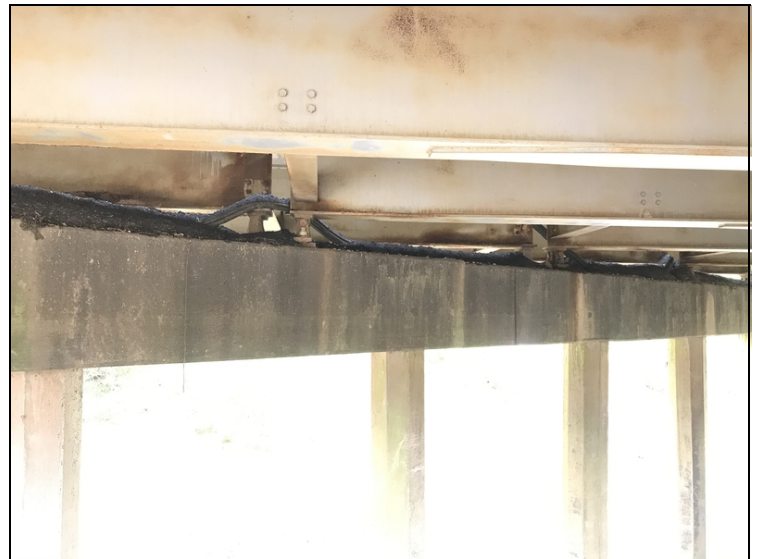
Bent 2 moveable bearings have heavy pack rust and section loss.
Bent 3 bearings are covered with asphalt debris.

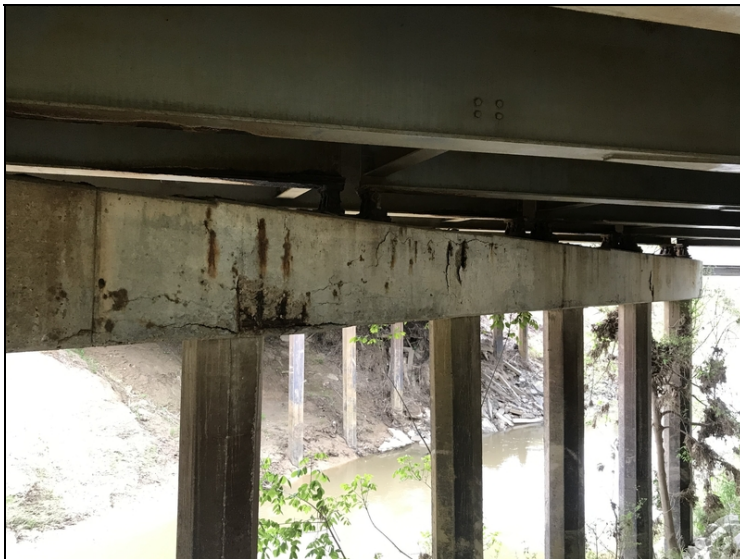
Bent 2 cap has several cracked/delaminated areas and spalls with rebar exposed. Cap has wide cracks/delaminated areas on bottom of cap from pile 3 to pile 5.

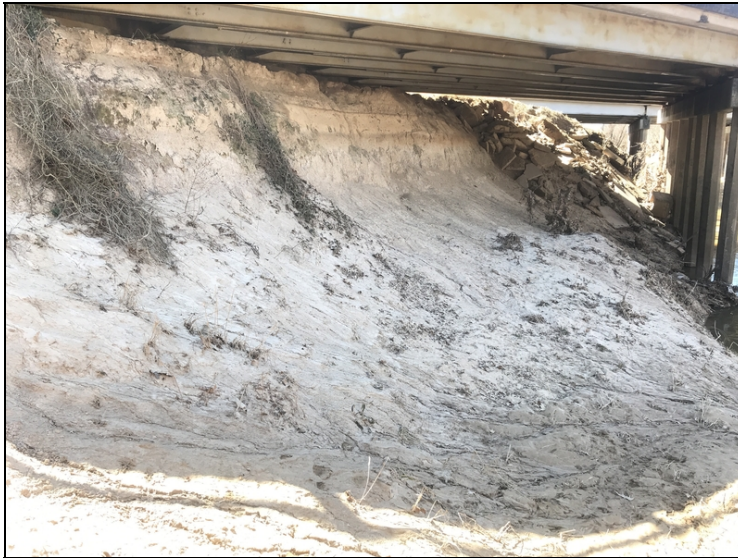
3/5/19 - Bent 4 embankment

Embankment under span 3 and on Lt side of bridge has on-going erosion. Rip rap and broken concrete placed on Rt side has slid down slope and is resting against bent 3 piles. Broken concrete is catching drift. Approximately 5' – 10' of berm remains in front of bent 4.
