Bridge #A5206(Routine)
I-555 over BIG CREEK DITCH
Location: 4.55 MI NW SH 18

Team Lead: Richard Jones Inspection Date: April 14, 2020

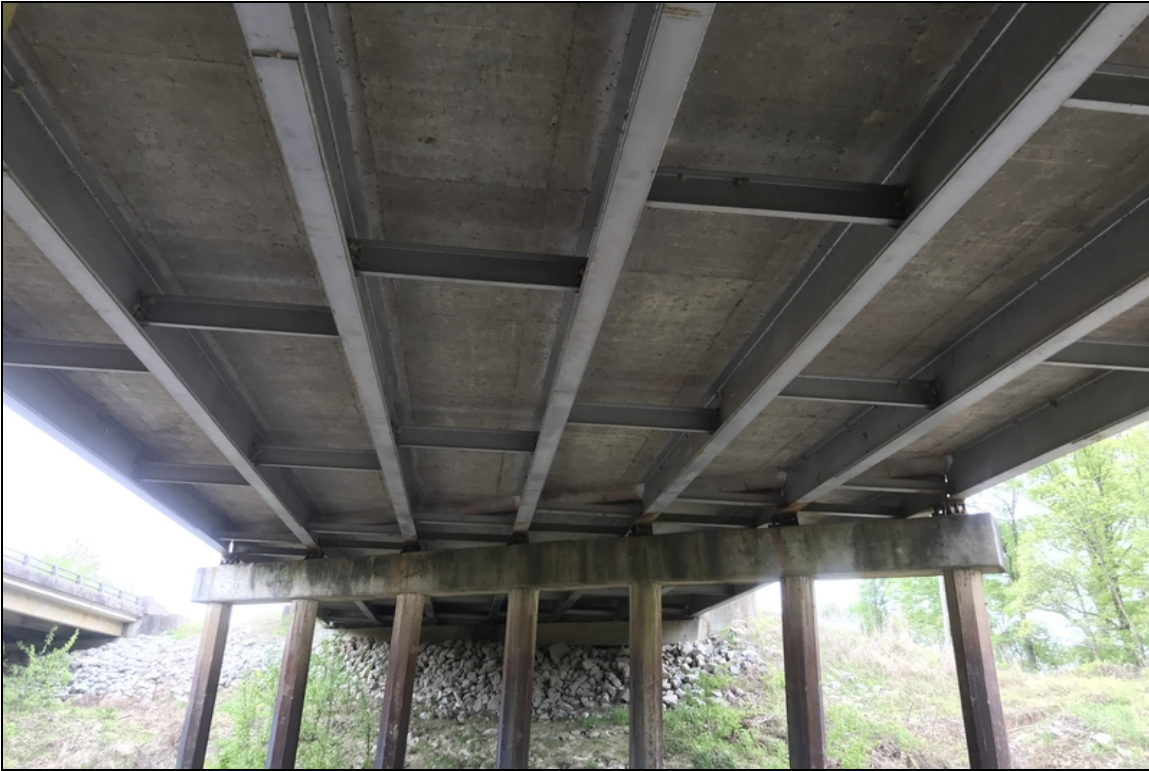
soffit

Soffit has a few cracks with efflorescence and/or rust stains, especially at span 3

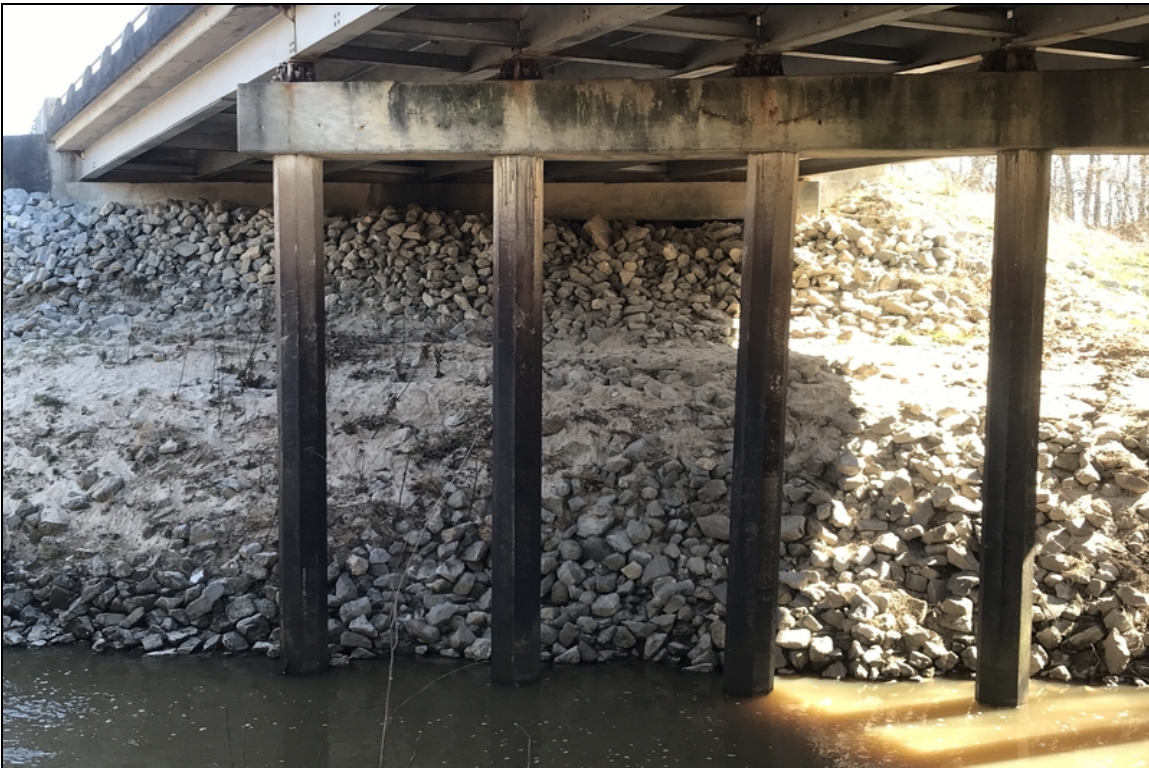
Bent 4 Embankment

Embankment under span 3 was lined with rip rap in 2017. Undermined cap and approach slab at bent 4 was repaired with flowable fill and hand placed rip rap.

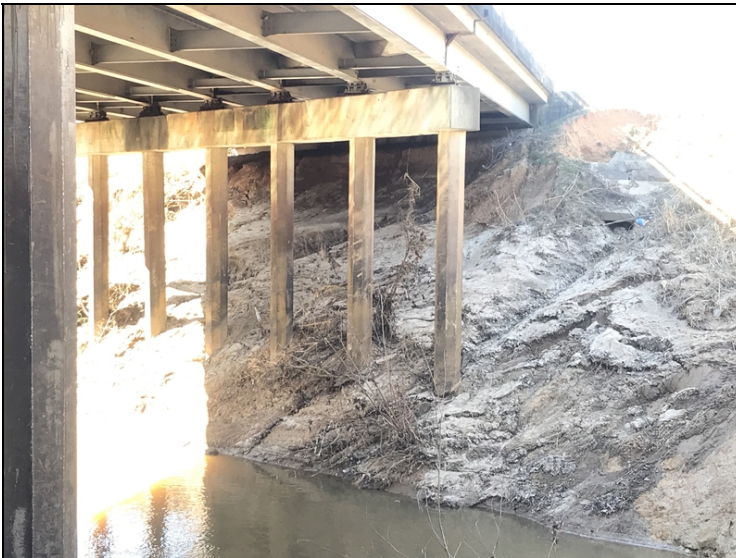
Bent 1 Embankment

Embankment erosion is continuing under span 1 with some slides/loss of fill.

Date Reported: 04/28/2011
Priority: C - Important
Type of Work: Repair
Status: Assigned
Component: Channel

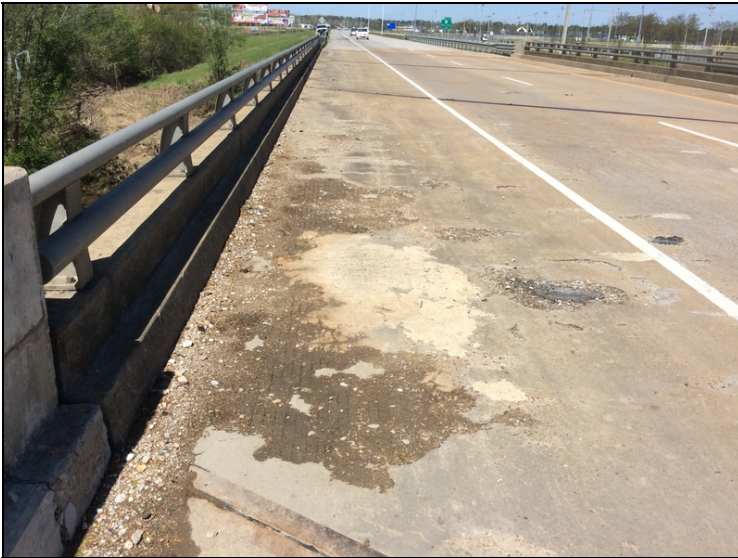
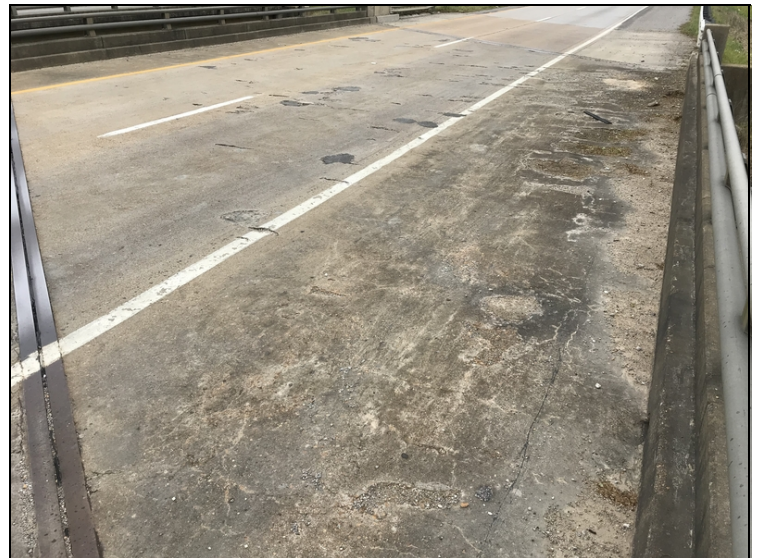
Span 3

Deck has several unsealed moderate width transverse cracks. Deck has several delaminated areas and spalls with rebar exposed along transverse cracks, especially at spans 2 and 3.

Gutters have several areas of map cracking, and several spalled and delaminated areas.

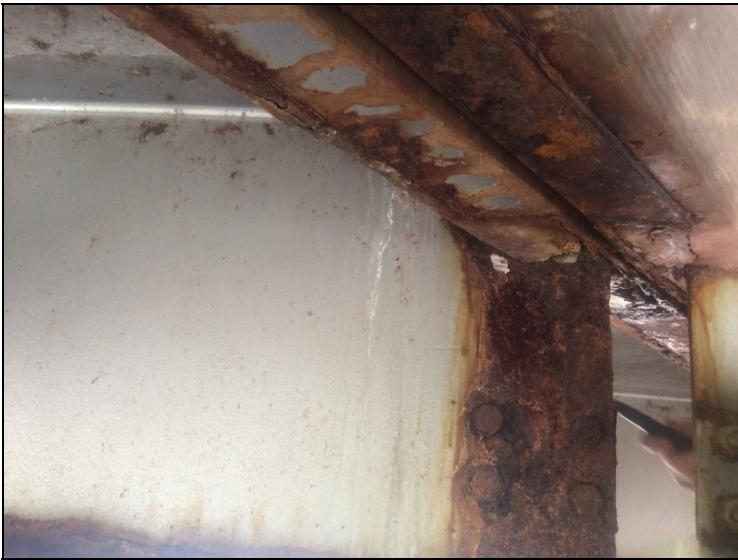
Span 1 bent 2 girder 4 has a 1" diameter hole in web below haunch.

Date Reported: 04/20/2018
Priority: C - Important
Type of Work: Repair
Status: Monitor
Component: Superstructure

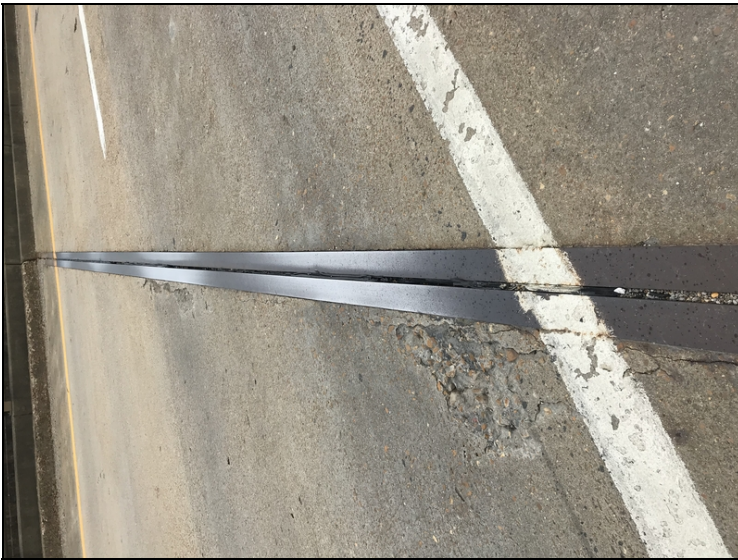
Compression seals are cracked, torn, and have a few areas losing adhesion.

Date Reported: 04/28/2020
Priority: C - Important
Type of Work: Replace
Status: Open
Component: 302 - Compression Joint Seal
