Bridge #B5206(Routine)

I-555 over Big Creek

Team Lead: Richard Jones Inspection Date: April 14, 2020

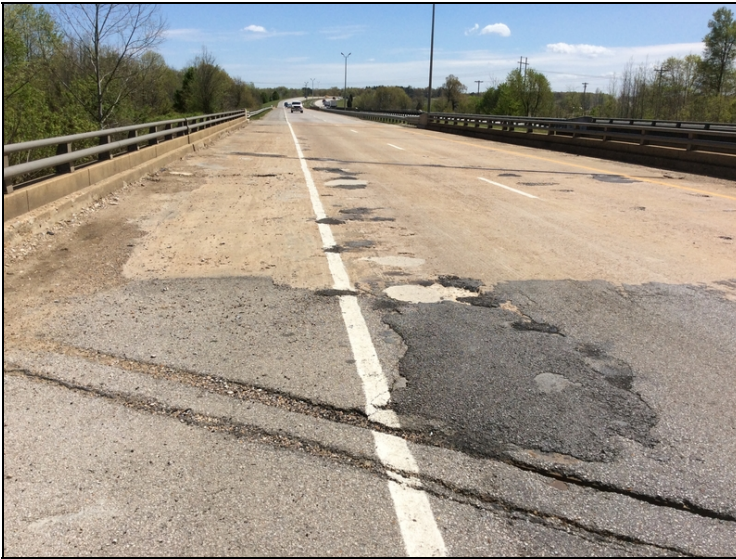
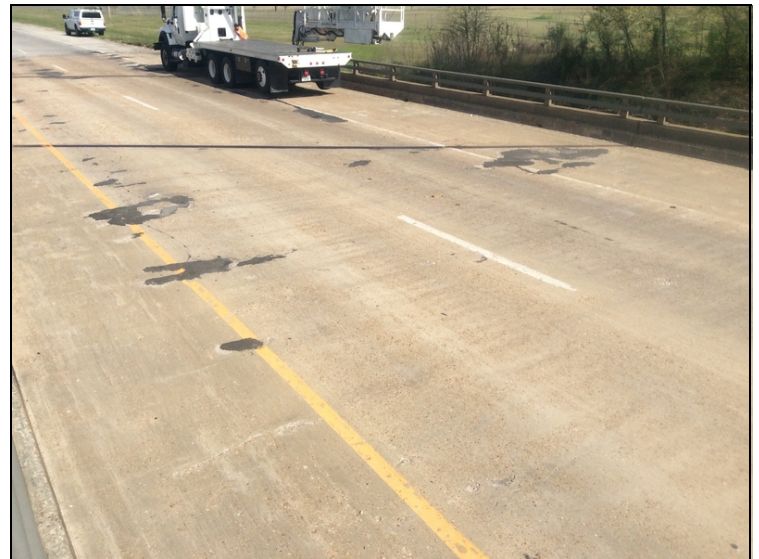
Deck has been reported as having several cracks; spalls, delaminated areas, and patches in the wheel path; and some spalls with rebar exposed.

Deck and approach slabs received an asphalt overlay in 2018.

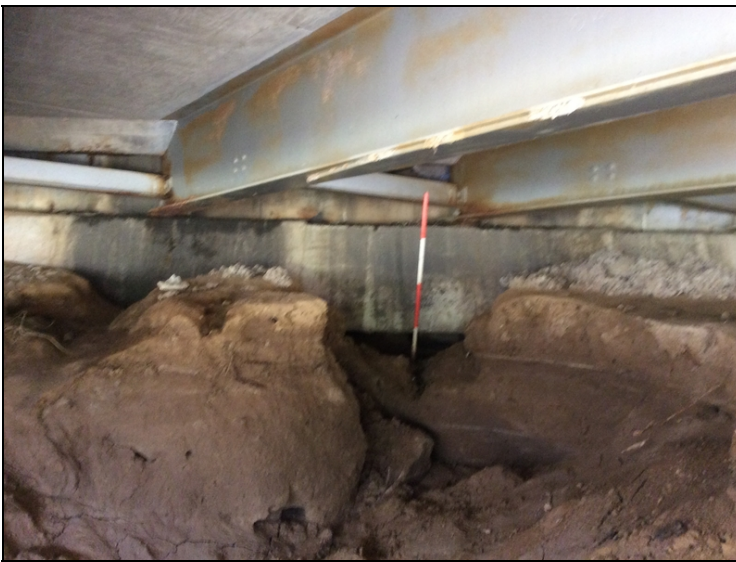
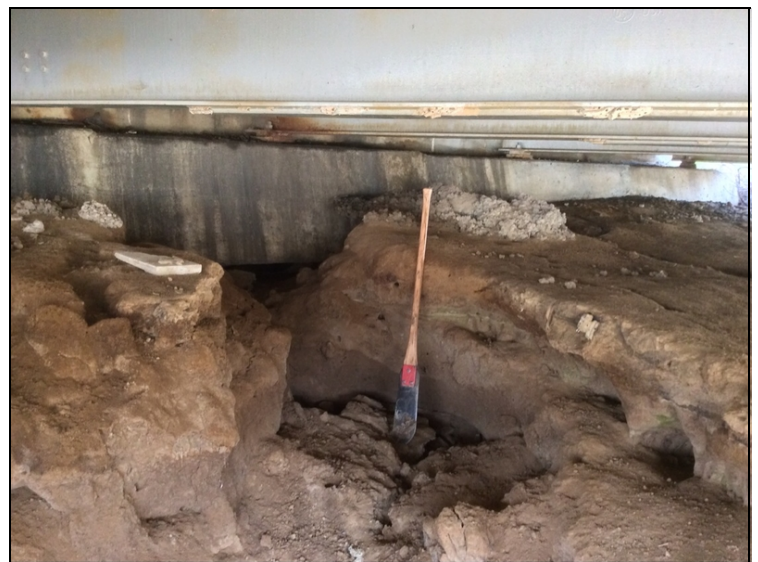
Bent 1 abutment is undermined for 6' near centerline up to 1' below cap and 2' back under.

Bent 1 is undermined near center line.

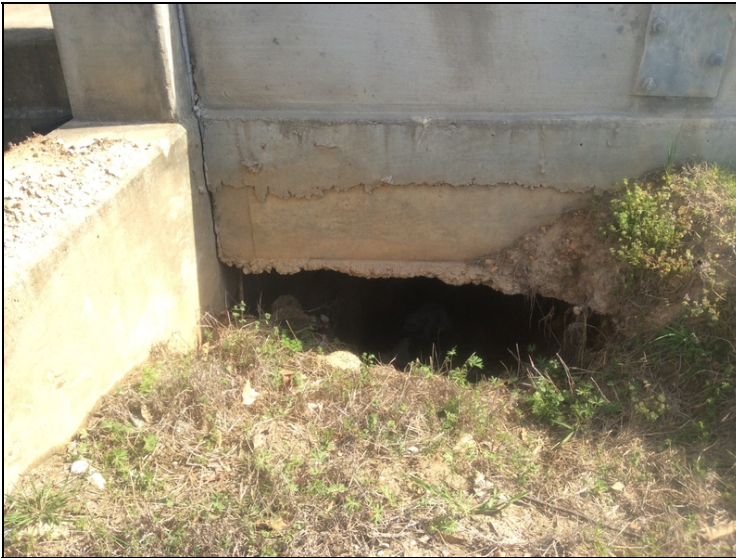
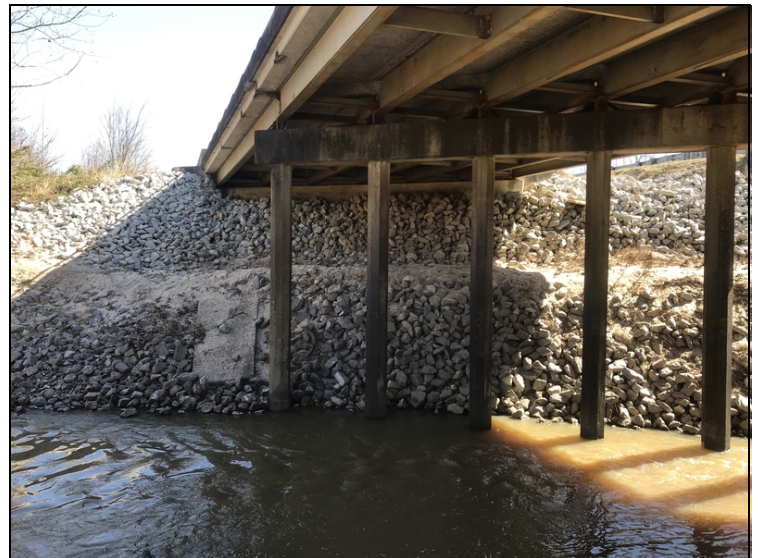
Bent 4 Embankment

Large Void Right side of bent 4 undermining back under approach slab, See photo 2018.

Embankment under span 3 was lined with rip rap in 2017. Undermined cap and approach slab at bent 4 was repaired with flowable fill and hand placed rip rap.
