Bridge #06858(Routine)

SH 91-02- LM 12.08 over US HWY 63

Location: JCT. US HWY 63 & 91

Team Lead: Richard Jones Inspection Date: August 18, 2020

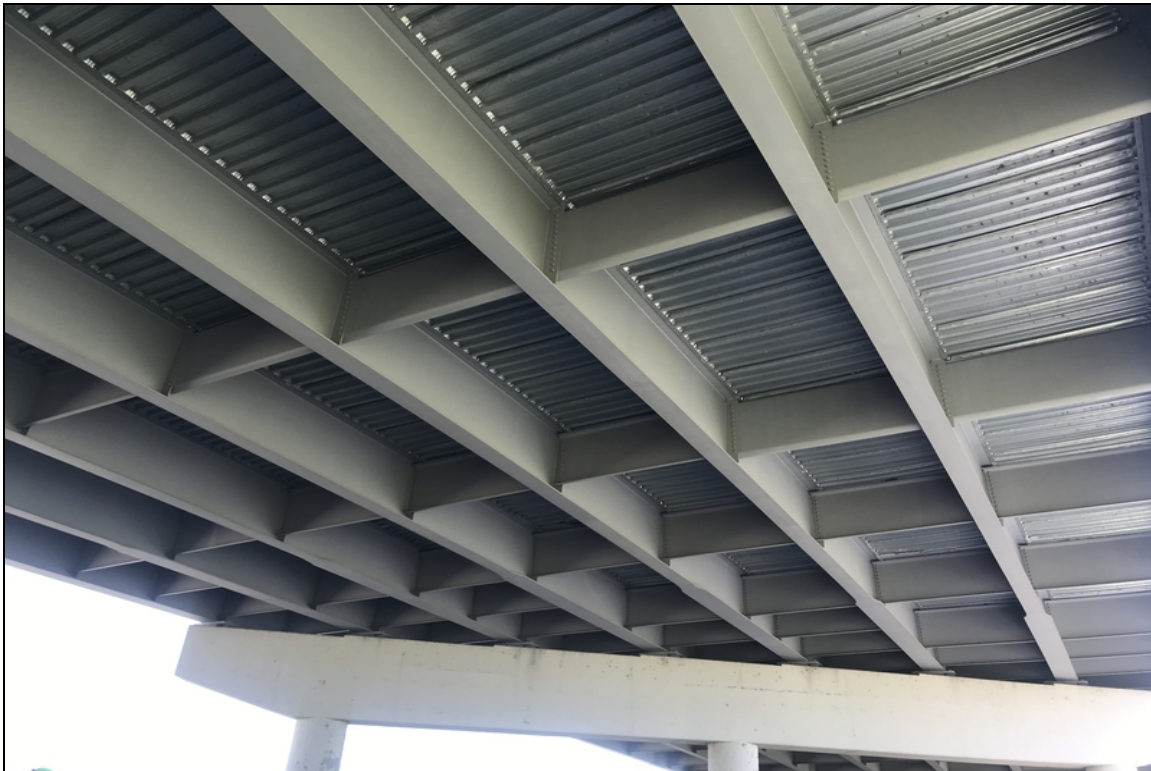
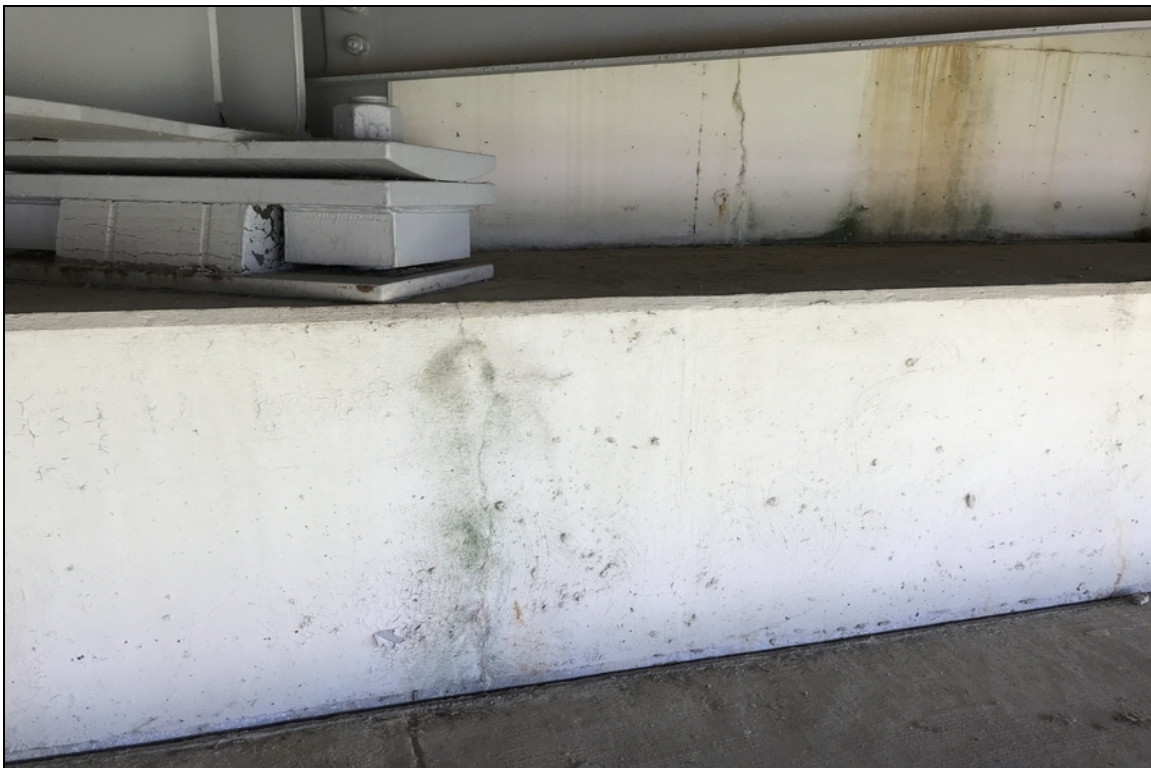
Abutment cracks

Abutments have several vertical cracks. A few have efflorescence.

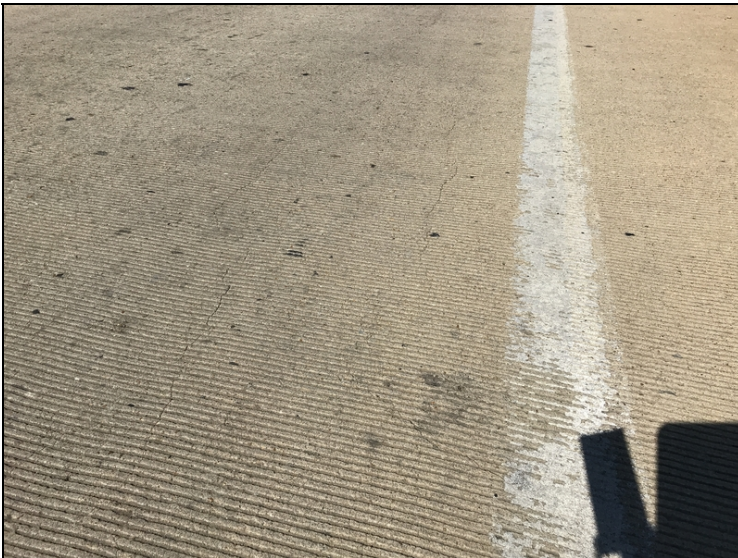
Deck has several unsealed transverse and longitudinal cracks.

Typ longitudinal cracks

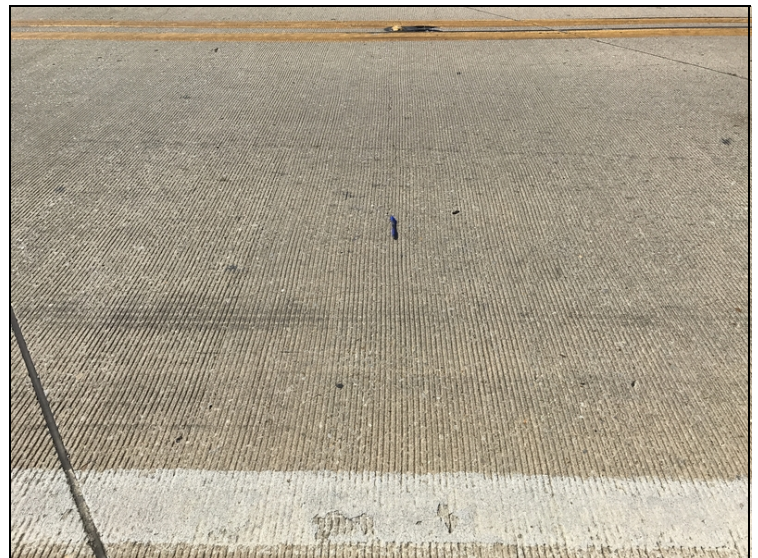
Typ transverse cracks

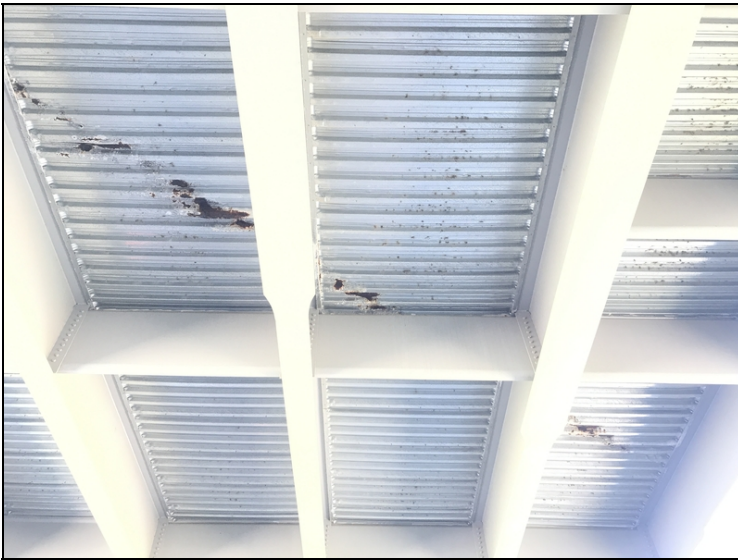
Span 3 stay in place forms have rust with areas of section loss near 3/4 point.

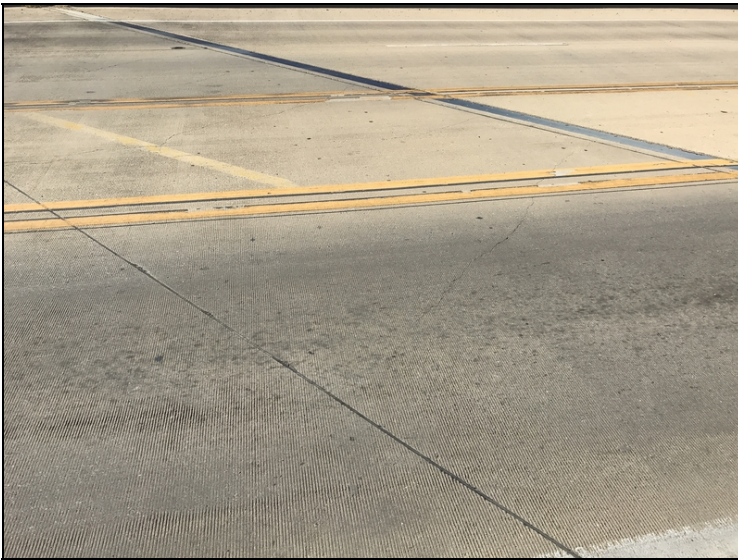
Approach slabs have several wide unsealed cracks.

Approach slab at end

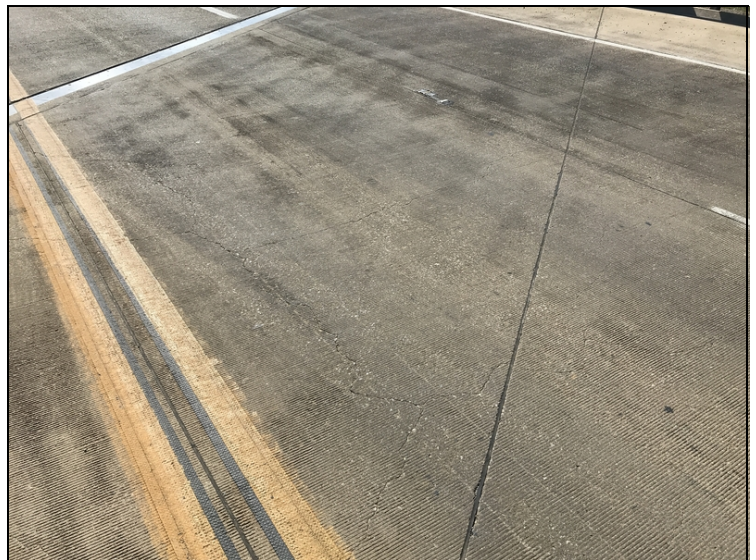
Approach slab at bent 1
