**Bridge #06888(Routine)**  
**STATE HWY 91 over BIG CREEK**  
**Location: 1.58 MI E JCT US 63**

**Team Lead: Richard Jones Inspection Date: October 06, 2020**

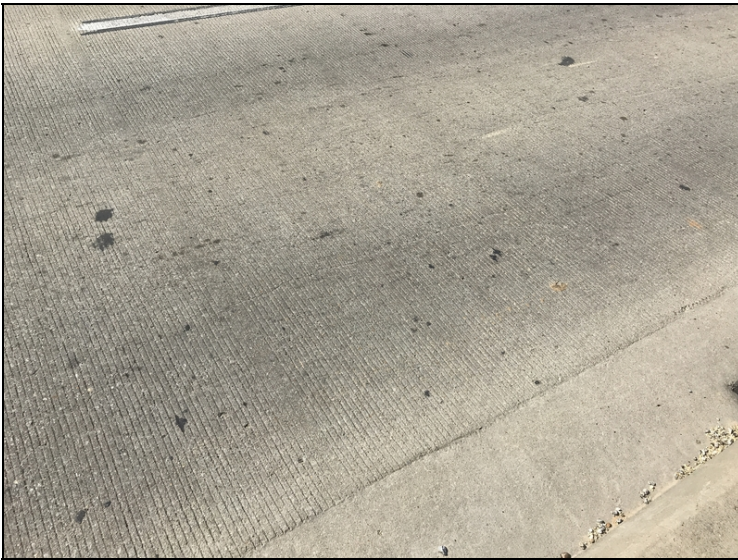
Deck has a few unsealed longitudinal and transverse cracks.

Deck cracks

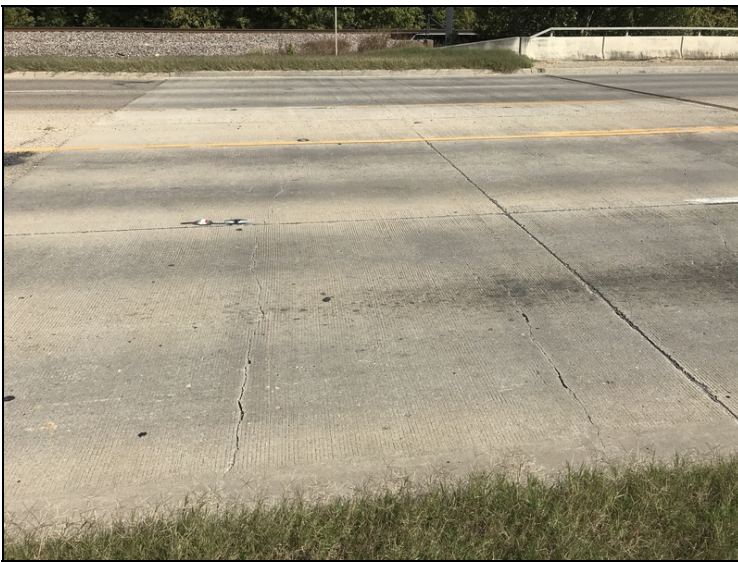
Approach slabs have wide unsealed transverse cracks.

Bent 1 approach slab

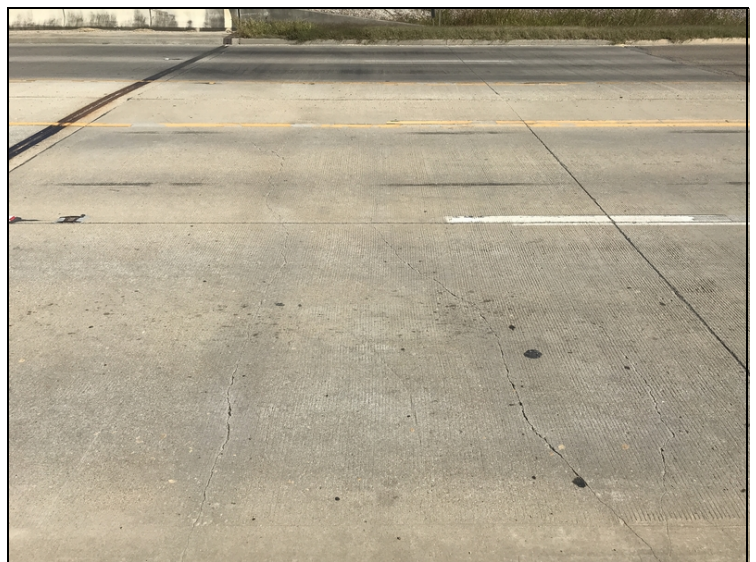
Bent 4 approach slab

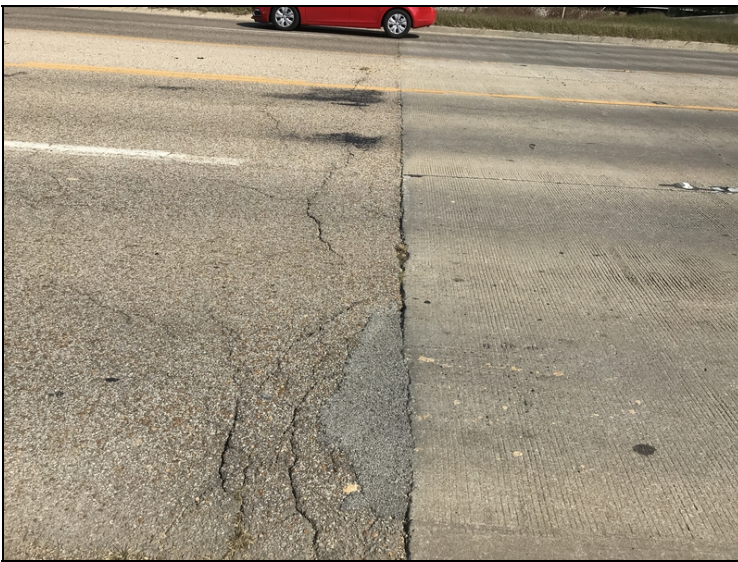
Approach roadway asphalt has settlement at end of approach slab at bent 1.

Bent 1 approach
