Bridge #06889(Routine)

SH 91 over LOST CREEK

Team Lead: Richard Jones Inspection Date: October 06, 2020

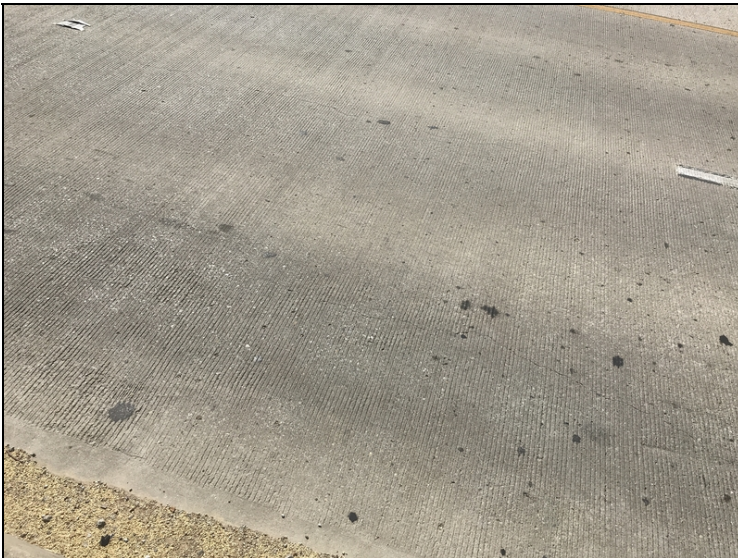
Deck has a few unsealed longitudinal and transverse cracks.

Deck cracks

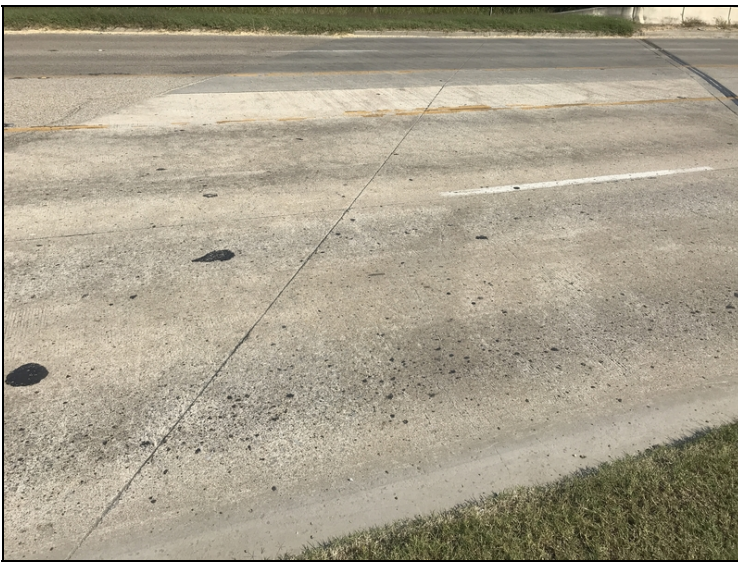
Bent 1 approach slab

Concrete approach slabs have several unsealed cracks.

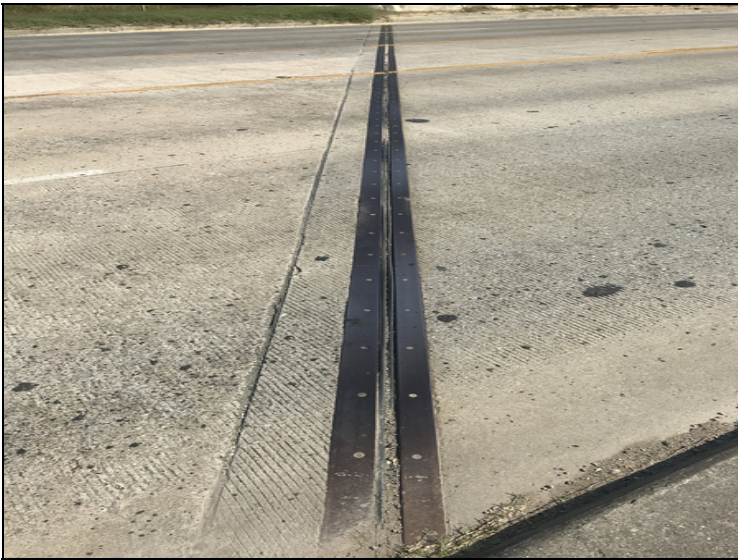
Bent 1 joint

Joint seals are beginning to lose adhesion.
